# **PALANGA GOAT SHELTER**

ERGİNOĞLU & ÇALIŞLAR

# PAAF\_PALANGA ART AND ARCHITECTURAL FARM

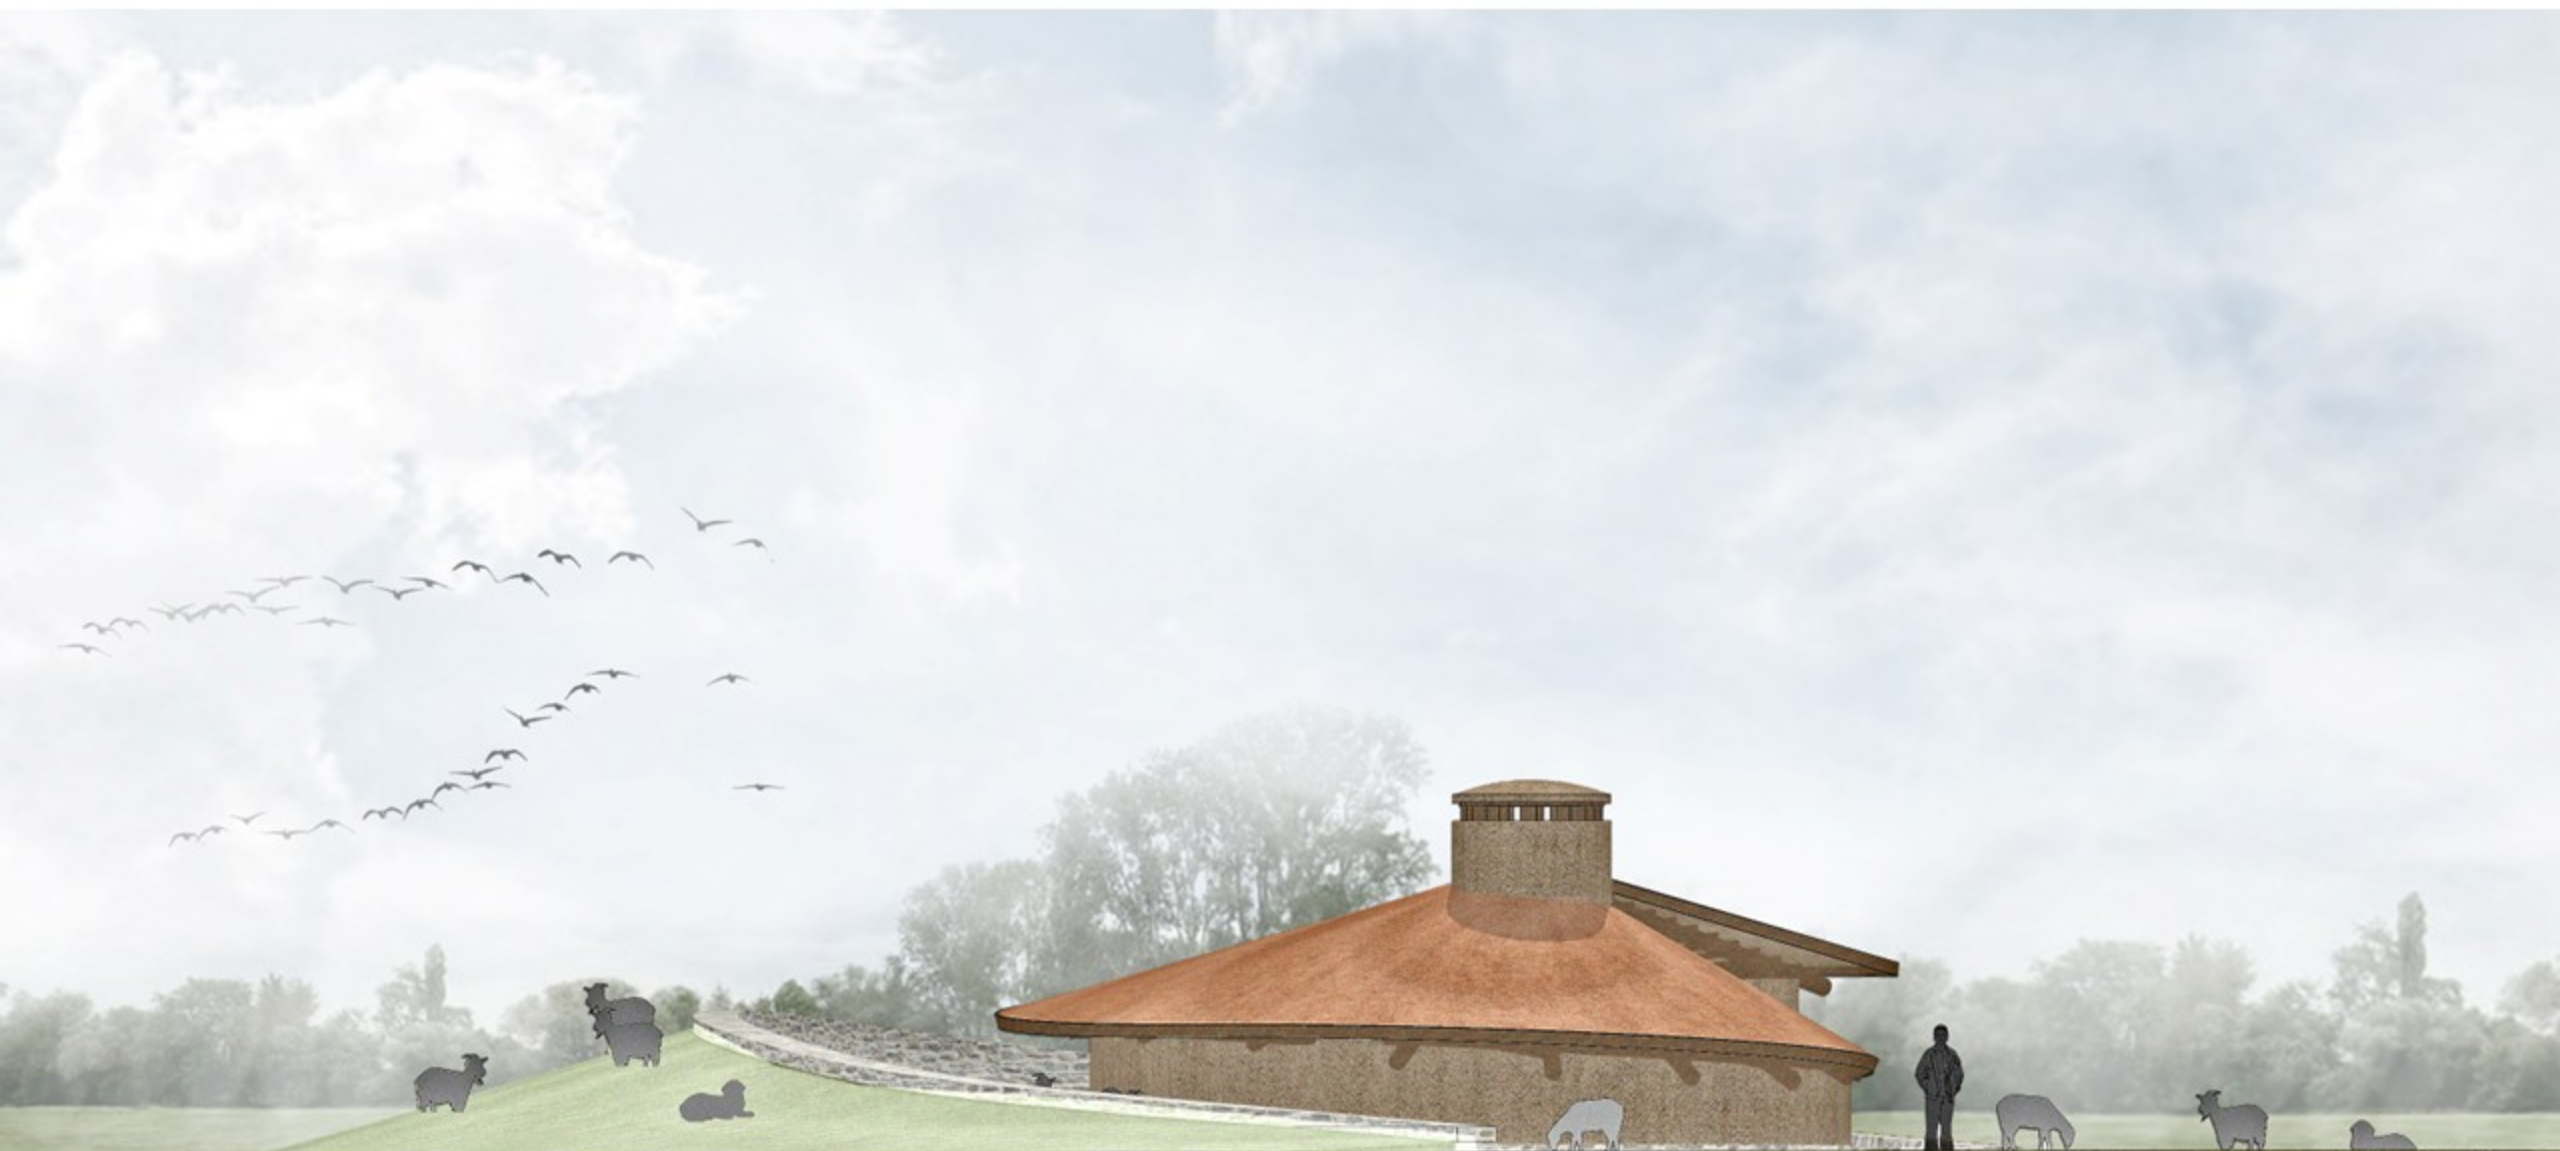
**ROOF AND WIND BARRIER RELATION**

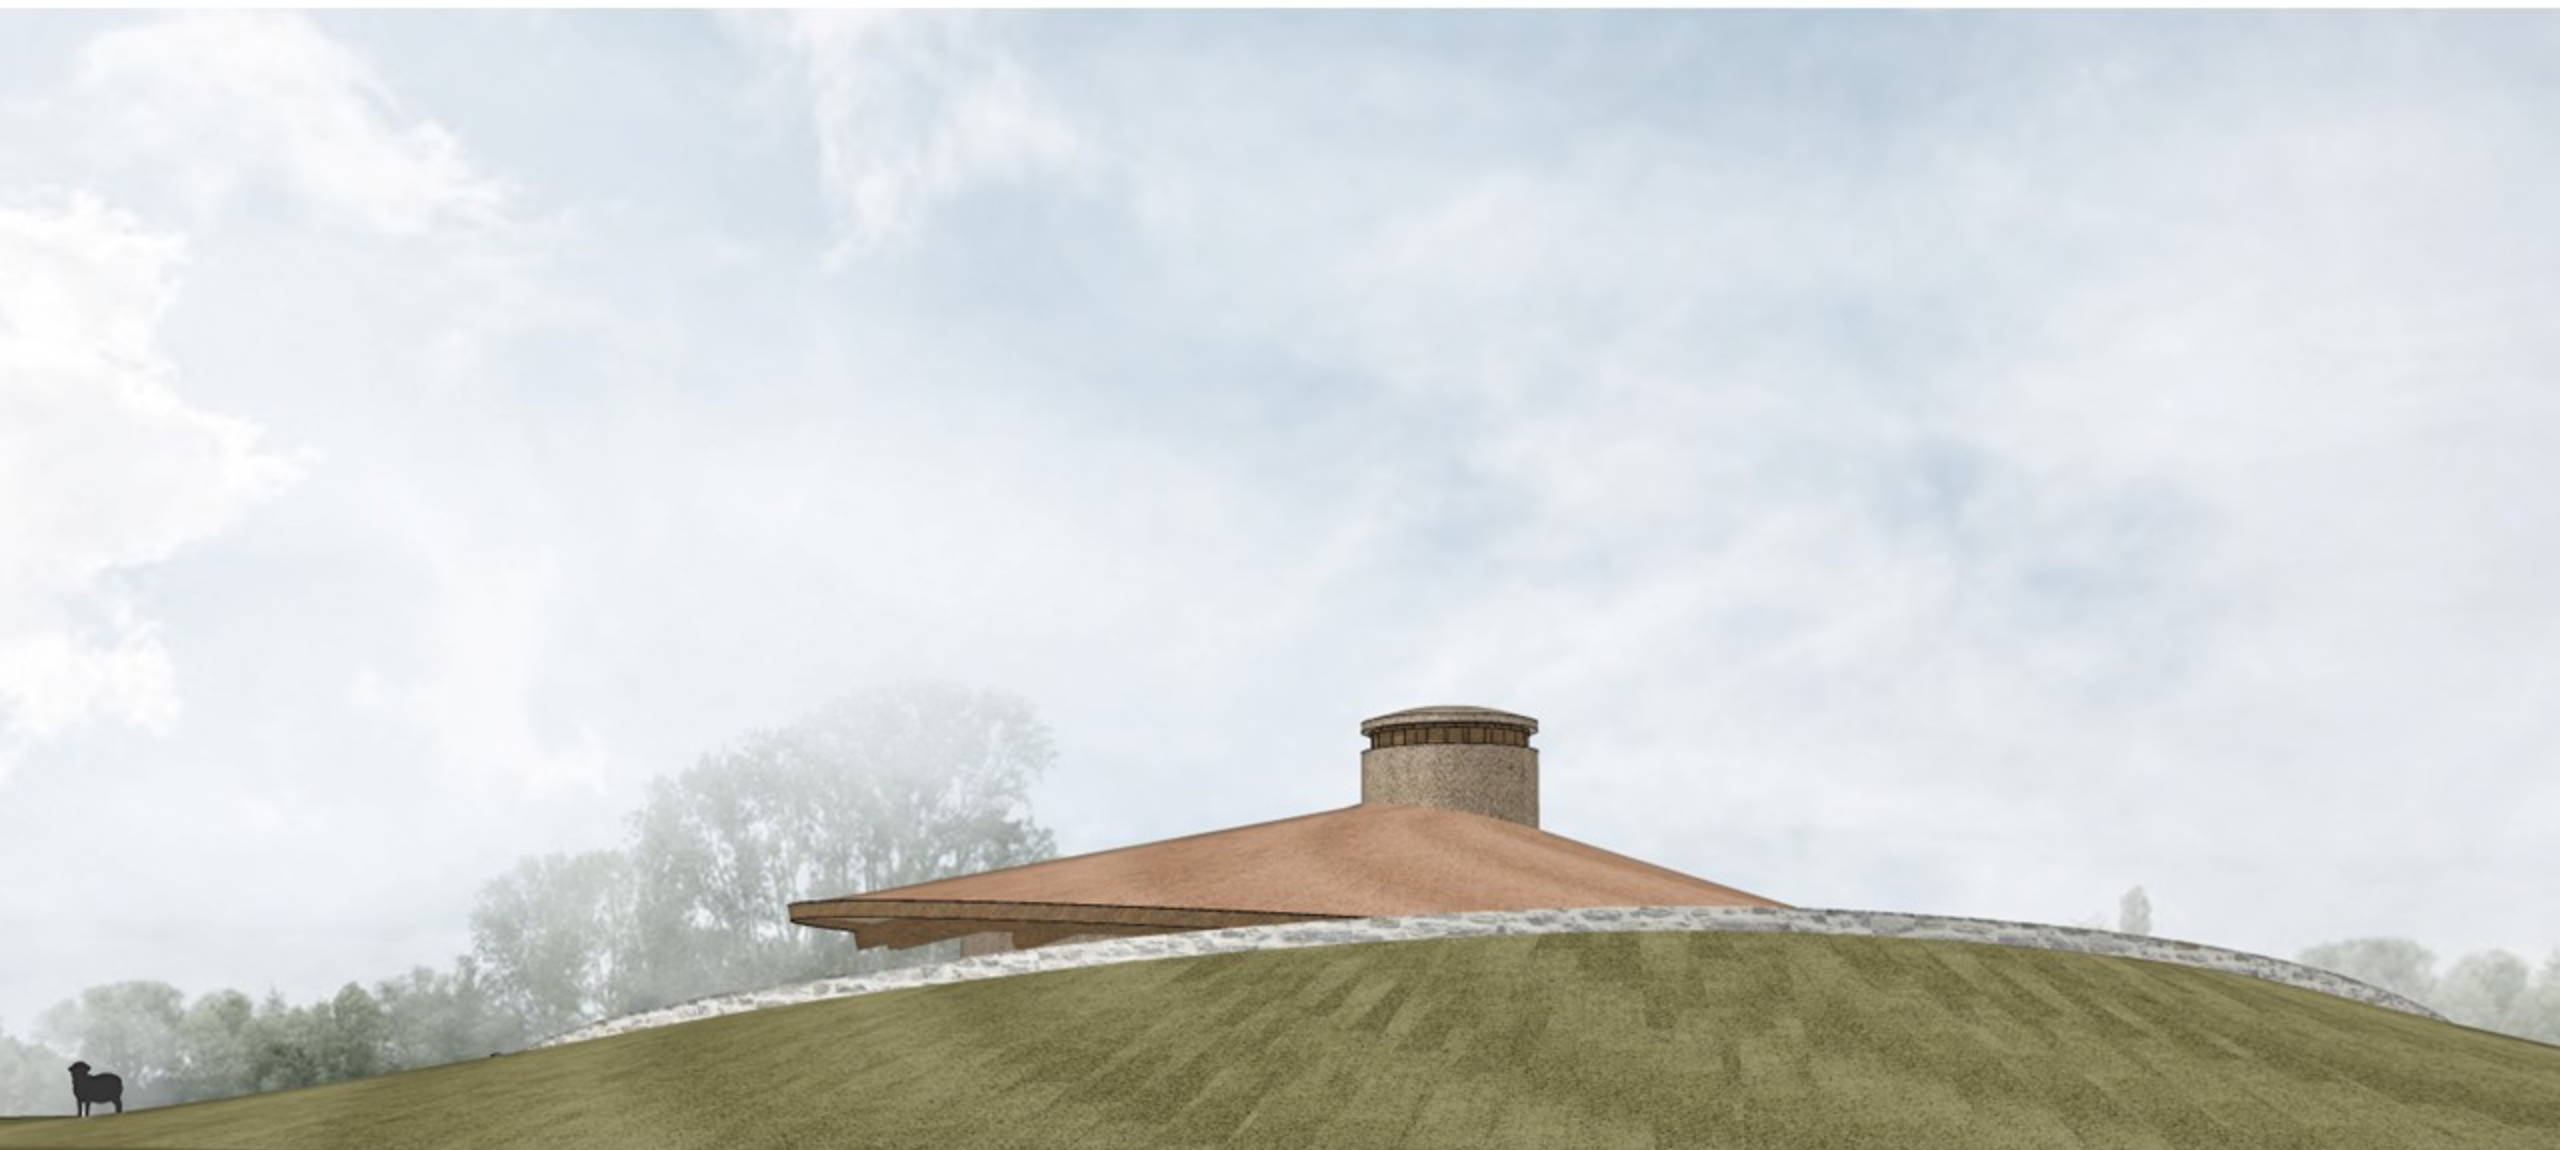
**ROOF BEHIND THE WIND BARRIER**

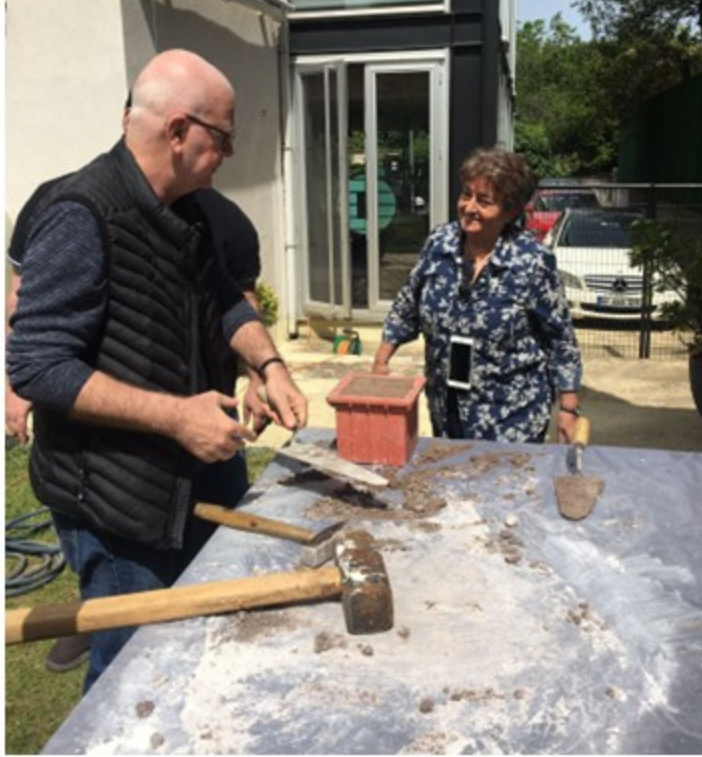
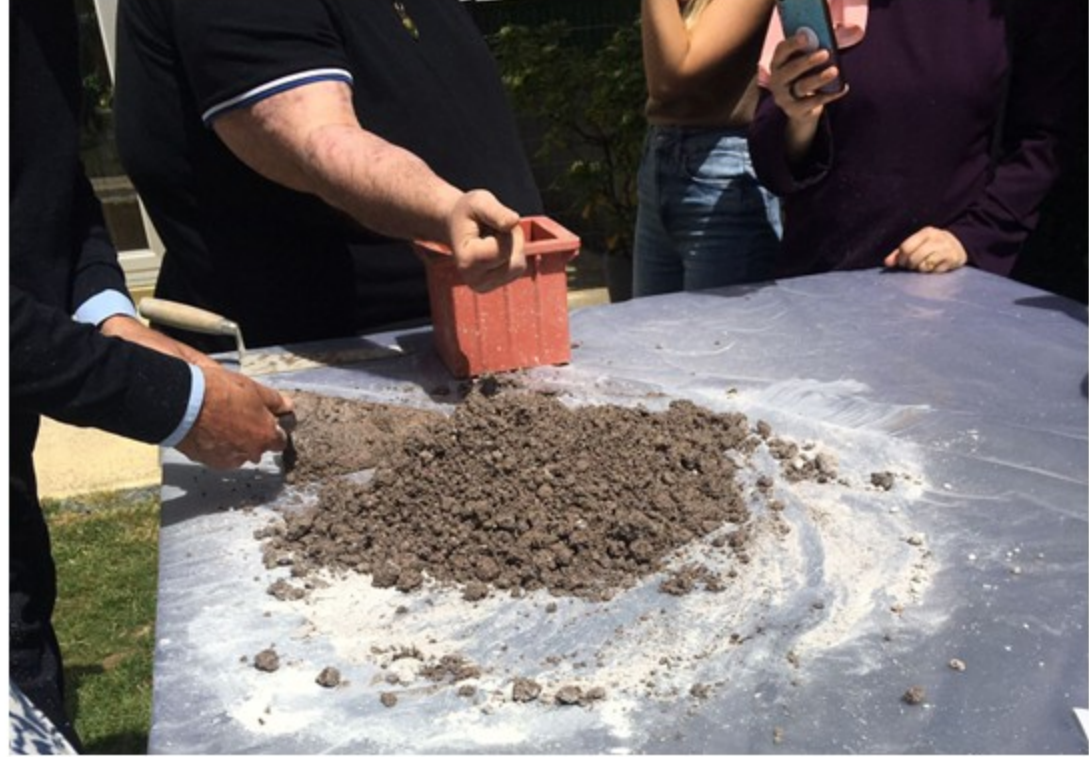
Rammed Earth Workshop with the sample soils from Erzincan, 26 May 2021,  
Participants: Prof. Dr. Bilge Işık, Suat Işık, Suat Güvenç, Dilara Demiralp

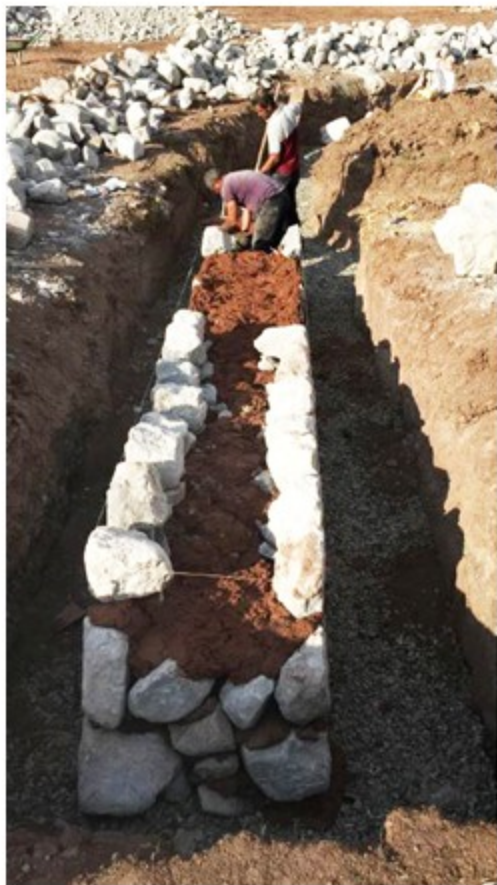
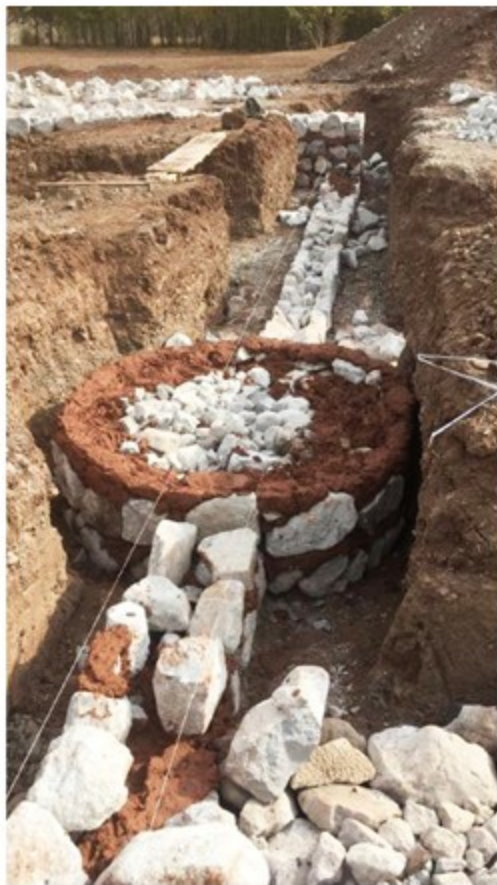
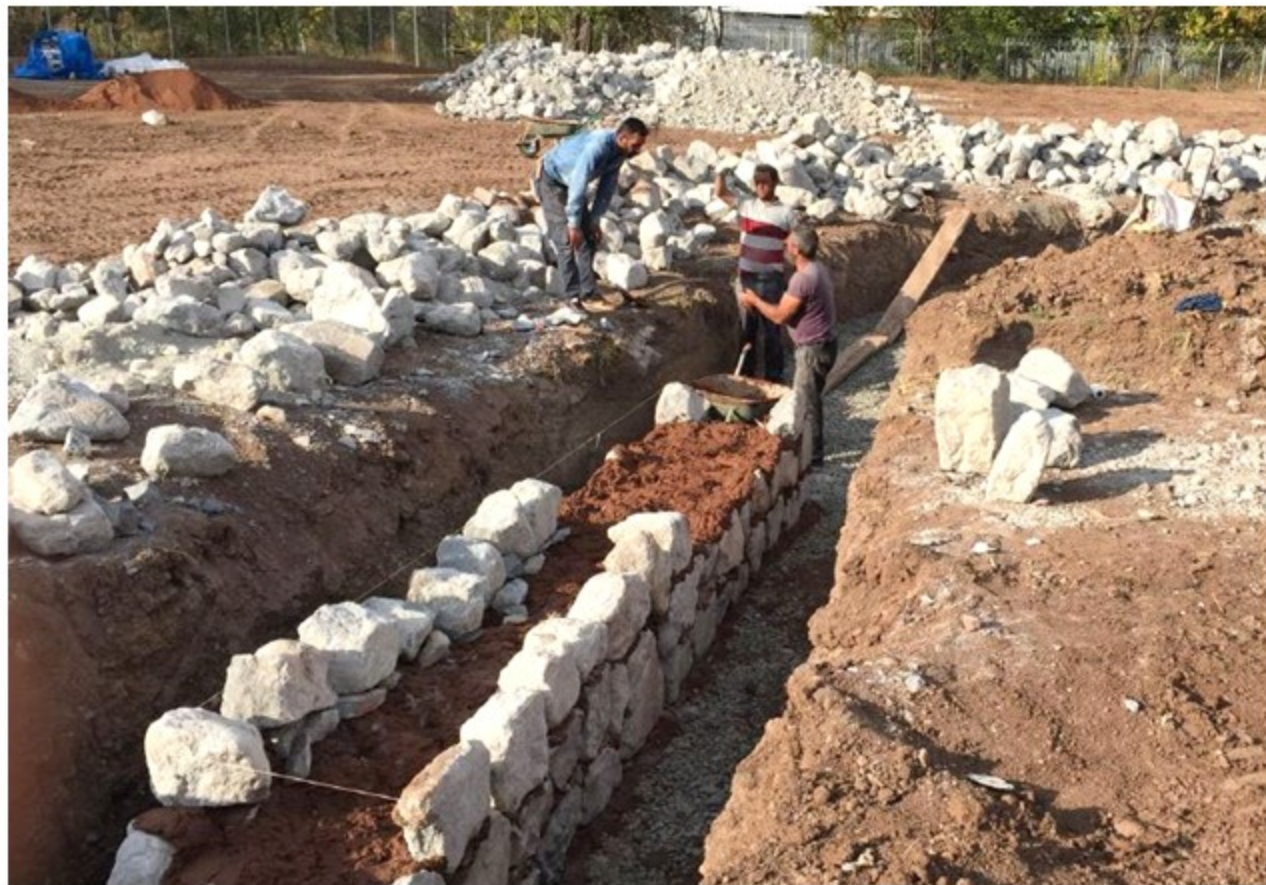
**BLOCKAGE LAYER and KHORASAN MORTAR MATERIALS**

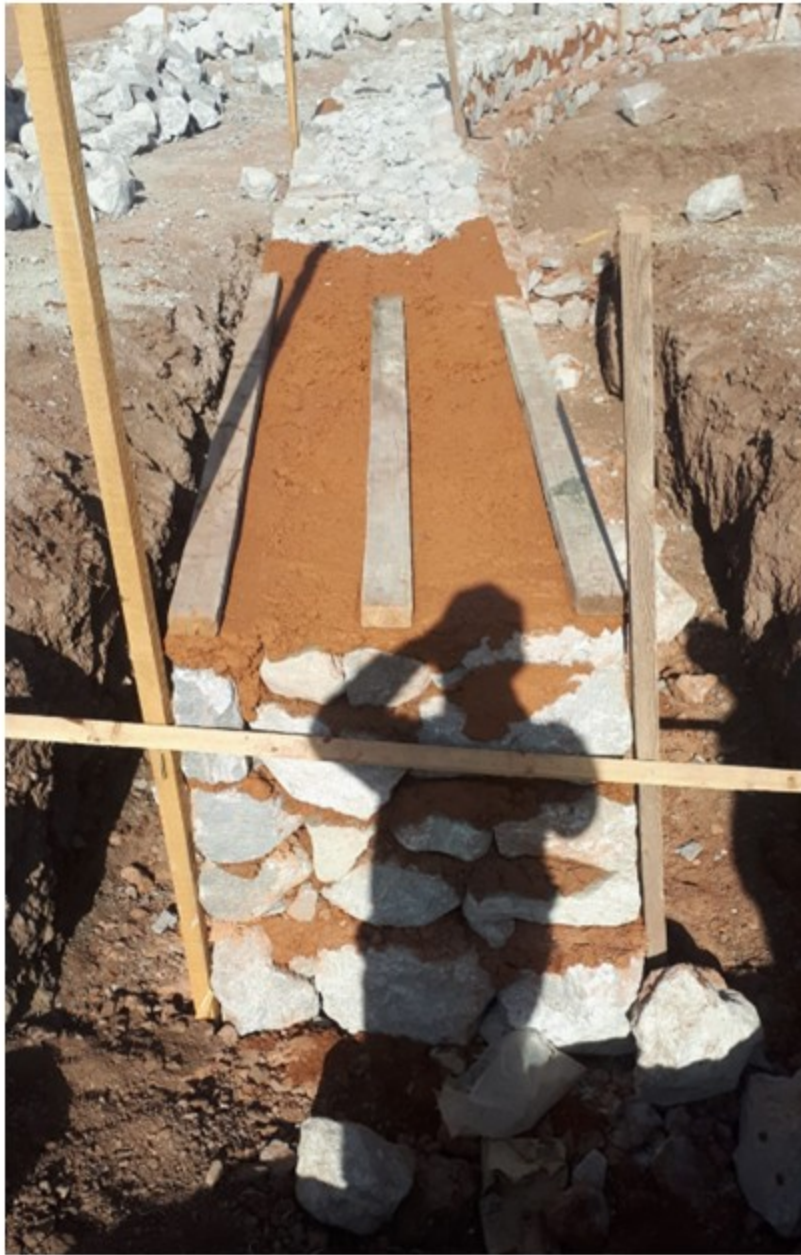
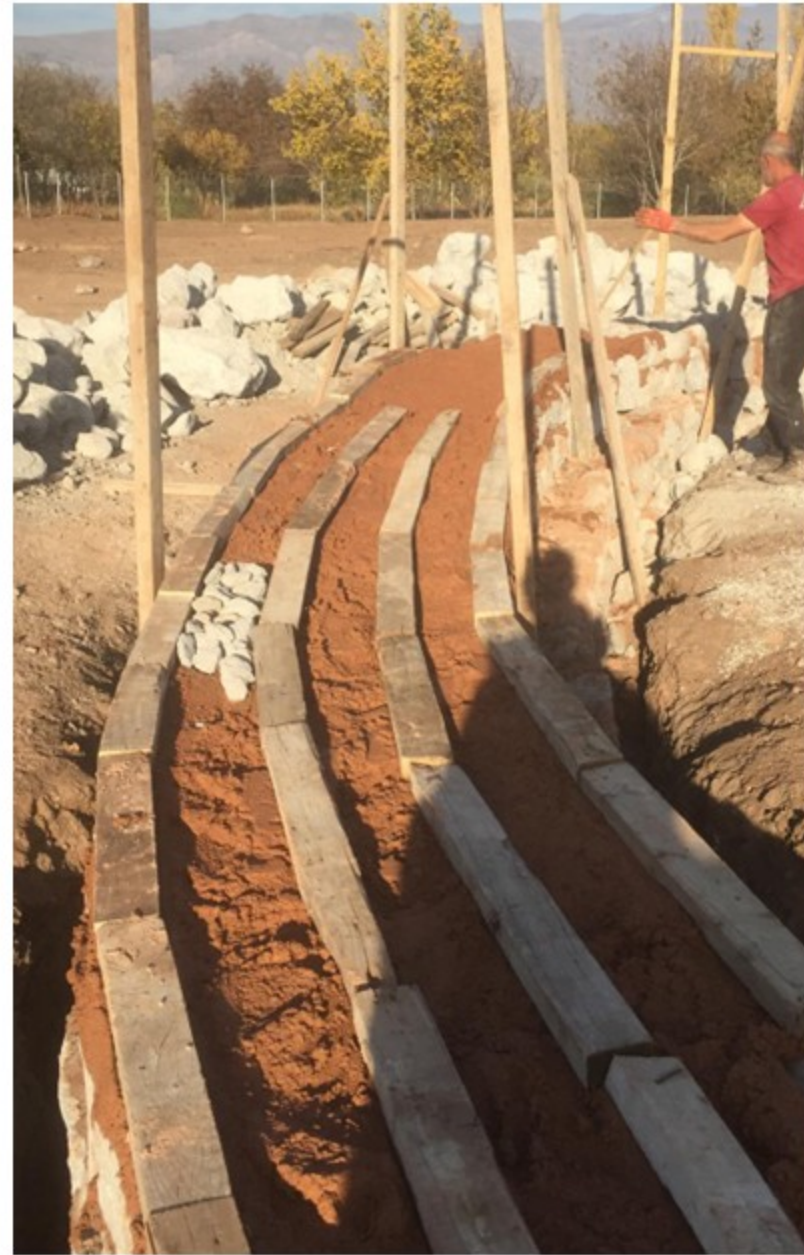
**WOODEN BOND BEAMS**

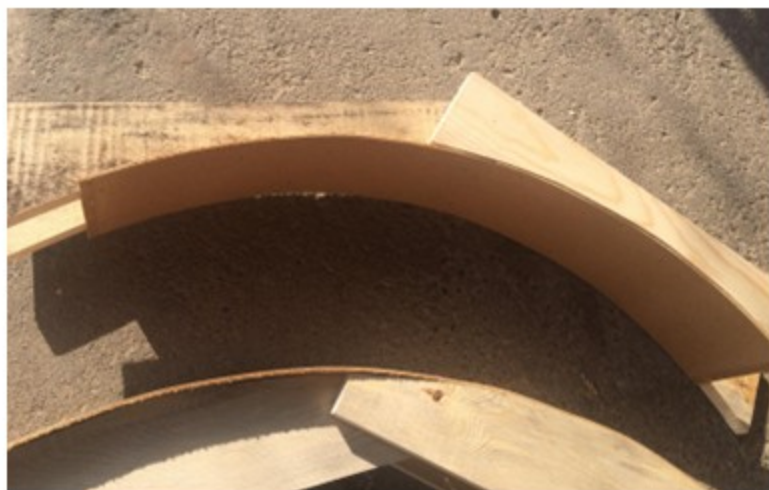
Wall molds made of plywood

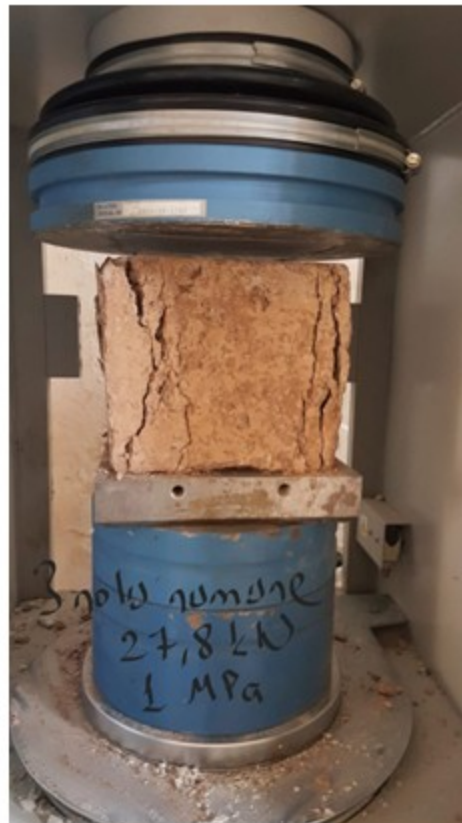
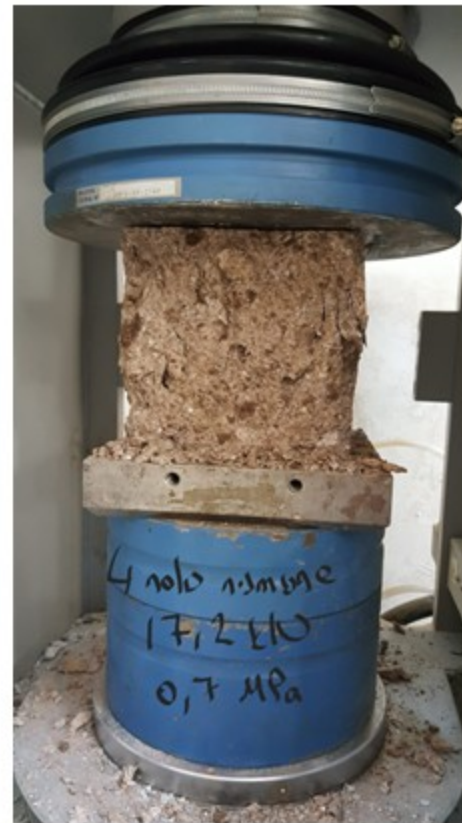
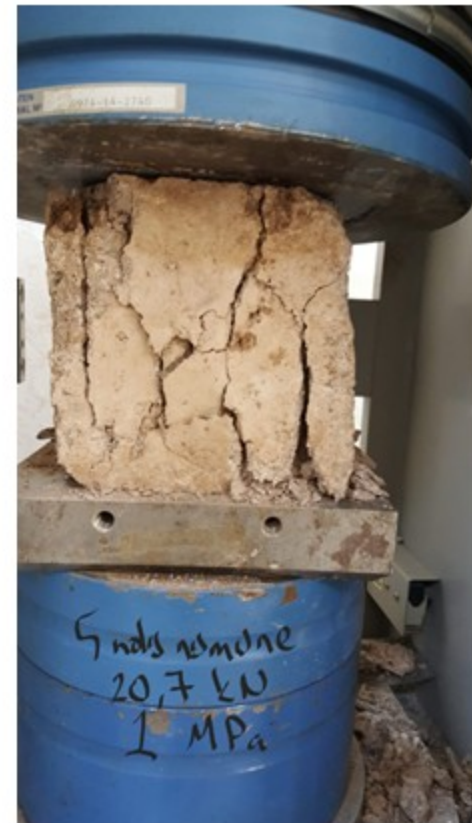
Soil samples were tested for compressive strength, Erzincan Binali Yıldırım University,  
22 October 2020

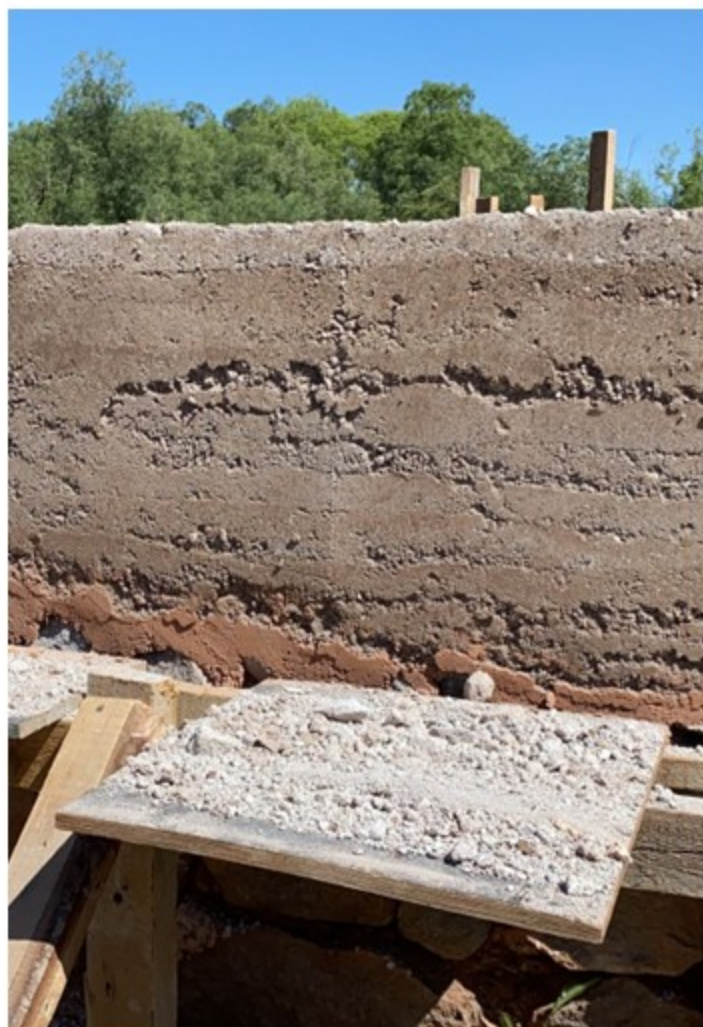
The first 60 cm of the two main earth walls were built, 10 June 2021

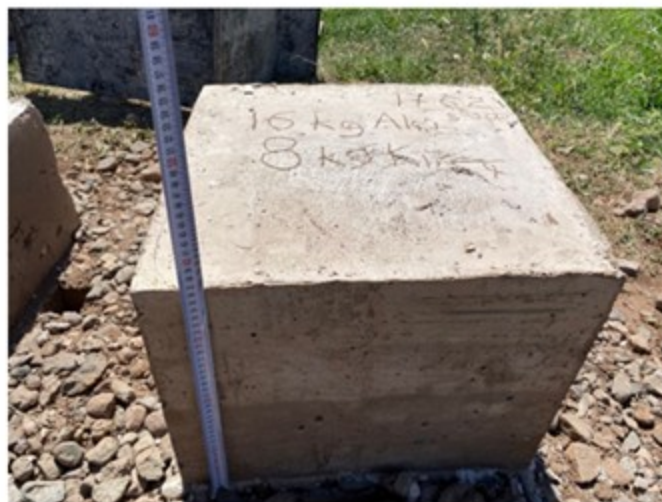
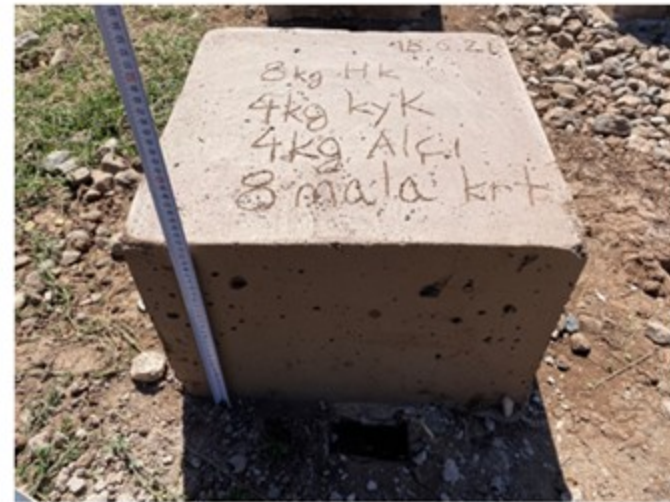
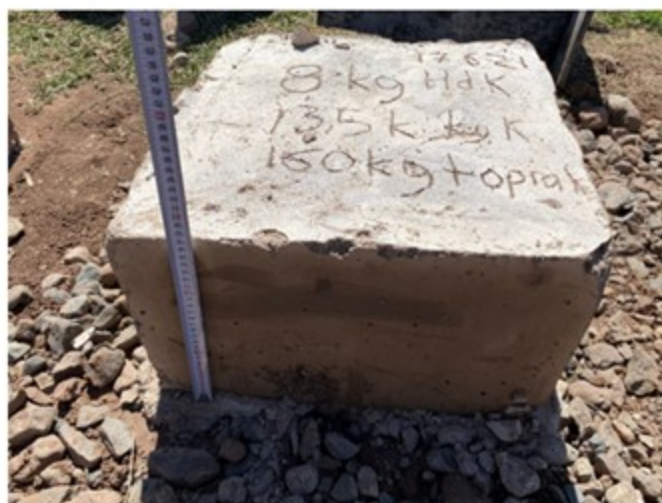
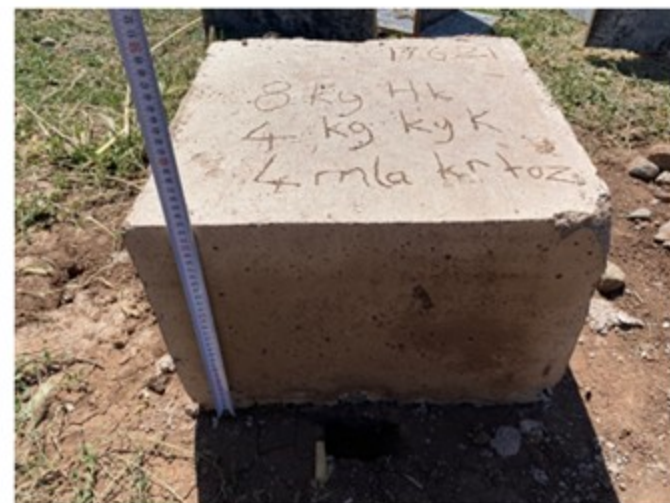
Soil mixture samples at different ratios were prepared and poured into the mold, 20 June 2021

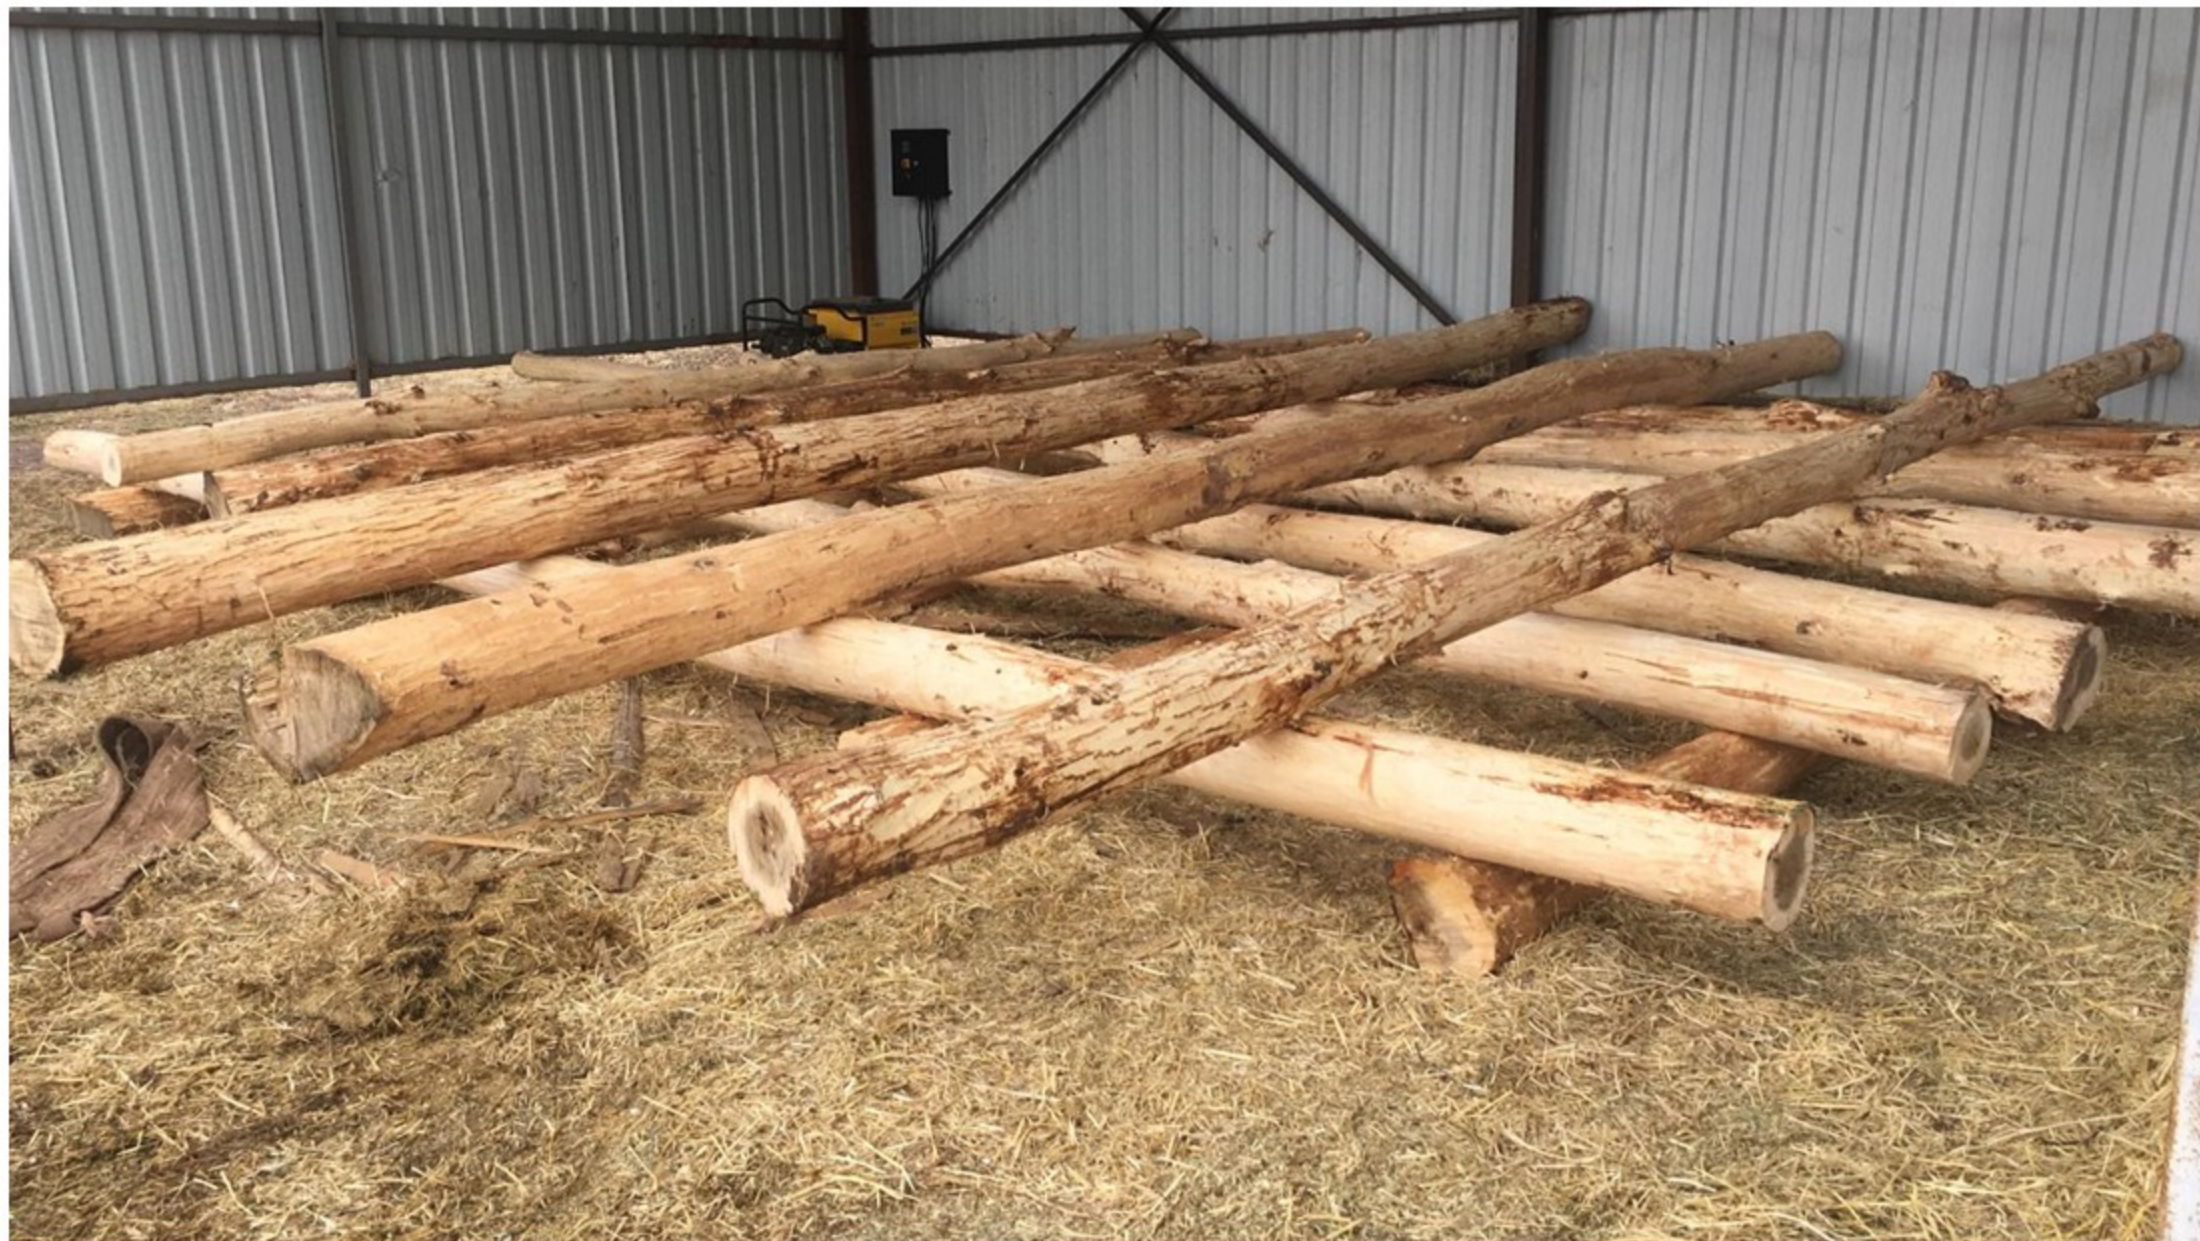
**POPLAR TREE DRYING METHOD**

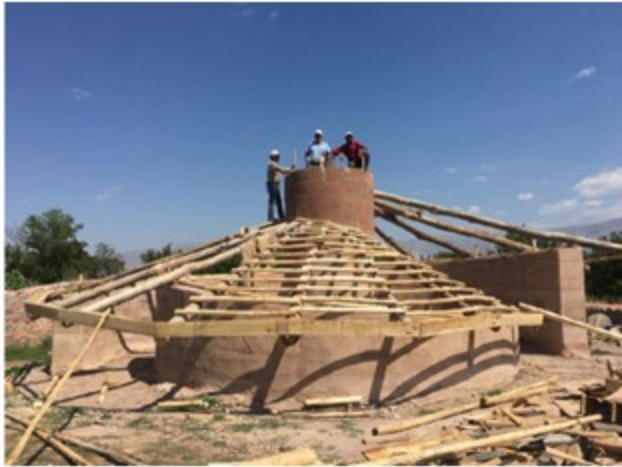
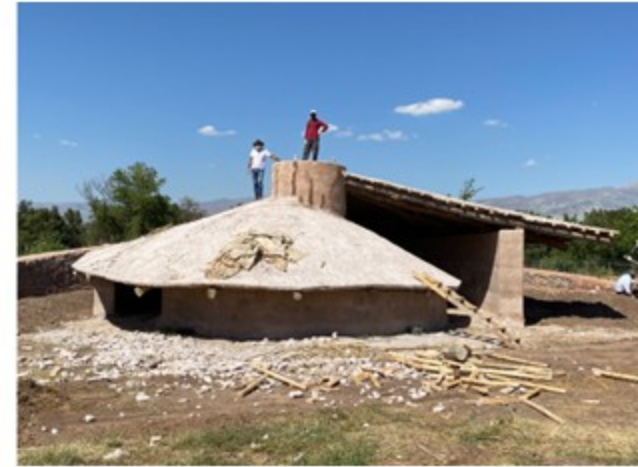
**PLACEMENT PROCESS OF WOODEN ROOF ELEMENTS:  
PURLINS, RAFTERS, BRUSHWOOD, JUTE, COVERING**

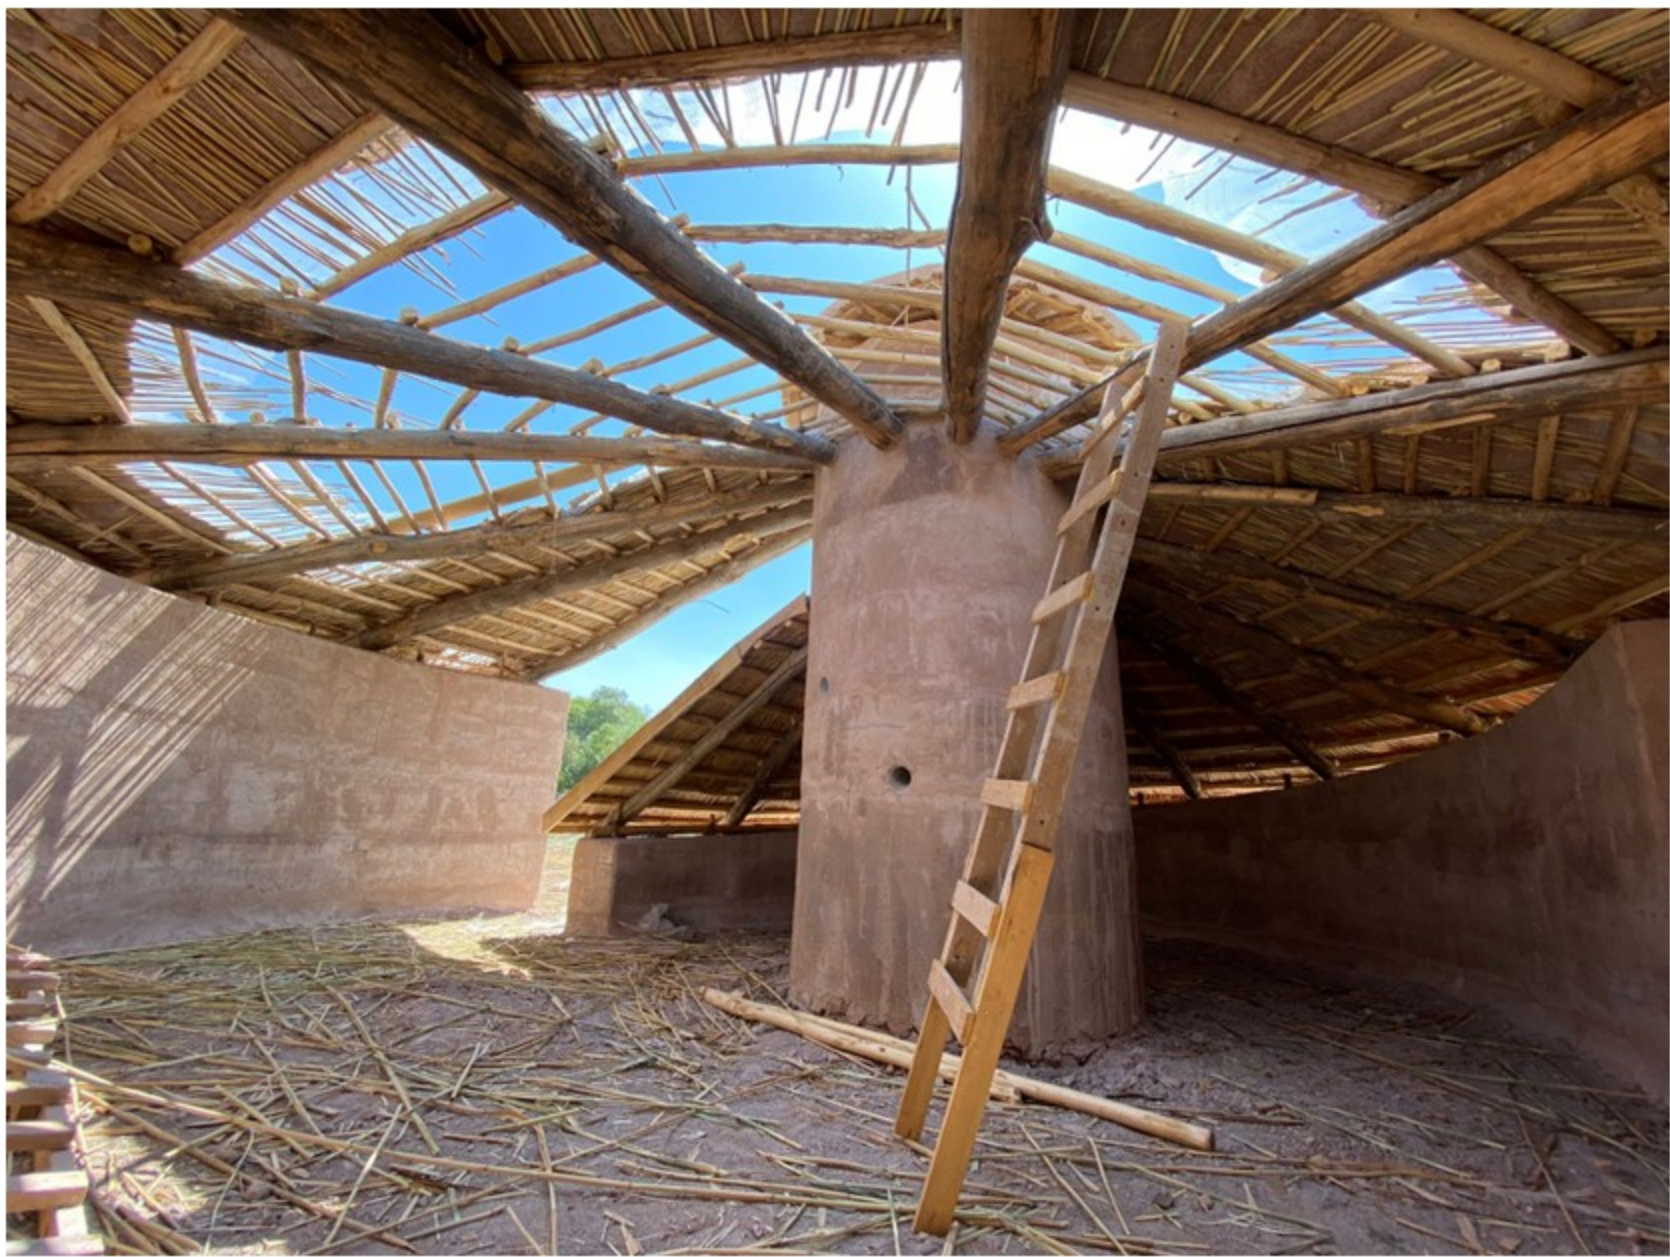
Layers visible during roofing, 31 August 2021
