PROCEEDINGS

10th International Conference

Kerpik'23

“GAIN INFORMATION FROM THE TRADITIONAL EARTHEN ARCHITECTURE“

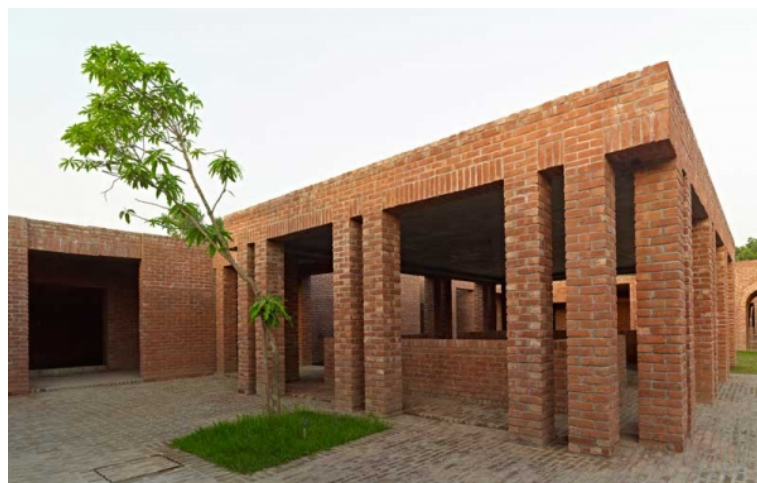
A load-bearing wall is one that supports weight (Fig. 1). It is an active structural element of a building that transfers the weight of the elements above it to the foundation structure in order to support that weight. A load-bearing wall transfers the weight from the slabs above to the base. Block, masonry, or concrete materials can be used to build these barriers. The bulk of the outside walls of a building are considered to be load bearing.

Figure 1. Load Bearing Wall

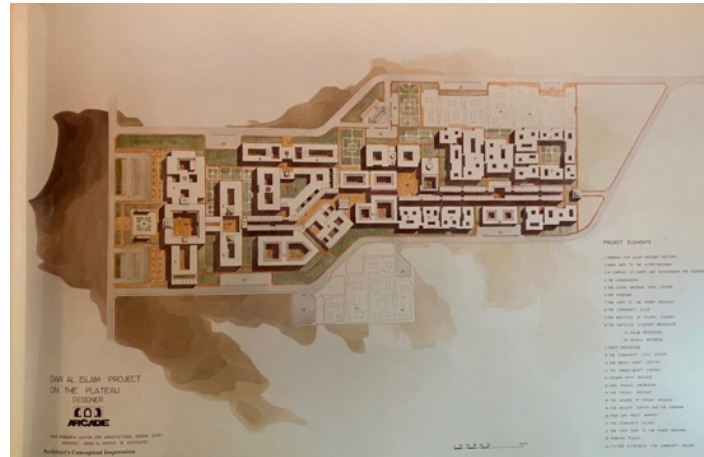
Figure 2. Site plan of Campus of Dar al-Islam, Egypt.
 (https://www.archnet.org/collections/2303)

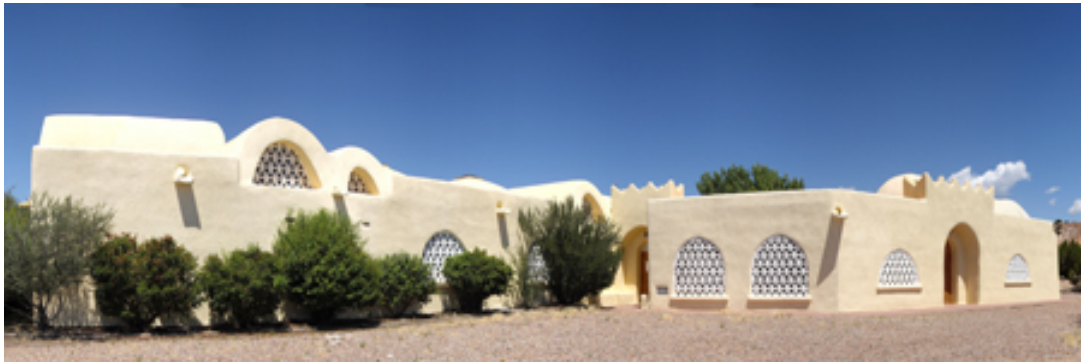
Figure 5. Dar al-Islam, the historic village of Abiquiu in Northern New Mexico, by Architect Hassan Fathy. (<https://www.archnet.org/collections/2303>)

Fathy and his team of Nubian masons, who came to the USA specially for the purpose of constructing the campus, built the campus in the low-technology building techniques of vault and dome construction that were quite commonly used especially in upper Egypt. Constructed entirely with mud brick, the mosque has load-bearing walls that carry arches and domes which cover the prayer hall. The campus, which occupies an eleven-square-mile site on a plateau above the Chama River Valley, is intended for 150 Muslim families to be grouped into comprehensible neighbourhood clusters, which present little wall surface to the east and west for better thermal performance, all relate to a main square in the middle of the community. A secondary square on the concept of a "piazza" nearby, provides a place for community to get together in groups. A mosque, which has been the first building to be built in the community, is located right at the hearth of this piazza, as including a madrasa that is attached to it. As if the mosque is the iconic center of the campus, it is quite compact and fine on its' design, as if to Show the humble soul of the believer on the context to the creator Allah. In a very efficient way, the mosque building is based on a nearly square plan that provides a forward prayer space for men and a screened area for women. While the humble design criteria of architectural style that was chosen by Fathy for the village may seem foreign in this western context, it does have much in common with the local, adobe tradition. Judging from both the technical and economic complexities involved in using adobe on this campus, however, it would seem that the intentional choice of adobe material and construction technique was made environmental on common cultural reasons, as the result seems more iconographic on the

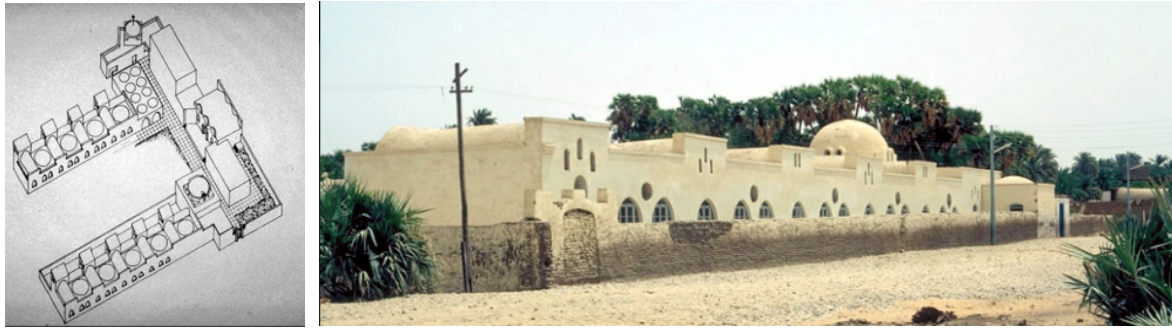
Figure 10. The Axonometric Drawing of Fares School & Figure 9 Fares School, Fares, Egypt(<https://www.archnet.org/collections/2303>)

Classrooms are facing to north and south and the architect created a courtyard between them in order to design a protected interior open air space against to the hot and dry wheather normals of the geography of the school. Quite likely to the other areas of the school the classrooms are originally intended to be naturally ventilated, due to the extreme difficulty and prohibitive cost of providing mechanical means of cooling. The architect divided each classroom into a square domed area and a rectilinear vaulted space next to the main unit to achieve the idea. The rectilinear space next to it was meant to contain a salsabil, or water pool, to further cool the air coming in through the slots in the vault above while the domed area is intended to be the seating for the classroom. Operable casement windows are paired with a circular fixed lunette specified to provide lightly and thus further ventilation is also expected to be supplied by them. In elevation, the classroom rows, which have alternating slotted vaults and rounded domes clearly intended function, even though they are now partially screened by a boundary wall. The boundary wall is built to separate the mentioned units from a main street running alongside. The salsabils are never installed, and the entire space is used for teaching, too in further process.

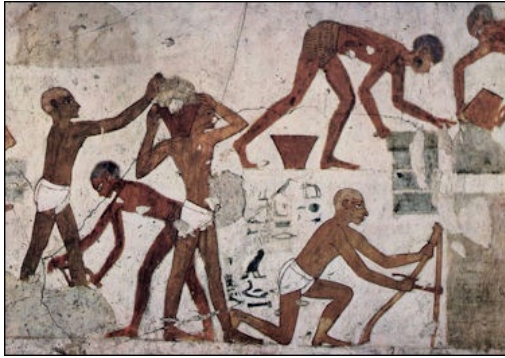
Figure 1,2. figure 1 is an Egyptian mural showing the process of producing mud bricks, Figure 2 show the site work [3]

To make bricks, the earth is cleaned, dumped in a circular area, broken up with hoes, and mixed with water to form the mixture. straw is then added to the earth mixture. The straw is kneaded into the earth mixture with hands or by feet, and the whole mixture is left to the fermentation for a night or two. The following day, the mixture is rekneaded and more water is added, at which point the mixture is ready to mold. Egyptian molds are simple rectangles made of wood. The mixture is carried from the preparation area, a brick field that has been strewn with straw to prevent the molded bricks from adhering to the ground surface while drying. The wooden mold is sprinkled with water to prevent the mixture to stick in it, then filled to over capacity with the mixture, which is compacted and flattened out. then carefully the mold is removed, and the process is repeated. the bricks are lined up to dry under the sun for almost three days where they are molded. The bottom of the mud brick is reversed to allow it to dry completely for another two or three days. It is then moved to a suitable area on the construction site and stored. However, it should not be kept for a long time in the site area. Thus, the total number of days needed to produce usable bricks varies depending on personal idiosyncrasies in technique [3,6]. As shown in the figures 1,2.

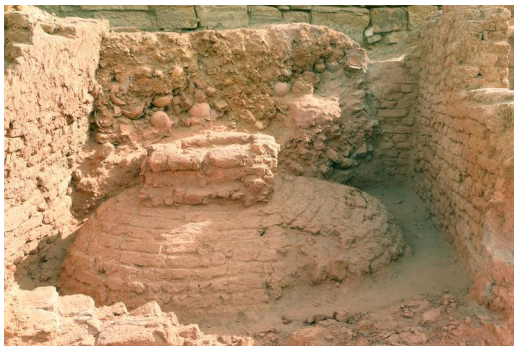
Figure 4. one of the flattened dome of the silos

The silos are almost taking a conical shape, with a circular base and ending in a smaller circle at the top with a flattened dome, the construction system is simple, mud brick courses are alternately stacked, the courses continuing to rise from the base upwards with an angle inward, to end with the flattened dome as in figure 4, It did not appear in the remains of the silos, as in the figures 5,6, any kind of internal or external supports for the upper part to resist the forces of the dome, the force generated from the flattened dome was directly distributed through the walls and then to the ground, The overall cohesion of the silos shape and the cohesion of the mud brick courses depended on the mortar material, which was also made of clay, it is clear that the quality of the soil used, whether in making mud bricks or mortar, is of high quality, as this soil is taken from the sediments of the bottom of the Nile for construction, with cohesion and porosity, which makes the constructed part as if it is one piece (like the stone's strength) to stand like this in a good condition for thousands of years.

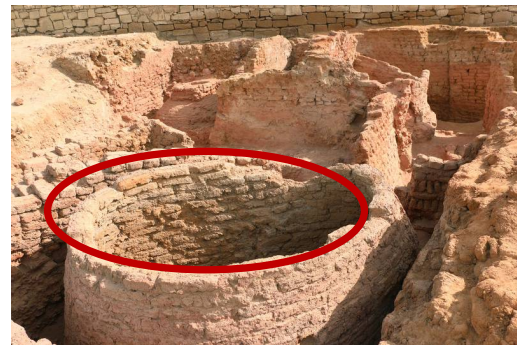
Figure 5. an open silo in a circular shape [7]

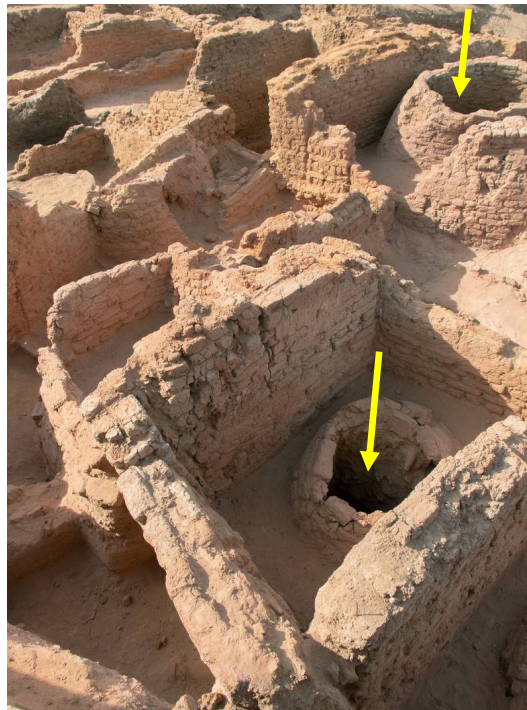
Figure 6. the depth of silos surrounded with thick mud brick walls [7]

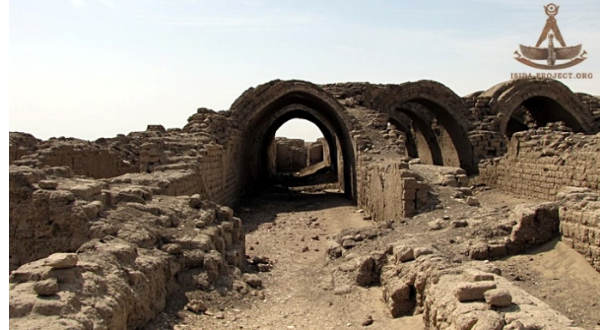
Figure 8. the front view of the arches. [10]

The technique: it consists of the construction various buildings with mud brick vaulted roofs, using only local materials (rocks, earth, water and straw), basic tools, and skills that can be mastered relatively easily. The bricks were laid off and on (alternately) with inclination angle. thick and strong supporting walls were used in parallelism, to create a resistance to the forces that have been created from the barrel vault, the compressive stresses in vaults are transferred from the upper part of the vault to its sides, then to the walls and finally to the foundations and the ground. [2] as shown in figures 8, 9

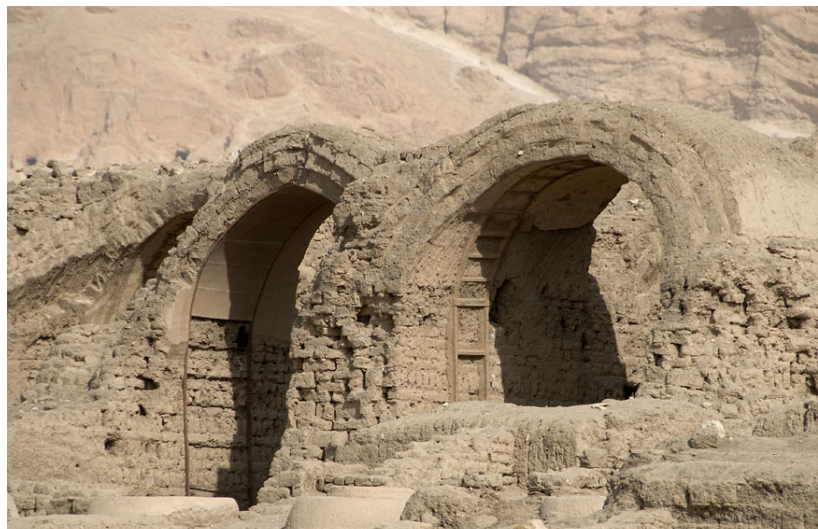
Figure 9. the silos' arches with four courses [10]

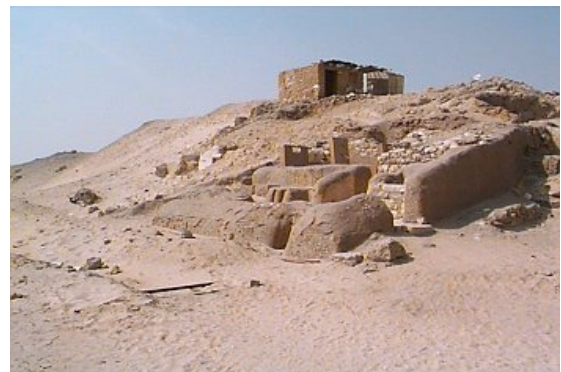
Figure 11. Some of remain mud brick walls

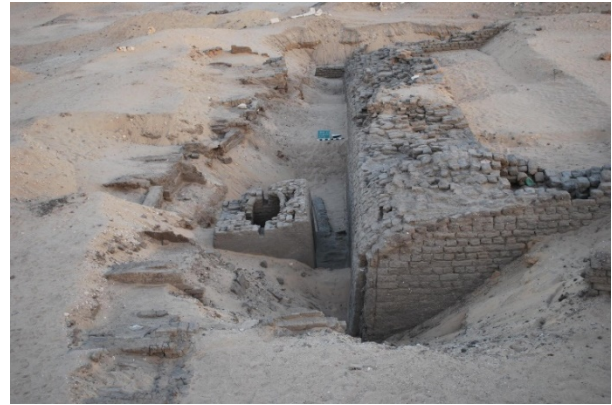
Figure 13. The remain mud brick walls [14]

Second or Third Dynasty. Today, Abydos is notable for the memorial temple of Seti I, which contains an inscription from the Nineteenth Dynasty known to the modern world as the Abydos King List. The figures below 12, 13, 14 show the remaining mud walls from the tombs of Abydos

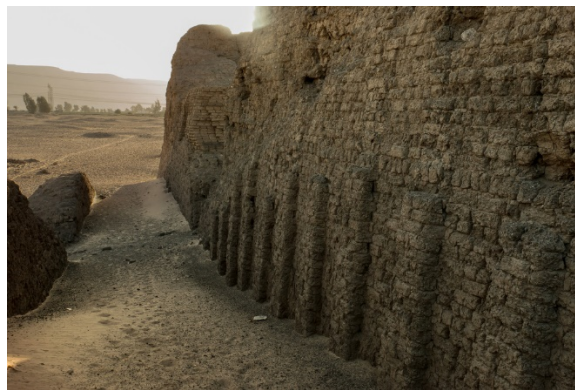
Figure 14. A remain mud brick walls [14]

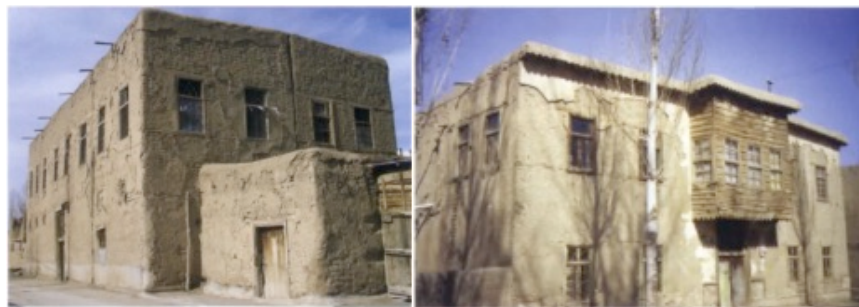
Figure 4. The extant adobe building and Niyazi Dayıoğlu House in Van city center [8]

The adobe building material, which is obtained by shaping the clay soil and straw mixture with the help of molds and drying in the sun, has been widely used in military, religious and civil architecture in the province of Van (Fig.4). However, as a result of the decrease in the resistance of adobe to abrasion over time, there are very few examples of adobe architecture that have survived to the present day [8]. The social, cultural and economic conditions of the local people, especially the climate and topography, were effective in shaping the rural settlements in the high parts of Van province, where the cold climate prevails. Local building materials, stone and adobe, form the main elements of rural architecture. Depending on accessibility, adobe is used completely in some settlements.

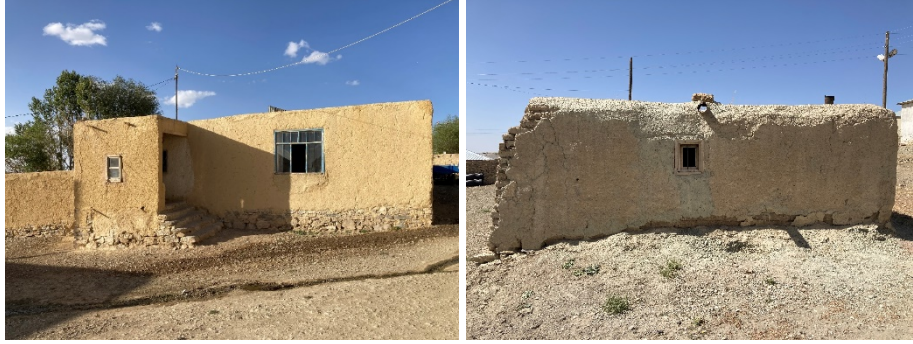
Figure 5. Examples of adobe houses from the village of Mollatopuz in Van (Gökdemir Archive)

Adobe houses, which are still used in rural settlements and built with adobe bricks on stone foundations, ensure harmony between rural architecture and nature and help in thermal insulation at low cost in the harsh conditions of the cold climate with its heat retention feature (Fig.5). Adobe material, which is easy to construct and maintain, balances the humidity level in the interior by absorbing moisture from the air thanks to its porous structure. It protects the structure from undesirable hot or cold weather conditions of the external environment with its long-time delay feature [9].

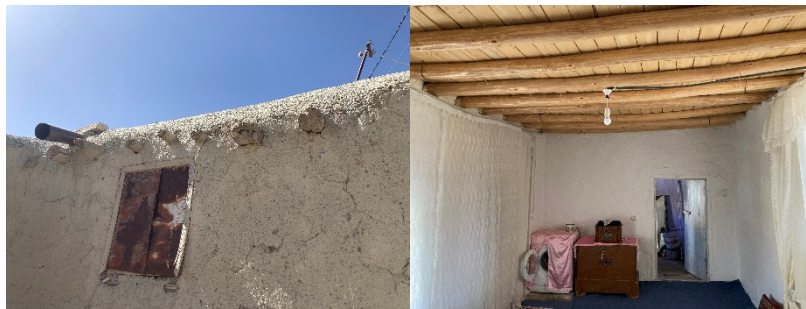
Figure 6. Exterior and interior view of the flat earthen roof from Mollatopuz Village (Gökdemir Archive)

The houses in the study area are generally single-storey and consist of rooms, sofa, halls, kitchens, toilets, bathrooms, warehouses, sheepfolds, stables and tandoor units. The thickness of adobe walls in houses in the region varies between 40-65 cm. In Mollatopuz village where the study was conducted, this thickness is generally 50 cm. Earth, which is the main material of buildings, is also used in the top cover system of houses. Wooden beams, varying in thickness between 10-20 cm, are placed at intervals of 20-30 cm along the short direction of the space and covered with covering boards and thin branches. The coating is covered with 20-25 cm thick clay and straw (Fig.6). Rammed earth is generally used as a floor covering material in adobe houses [10].

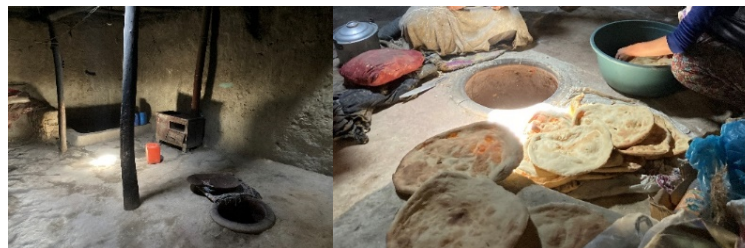
Figure 7. Sample of adobe tandoori house in use-Mollatopuz Village (Gökdemir Archive)

In addition to the climatic strategies in the material dimension of the rural architecture, the tandoori houses used for activities such as cooking, sitting, resting and sleeping are both cultural and climatic elements (Fig.7). The tandoori, which was frequently burned by the users before, is now burned every 15 days. Tandoori houses, which are used for heating and hot water needs as well as cooking, especially in the cold days of winter, are burned for 3 hours a day, sometimes twice a day.

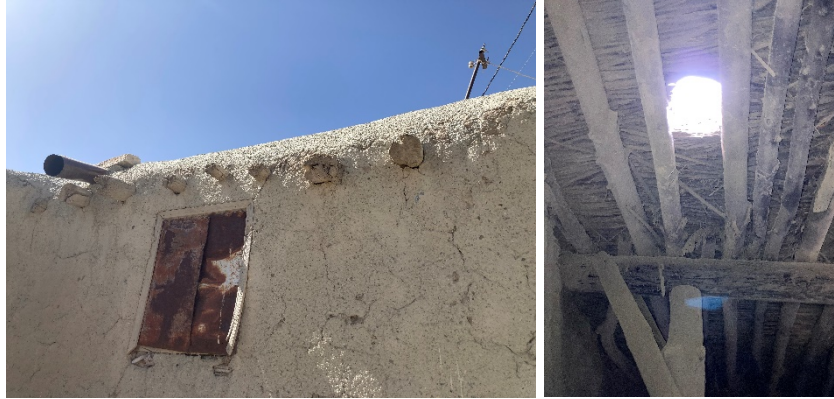
Figure 8. Window and chimney view from Mollatopuz Village

In tandoori houses where the masonry construction system is used, the main material is adobe. Wooden material was used in the upper covering system, lintels and doors. Window openings were kept between 60-85 cm as a climatic strategy. In some tandoori houses, there is no ventilation element other than a chimney (Fig.8).

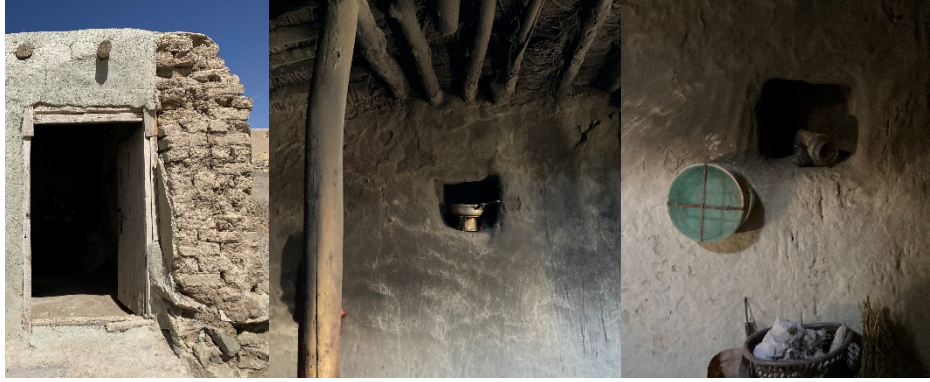
Figure 10. Views of adobe wall and niches

The wall thickness of tandoori houses built of adobe is 50-55 cm. The diameter of the tandoors used for cooking, heating and hot water is 60 cm wide and the depth is 80 cm. Chimney openings used for smoke evacuation and ventilation in tandoori houses have sizes between 20 cm and 30 cm. On the adobe walls, there are niches containing the ingredients used when making tandoori bread (Fig.10).

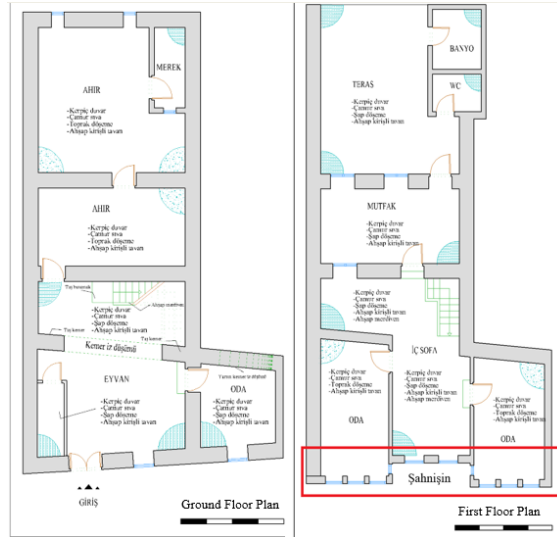
Figure 2.4. Plan scheme of a traditional Hüseyinik house

Although the houses in the region are mostly with interior or exterior sofas, there are also plans without sofas. In some houses, the interior sofa is in the form of 'L'. In the planning with an outer sofa, the rooms are arranged in a "U" or "L" shape around the sofa. The ground floor sofa, which is connected to the street, acts as a buffer between the building and the street. On the upper floors, the sofa provides the circulation between the rooms and the floors. Sitting sections called şahnişin were created by making exits on the facades of the sofa that open to the street or the view. In some houses, besides the sofa, there is a şahnişin in other rooms. On the left, a traditional Hüseyinik house plan scheme is given. Şahnişin and alcoves are marked on the plan (Fig.2.4)

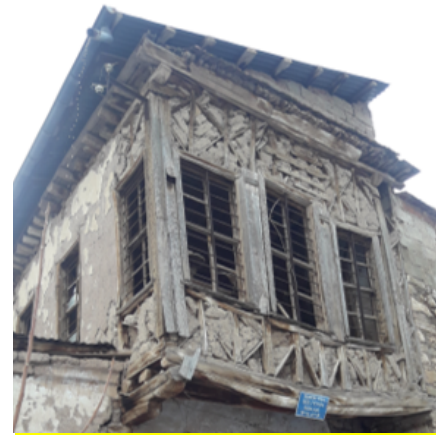
Fig.3.3. A şahnişin built with the technique of hımış

Hüseyinik houses have a very simple facade arrangement. The most striking façade element is the şahnişin. Şahnişin can be built entirely of wood or be surrounded by hımsı walls. In addition wooden angle brace elements support the şahnişin from the outer walls. There are examples with 3,5 or 7 windows, depending on the size of the Şahnişin. These sections, which overlook the street or the landscape, function as gathering and resting areas during the day.

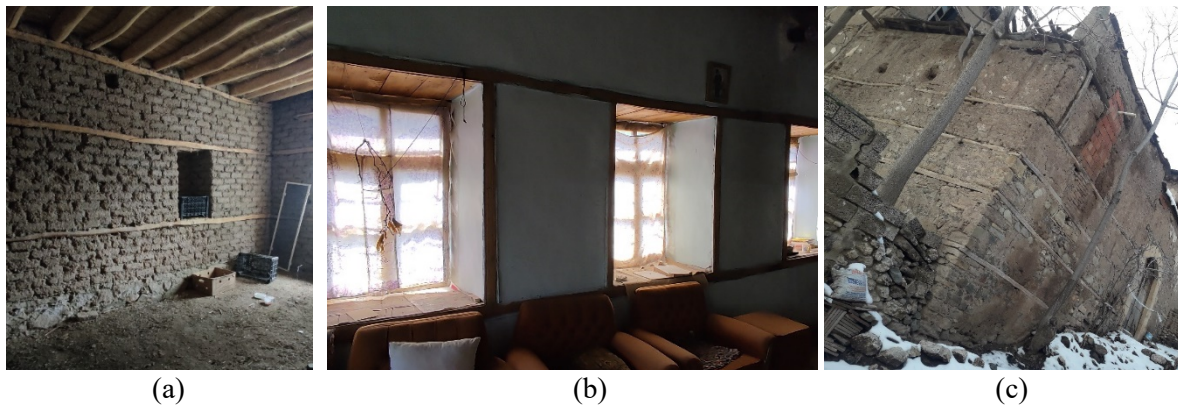
Wooden intermediate beams were placed regardless of the type of material used in the masonry wall construction technique in traditional Hüseyinik houses. These beams are found at distances ranging from 60 to 100 cm, without regular spacing. There is the use of beams on both interior and exterior walls. It is also observed that wooden lintels are used in the door and window spaces. The use of wooden beams on floor moldings and under windows is quite common in the region.

Figure 3.4. The use of beams and lintels in traditional Hüseyinik houses (a: intermediate beams on the inner wall; b: lintels on the windows; c: beams on the outer wall)

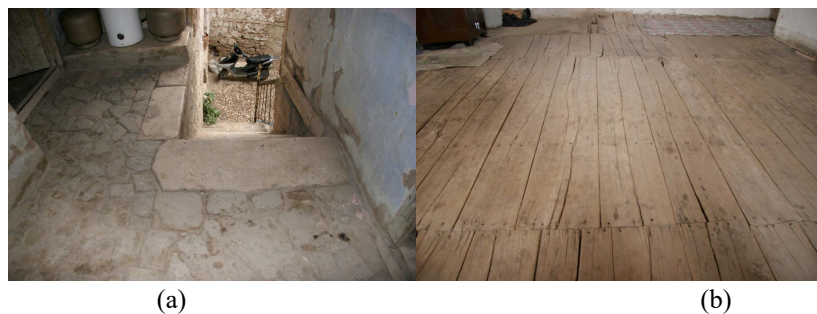
Fig.3.6. Upper floor slabs in Hüseyinik houses: (a) slate paving; (b) wood veneer

Except for the service areas such as the toilet and kitchen on the upper floor of the houses, mostly wooden cladding is used. However, in some houses, it is seen that the floors of the sofas and rooms are only plastered with earthen mortar plaster. There is also a paving stone in the upper floor spaces of large houses. In recent years, tile or screed coating has been used in some houses in line with the needs that have developed over time, in addition to wooden coating, and its originality has been lost.

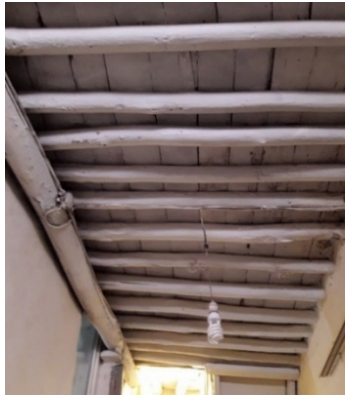
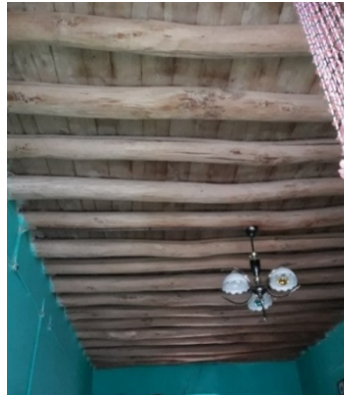
While creating mezzanine floors, first of all, wooden objects (cisir) with an average diameter of 15 cm in the direction of the short side of the space are laid at intervals of approximately 40-50 cm to form a beaming system. After creating a smooth horizontal and vertical beam system, it is covered with a wooden board measuring 3*20 cm.

Fig.3.7. Beaming system (cisir) in Hüseyinik houses

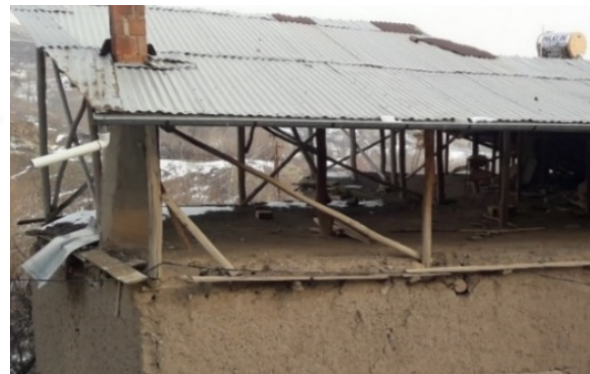
Fig.3.8. (Left) Traditional roof detail; (Right) Traditional roof covering covered with sheet metal cladding

Some of the traditional Elazig houses with flat earthen roofs do not have eaves. Some have eaves on the front and rear facades, where only the slope is given. The eaves are built as straight eaves to protrude approximately 35 cm [4]. It is very difficult to find original eaves in the region, since the roofs have recently been covered with hipped, gable or porch roofs. While the original eaves are being built, the ceiling beams are removed from the outer walls of the house to the desired extent. The ends are covered with flat face boards. In the Hüseyinik campus, non-original eaves are frequently encountered, as the traditional roofs are covered with a roof. The eaves protruding from various facades, depending on the type of roof, are formed by extending the rafters outwards to the desired extent. It is usually covered with sheet metal. With metal gutters, rain and snow waters are discharged.

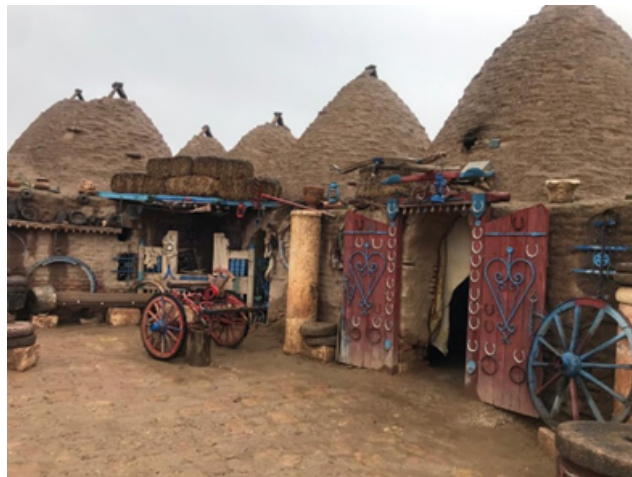
Figure 2. Harran houses which consist of a conical con shape like beehives (Photo by authors)

Harran houses are covered with domes, which consist of a conical cone shape by gradually narrowing the bricks laid on a square or nearly square prismatic infrastructure (Figure 2). The transition to the domes is made with simple squinches and pendentives (bingi). The domes, with a height of up to 5 m from the inside, were built with 30-40 bricks on top of each other.

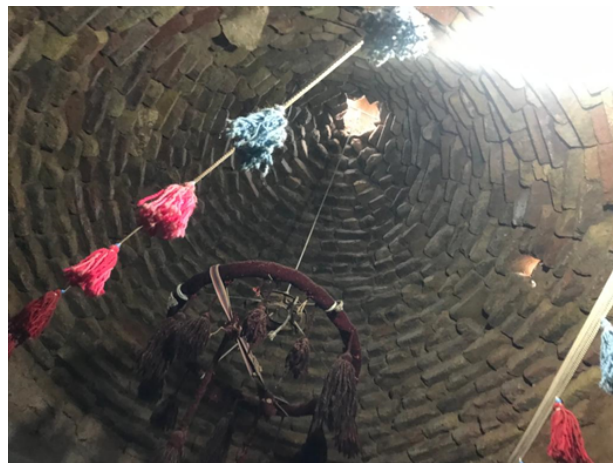
The domes used in Harran houses were developed and applied in parabolic form. The reason for the formation of this form is the overlapping dome technique, while it rises circularly from the center, a large part of the load on the dome is transferred to the load-bearing walls as a pressure load. For this reason, the longitudinal section of the dome has developed in a parabolic/conical shape, not a semicircle (Figure 4).

Figure 4. The longitudinal section of the dome has developed in a parabolic/conical shape (Photo by authors)

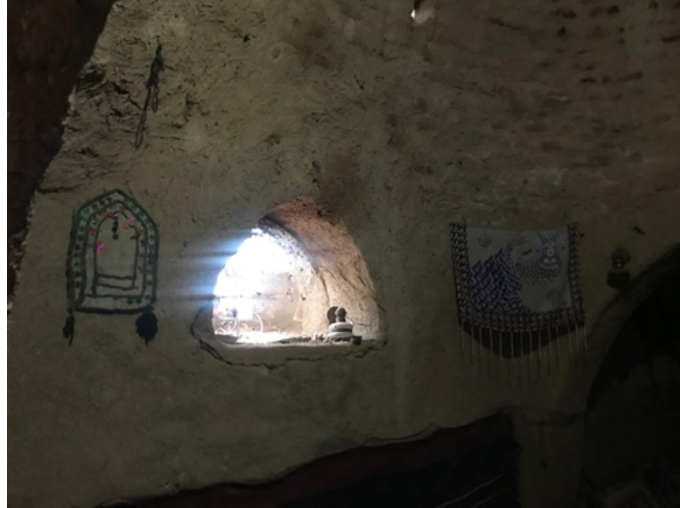
The openings used for ventilation, lighting and passage are used as small and few as possible in the structure. Window openings used for ventilation are made in a way that increases the ventilation circulation. The opening at the top of the dome provides a chimney function and natural ventilation for the smoke to escape (Figure 5).

Figure 5. The openings used for ventilation, lighting and passage (Photo by authors)

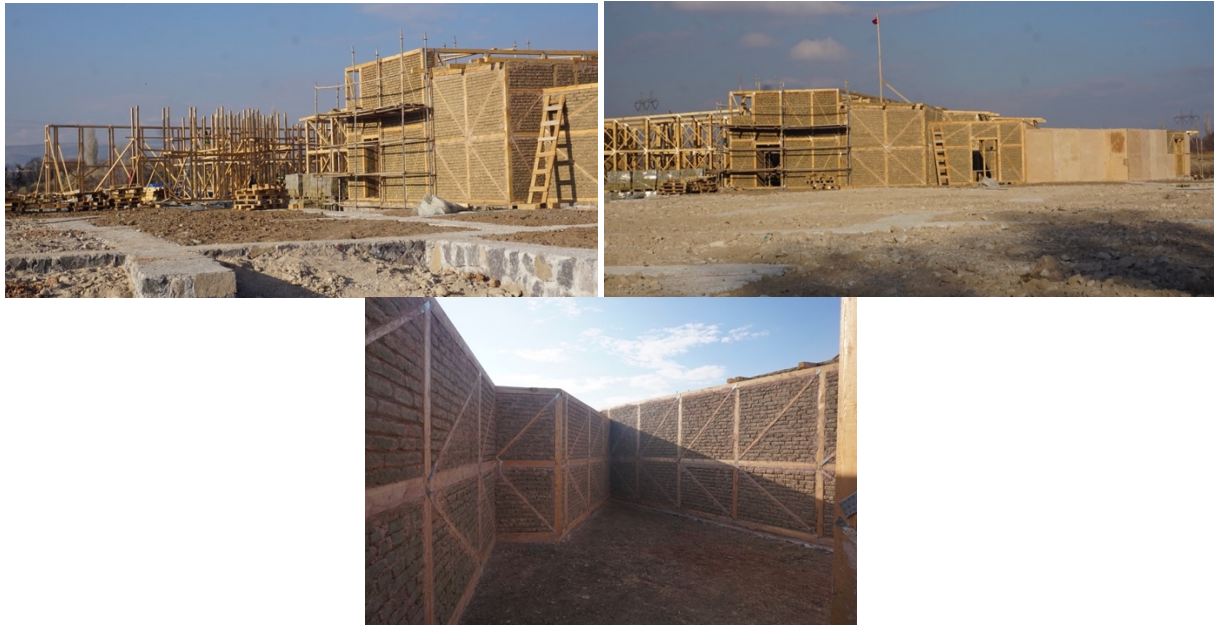
The project was designed by the architect Hakan Şahan, with the advice of the excavation president Prof. Dr. Fikri Kulakoğlu. The project began in 2022. The adobe blocks used for wall construction are in 30x40x8 cm measurements. 30x40x8 (or 10) cm bricks were used in running bond patterns on the supports. For each 1,5 or 2-meter, one or two wooden posts are used as supports (Fig.27). Residence floors are of earth and workshop floors are of stone [28]. Using both architect Akok's drawings and techniques from the surrounding village residences, the project, which started in 2022, is now close to the final. Similar to Hattusa city walls and Aşıklı Höyük residences, the Kültepe-Kanesh "Neighborhood of Assyrian Merchants" experimental archaeology project is also placed close to the ruins entrance.

Figure 7. Views from the construction phase of the Neighborhood of Assyrian Merchants Project [29]

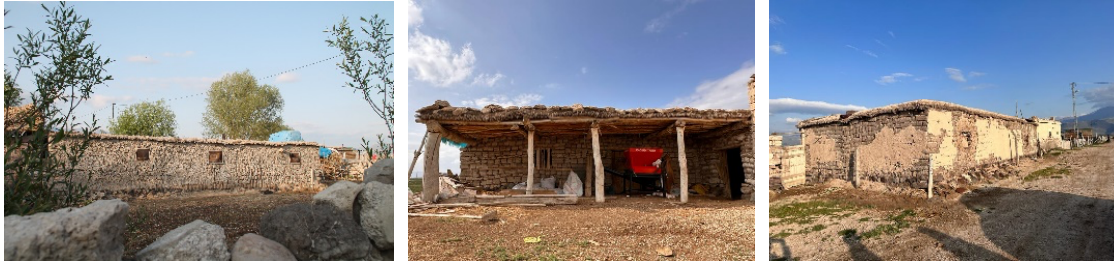
In the buildings where the earth is used as the main construction material in Sindelhöyük, the upper covering is created by gathering reeds from the marshes and covering them with soil. This feature represents the oldest known characteristic of earthen construction (Figure 3).

Figure 3. Traditional earthen buildings in Sindelhöyük, 2023

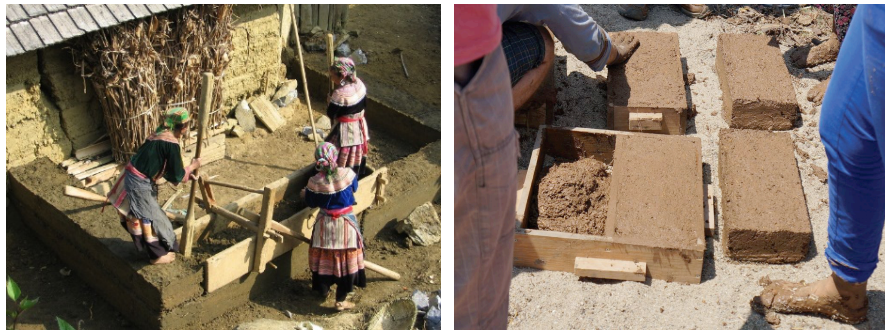
Figure 5. Earthen Construction Techniques [11].

The first technique involves mixing suitable soil and additives with water, pouring the mixture into molds, and allowing it to dry in the sun. This method is the most commonly used (Figure 5).

The second technique involves mixing suitable soil and additives with water, pouring the mixture into molds that shape the walls of the structure, and compacting it to form earthen bricks (Figure 5).

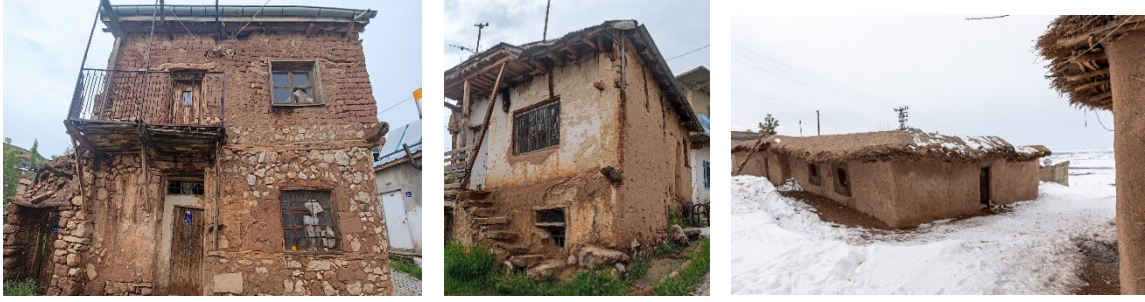
Figure 6. Different traditional earthen construction systems, 2023.

Earthen construction systems, using mud bricks as the main building material, are divided into three types: solid, lightweight, and mixed brick construction systems[12].

Lightweight brick construction systems are created by filling the voids between horizontally, vertically, and diagonally placed wooden elements in a structural framework with mud bricks.

Mixed brick construction systems combine both solid and lightweight techniques in their construction.

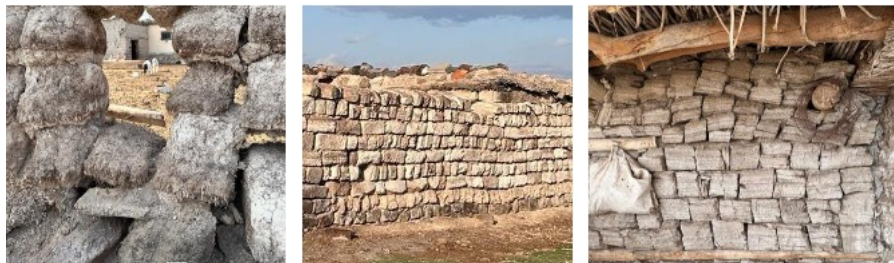
Figure 8. Use of vernacular earthen in Sindelhöyük, 2023

However, the earth material used in these structures is a type of earth that is produced differently from the conventional method of cutting and drying clay soil manually. Therefore, the local community has described and documented how it is made through practical applications.

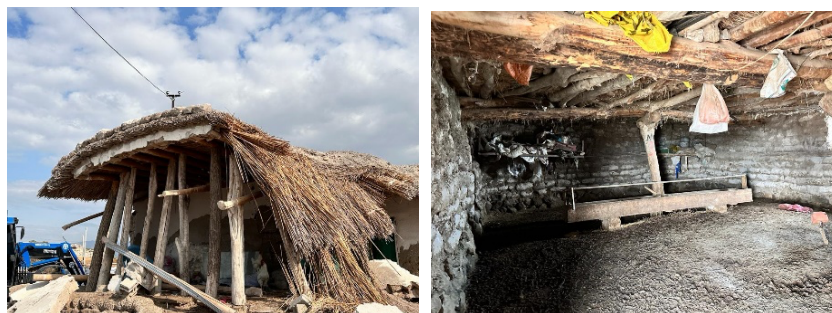
Figure 9. A traditional earthen building about to be demolished in Sindelhöyük, 2023.

In the mezras (hamlets) of Sindelhöyük, it can be observed that the number of earthen buildings has decreased in modern times, and in newly constructed buildings, different materials are used instead of earthen and traditional building materials (Figure 9). The main reasons for this can be listed as follows:

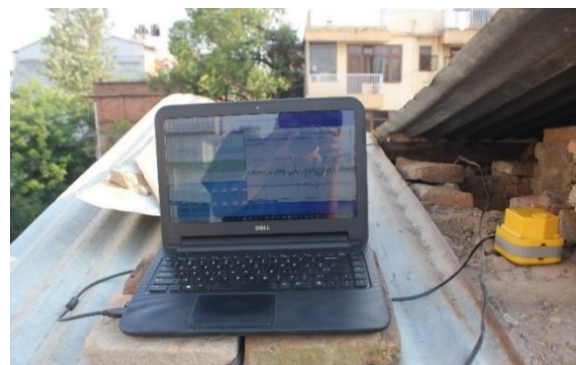
Figure 3. Data Collection at site. The highest point accessible in the mid longitudinal wall

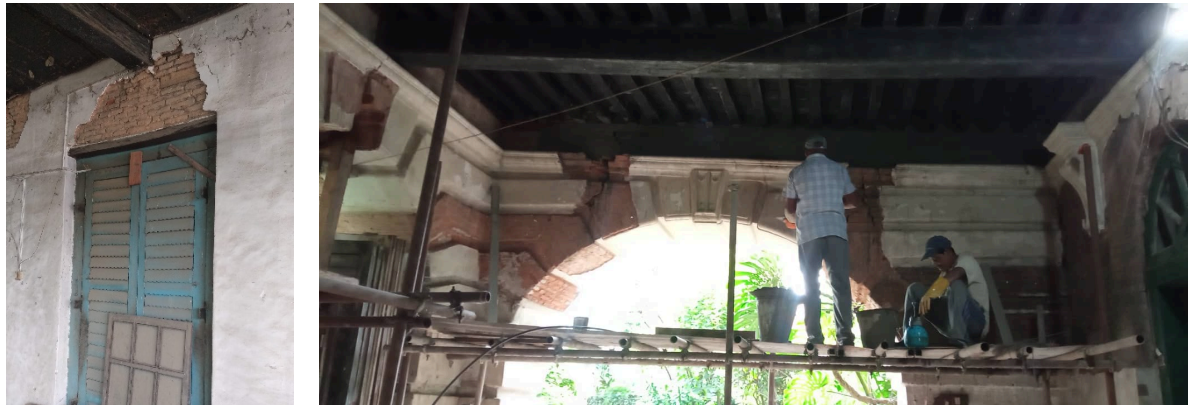
Figure 14. Photographs of the cracks in the openings and the arches after the 2015 earthquake

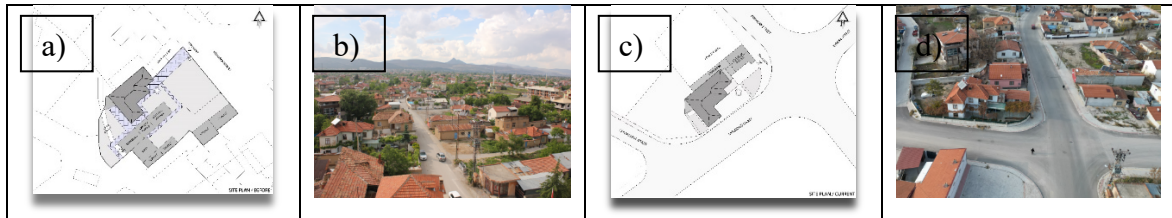
Figure 6.a) Site Plan in 2017 [31], **6.b)** Street Texture of the Year 2017 [28], **6.c)** Current Site Plan [31], **6.d)** Street Texture of the Year 2022 [28].

During its initial construction, the entrance to the house was through the courtyard gate opening onto Pirhasan Street in the northeast direction. The house was built adjacent to the northeast wall of the courtyard. The courtyard included elements such as an outdoor kitchen, a tandoor-oven area, a woodshed, and a toilet (Fig. 6-a, 6-b). However, due to the 2019 urban planning parcel regulations, the courtyard was reduced in size (Fig. 6-c, 6-d). The outbuildings that were originally present in the garden were demolished under municipal control. A road was constructed in the demolished area, resulting in a smaller garden. Currently, the house remains on a corner plot at the intersection of three streets (Fig. 6-c, 6-d). Today, the courtyard is accessed through Pirhasan Street in the northeast direction, just as it was in the past. The entrance to the building is from the northeast, opening into the courtyard. In the remaining part of the courtyard, new kitchen, storage, and toilet facilities have been built to meet the needs of the present day (Fig. 6-c).

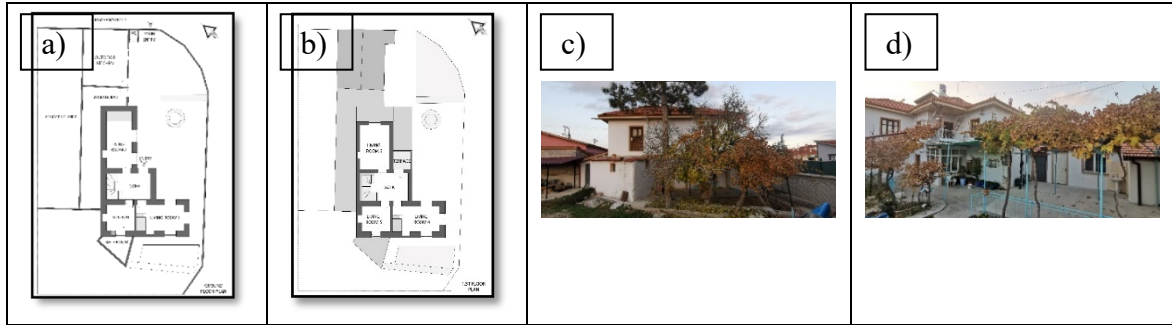
Figure 7.a) Ground Floor Plan [31], **7.b)** First Floor Plan [31], **7.c)** Rear (Southeast) Elevation and Garden of the House [28], **7.d)** The House's Courtyard After Renovation and Its New Kitchen [28]

The building has a sawtooth-shaped floor plan. The entrance to the rooms is through the central hall (sofa). The central hall serves as a space that connects the rooms and the staircase, and it is accessed from the courtyard on the ground floor (Fig. 7-a). Both floors consist of three rooms and one central hall (Fig. 7-a, 7-b). Due to the sawtooth-shaped floor plan, the external facade of the building has a dynamic appearance. The ground floor windows open to the northeast, southeast, and southwest directions (Fig. 7-c, 7-d).

After the initial renovation, the lower and upper floors are used by two separate families. Access to the upper floor is provided through an external staircase. Today, this staircase has been removed, and both floors are used by the owner as originally intended (Fig. 7). The current user of the building has renovated the storage areas and the windows of the lower floor when they purchased the house (Fig. 8). Due to the maintenance difficulties of the grid wooden system, the ceilings have been covered with wooden paneling. Additionally, a wooden staircase has been added later on. In the central hall (sofa), there is a wooden staircase that connects to the upper floor (Fig. 8-b). The heating system of the building was provided by a stove until 2016. With the introduction of a natural gas pipeline to the neighborhood, heating is now done using a natural gas central heating system (Fig. 8-a).

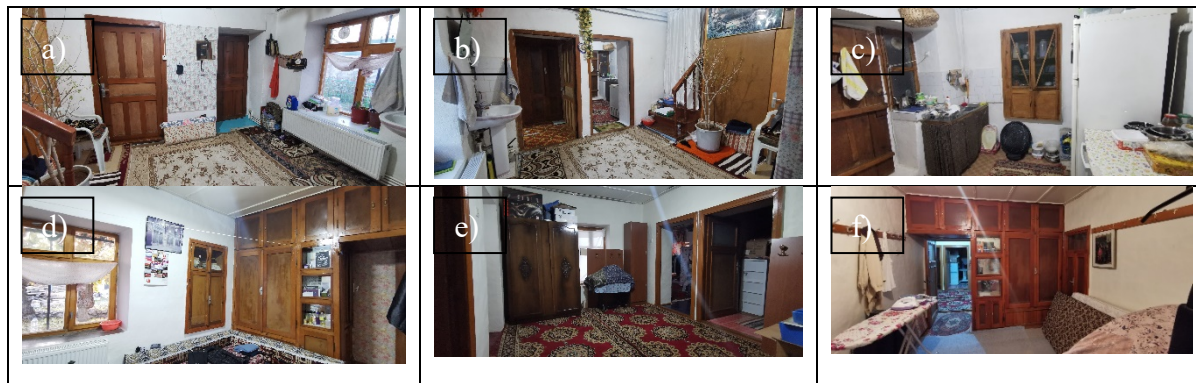
Figure 8.a) Ground Floor Reception Room and House Entrance [28], **8.b)** Ground Floor Reception Room [28], **8.c)** Kitchen [28], **8.d)** Niche and Cupboard in the Living Room [28], **8.e)** First Floor Reception Room [28], **8.f)** Niche and Cupboard in the Living Room on the Upper Floor [28].

On the ground floor of the building, there are two rooms, and the same rooms on the upper floor have niches and storage areas. The storage areas include wet areas to meet the bathroom needs (Fig. 8-d). The kitchen requirement of the building is designed in one of the rooms on the ground floor, specifically for kitchen use (Fig. 8-c).

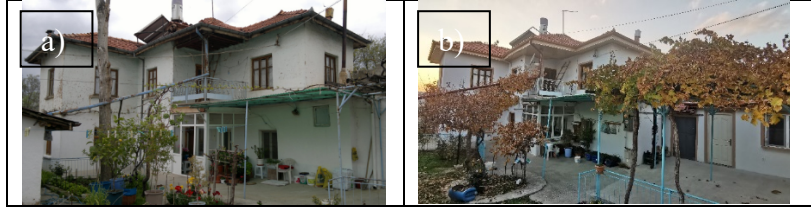
Figure 9.a) Building Photo Before Facade Renovation in 2011 [28], 9.b) Building Photo After Facade Renovation in 2022 [28]

The exterior facade of the building was initially finished with a layer of clay over the adobe plaster, followed by a lime wash (Fig. 9-a). In the exterior facade renovation carried out in 2018, a cement-based plaster was applied to the entire facade. The roof covering was repaired, and the eaves were covered with wooden material (Fig. 9-b).

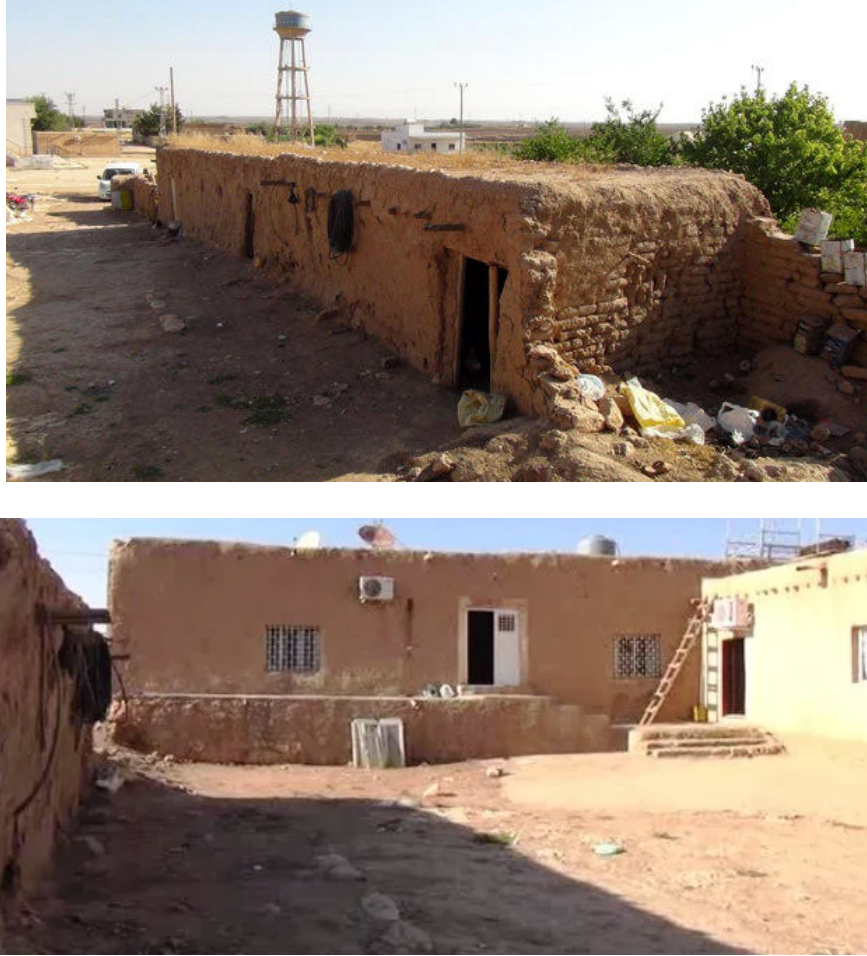
The most notable damage identified in the adobe structure samples examined in the region occurred predominantly in the load-bearing exterior walls. Exterior walls are in direct contact with the external environment, making them more exposed to outside temperature fluctuations. Adobe material expands in high temperatures and contracts in low temperatures. Over time, these processes have caused damage such as cracks, deformations, and loosening within the structure. High temperatures and low humidity levels have led to the drying of adobe material in the walls, resulting in crack formation during the drying process. These cracks have enlarged over time, weakening the structure. Temperature variations throughout the day have also caused expansion and contraction of the adobe material, leading to stress and cracks on the structure. As a result of these effects, the material weakened, reducing its durability and causing damage to the structure. Apart from temperature differences, the moisture level is another significant factor in adobe structures. High humidity has caused the adobe material to absorb more water, and this water has had harmful effects during freeze-thaw cycles. Additionally, direct exposure to sunlight intensifies temperature variations, exacerbating the damage to the material (Figure 1).

Figure 1. The adobe structure examples located in the Alakuş neighborhood of Kızıltepe, Mardin, exhibit issues such as 'cracks and deformations, warping and bending, and color changes' attributed to temperature differences.

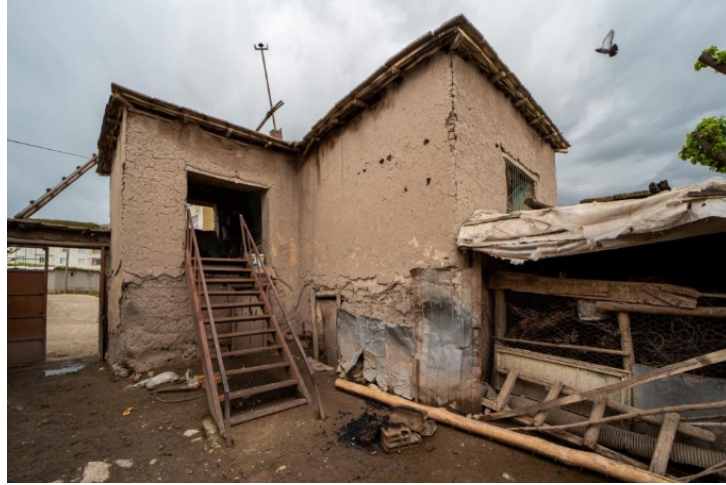
The elements located in the wall cavities of adobe structures in the region, such as windows, doors, and arches, experience damage attributed to temperature differences. The hot weather causes the adobe structure elements to expand, leading to stress and cracks in these elements. These cracks on windows, doors, and arches have reduced the stability of the structure elements and marred their aesthetic appearance. It is evident that these issues will harm the structural integrity in the long run. High temperatures can cause the moisture in the adobe elements to evaporate and the material to dry out. This drying process has led to warping and bending in thin and long structure elements like windows, doors, and arches in the region. Such deformations have adversely affected the functionality and durability of the structure elements, particularly hindering the smooth operation of doors and windows. Furthermore, material differences between the adobe structure elements and windows, doors, and arches (e.g., wooden or metal frames) react differently to temperature changes. These differing responses have caused discrepancies and stresses between the elements. These discrepancies have led to dislocation, cracks, and breakage of elements, particularly causing aesthetic and structural issues in arches. Extended exposure to sunlight has caused fading or changes in the color of the adobe elements. Visually unpleasant color variations can affect the appearance of the structure elements, resulting in an inconsistent look when viewing the structure (Figure 2).

Figure 2. In the adobe structure example located in Diyarbakır, issues such as 'cracks and deformations, warping and bending, and color changes' have been identified due to temperature differences.

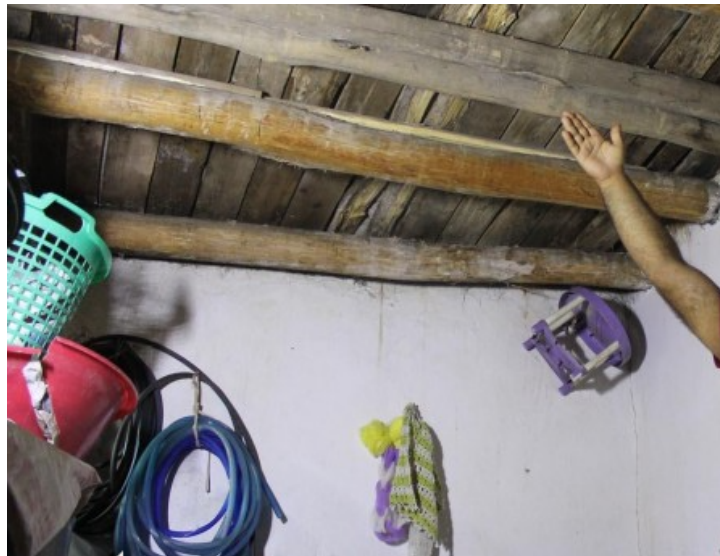
It has been observed that many of the floors in adobe structures in the region are covered with soil on top of wood. This situation has led to material issues and structural damages due to various temperature differences. Wood and soil react differently to temperature changes. Wood expands in hot weather and contracts in cold weather. These different rates of expansion and contraction have caused cracks and deformations in floor materials. Wood is sensitive to temperature changes, and these changes have led to cracks and deformations in the wood. Prolonged temperature changes, in particular, have resulted in permanent cracks in the wood flooring beneath the soil cover. Temperature variations can affect moisture and water levels in the wood beneath the soil cover. Especially during heavy rainfall periods, water penetrating the wood can lead to decay and structural weakening. In hot and arid regions, extreme temperatures have caused the wood flooring to dry and crack (Figure 3).

Figure 3. Issues like 'cracks and deformations, fungal and pest damage, warping and bending, and color changes' observed in the flooring of an adobe house in Şırnak are due to temperature variations.

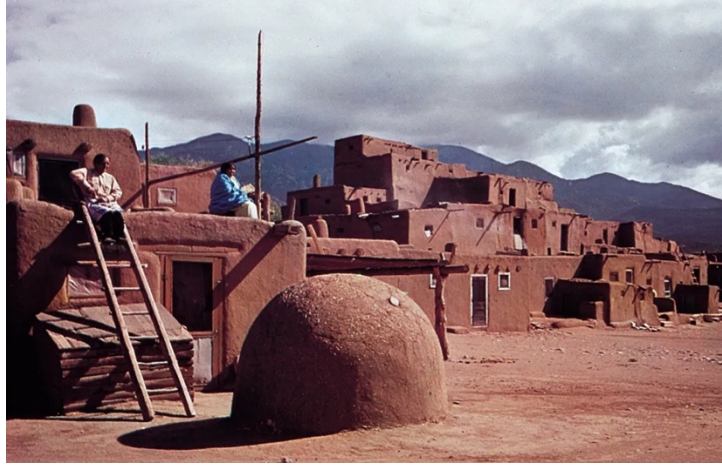
Figure 12. Taos Pueblo De Taos adobe houses in New Mexico [URL 11].

New Mexico'da yer alan Taos Pueblo'daki Taos kerpiç evleri ile dikkat çekmektedir. Taos Pueblo De Taos, located in New Mexico, attracts attention with its adobe houses. Traditional pueblo construction used limestone blocks or large adobe bricks; the latter were made from clay and water and generally measured approximately 8 by 16 inches (20 by 40 cm), with a thickness of 4 to 6 inches (10 to 15 cm). In the early 21st century, modern construction materials were sometimes used in tandem with adobe, creating stronger and more durable structures [URL 10].
