PROCEEDINGS

10th International Conference

Kerpik'23

“GAIN INFORMATION FROM THE TRADITIONAL EARTHEN ARCHITECTURE“

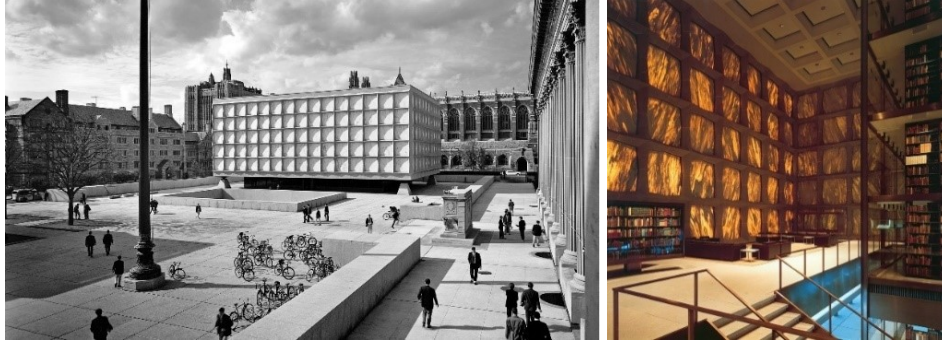
Figure 4. The exterior and interior photographs of Beinecke Rare Book & Manuscript Library built in 1960s in Yale, USA designed by SOM [10].

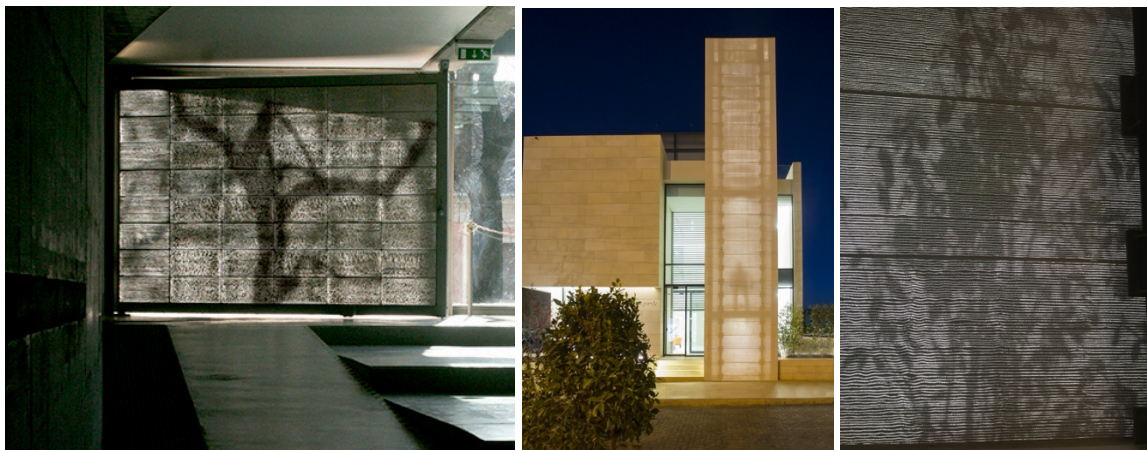
Figure 5. The main entrance door of Museum Cella Septichora (left) [15], the translucent concrete facade of Amman Capital Bank (middle & right) [13].

There are also few built examples that using optical glass fibers and polymer-based optical fibers can transmit light as a reinforcement to concrete. The main entrance door of Museum Cella Septichora can be given as an example, which consists of Litracon Classic blocks that have 10 cm thickness. To construct the panels, 4% glass optical fiber and 96% concrete was used (Figure 5, left) [12]. Another example that have been built in Jordan using glass fiber reinforced concrete panels is 14 meters high stairwell of Amman Capital Bank; made of 30 mm thick light concrete panels which mounted on a steel structure above undercut anchors (Figure 5, middle & right) [13]. Even though there are built examples, it still seems like glass or plastic reinforced concrete is not available to apply in large scales or without a supporting load-bearing system. To widen the usage of this material it is necessary to study and improve the structural performance of this material. Therefore, a study found on the literature exhibits that translucent concrete containing 2%, 4%, and 6% volume ratios of plastic optical fibers has a lower compressive strength, significantly decreased flexural strength, ending moment, shear stress, normal stress, and bending stress carrying capacity but on the other hand better ductility and energy absorption and higher flexural toughness comparing the opaque concrete [14].

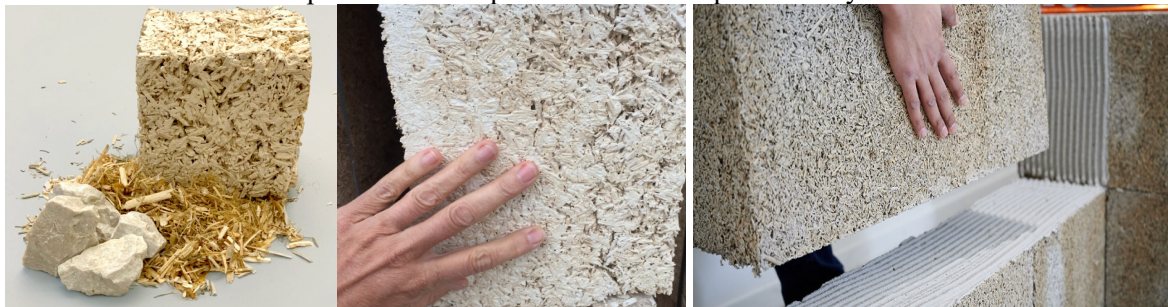
Hempcrete Block: Producing Hempcrete outside the construction site and bringing it to the construction site ready for use provides various advantages, especially speed and ease in production. The fact that the supply and assembly of ready-made blocks can be done quickly enables this method to compete with other precast construction methods [16]. Hempcrete blocks are connected to each other with lime mortar and lime plaster is applied (figure 2). The blocks are often used as insulation for exterior and interior walls, as well as floors and roofs. While saving labor and time compared to Cast in Place hempcrete, hemp block has a smoother surface as it is prepared in the factory environment. Binder/hemp ratio and hemp shiv sizes in hemp block vary.

Figure 1. Hemp, lime and hempcrete [19]. **Figure 2.** Hempcret Block [20].

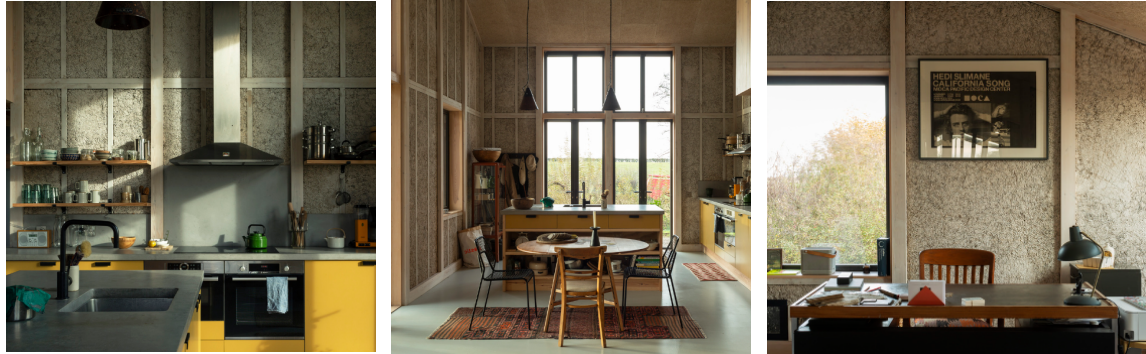
Precast walls and panels: Similar to the hempcrete block, walls and panels can also be produced. These insulating walls and panels, produced in the factory environment, provide rapid construction of both sustainable and aesthetic-looking projects with their rustic appearance. The precast wall system is created by spraying hempcrete onto the metal or wooden frame created in the factory environment. Precast walls transported to the construction site provide easy and fast building construction (figure 3).

Figure 3. Prefabricated Panel usage [21].

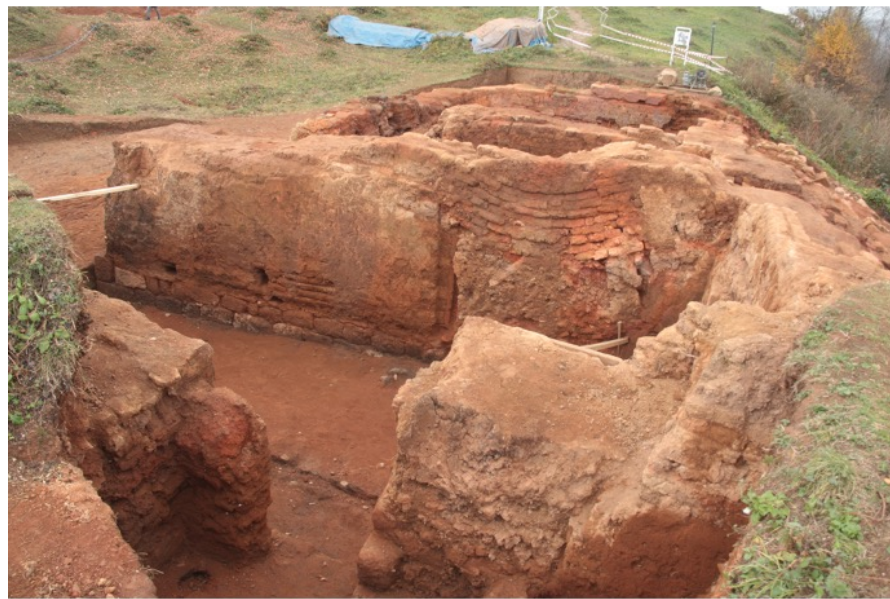
Because of the rainy and humid climate, an effort was made to protect the adobe bricks in the Kurul Fortress by coating the walls with an earthen plaster. This is evidenced by wall plaster found in-situ and well-protected at a number of places in the Kurul Fortress (Fig. 5).

Figure 5. The Plaster on the Face of the Western Wall of the İYA-3 Structure.

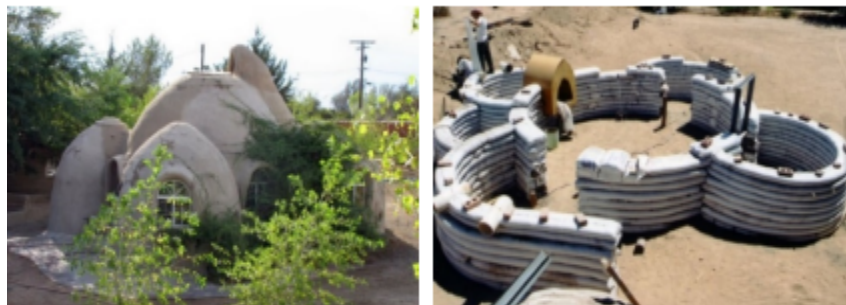
Figure 2. Eco Dome House and the Construction Phase of the Project [17; 18].

Khalili has developed the Superadobe system, which is formed by stacking bags on a circular plan and using belts in many parts of the world [Figure 2]. In addition, he established the organization called Cal-Earth, where the applications and training in which this system is used are carried out. With this system he created, the architect received the Aga Khan Architecture Award in 2004 [17; 18].

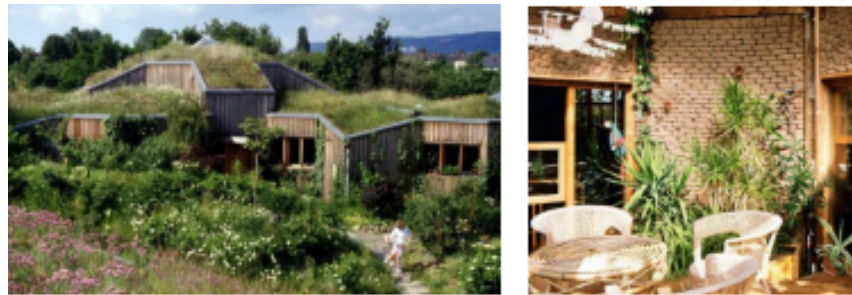
Figure 3. Kassel House [20]

In Minke's applications, he generally used earthen blocks with baked bricks, and wooden building elements [Figure 3] [21].

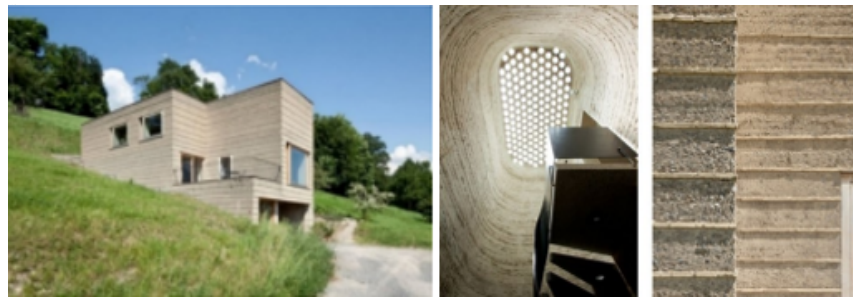
Figure 4. Rauch House [22]

Rauch projects include the light-shadow factor created on the facade surface by the linear surface movement created with earth blocks on the facade surface of the buildings and applied to slow down the water movement giving the building an identity and adding an aesthetic value to the space [Figure 4].

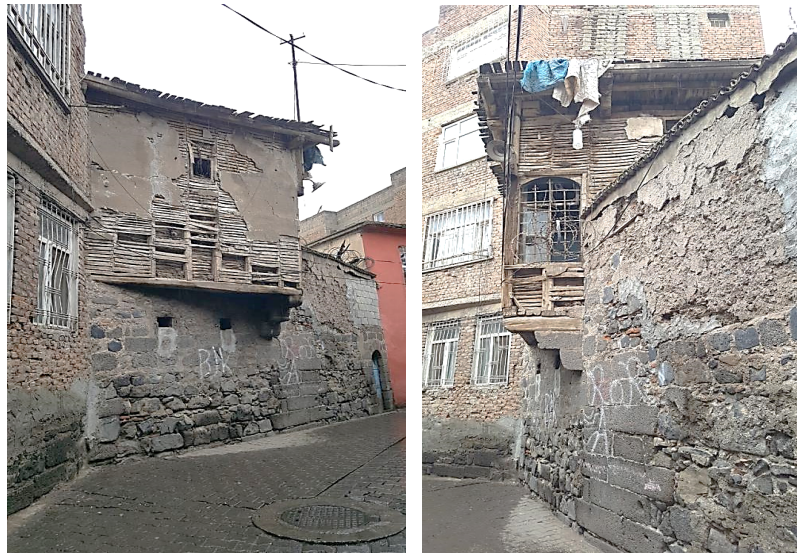
It is located in Ziya Gökalp Neighborhood in the Suriçi region. On the front of the bay window, which belongs to the building, it is seen that the plaster has been poured from place to place and there are deteriorations in the places that have not been poured. It is observed that the wooden laths are rotting and there are material losses in some exposed parts. On the side facade of the bay window, it is seen that almost all of the plaster has been poured and the wooden material has rotted and lost material here (Picture 1).

Picture1. A bay window made with the bagdadi construction technique in the Suriçi region of Diyarbakır

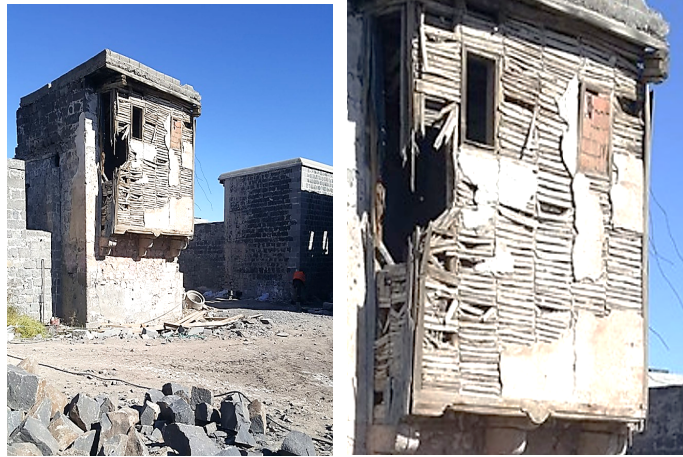
construction technique is used in its bay window, the plaster has fallen from place to place, there have been losses of wooden laths, and wood decay has occurred. Wooden slats are deformed. Where material loss occurs in the wooden laths in the left corner, it is observed that there is also material loss in the carrier pillar (Picture 2).

Picture 2. A bay window made with the bagdadi construction technique in the Suriçi region of Diyarbakır

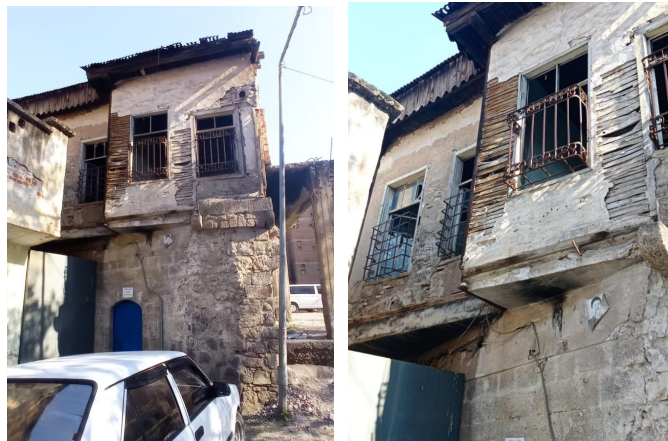
G An example of a traditional house is located in Iskender Pasa Neighborhood. There were losses due to plaster spills on the walls, especially on the windowsills, and rot in the wooden laths. It is observed that there is a color difference in the wooden laths used. Wooden laths have also undergone deformation due to rotting (Picture 3).

Picture 3. A bay window made with the bagdadi construction technique in the Suriçi region of Diyarbakır

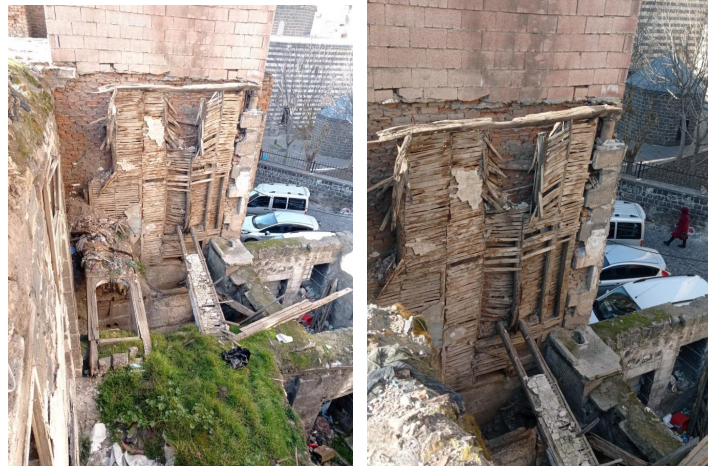
The building, located in the Fatih Paşa district, is heavily damaged in terms of all building elements, except for the Bağdadi walls. It is seen that the bağdadi wall used on the outer wall is exposed and has lost its function. Most of the plaster has been poured, and there are deteriorations and losses in the wooden laths. Formal deformations have occurred in the wooden laths, the integrity of the wooden carcass has been disrupted and the static state of the wall has changed (Picture 4).

Picture 4. The exterior wall made with the Baghdadi construction technique in the Suriçi region of Diyarbakır

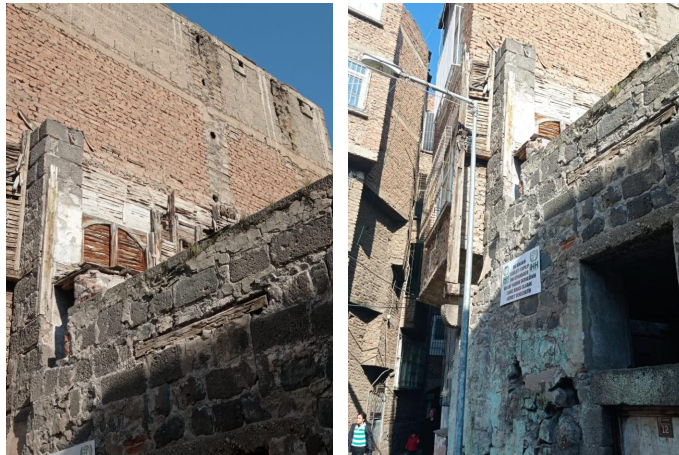
When the traditional house where the bagdadi wall was applied in the Mosque Kebir District in the Suriçi region was examined, it was determined that all the elements in the building were destroyed except the bagdadi wall. There were plaster losses on the wall, and it was observed that there were deteriorations in the wooden laths due to rot. Formal deformations in wooden laths are in a position to affect the structure of the building (Picture 5).

Picture 5. The exterior wall made with the Baghdadi construction technique in the Suriçi region of Diyarbakır

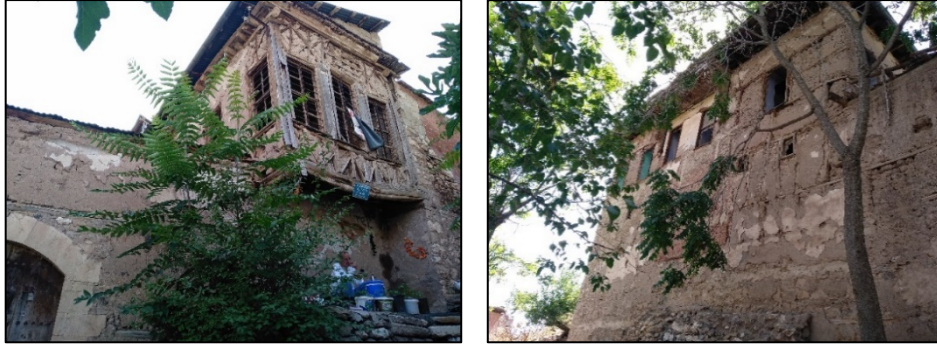
Faik Bey Mansion is a house built in a traditional style, which has survived for a long time since its construction date and has been exposed to various influences and interventions in this process, and its structural problems have arisen (Figure 6). The building, which was not used for a long time, was left empty due to neglect and abandonment, and the existing structural problems increased. According to the information obtained from the residents of the neighborhood residing in the region, the building has been looted many times and the building has suffered serious damage. Recent earthquakes around the region have also affected the structure and caused damage.

Figure 6. Faik Bey Mansion East and South facades (2023)

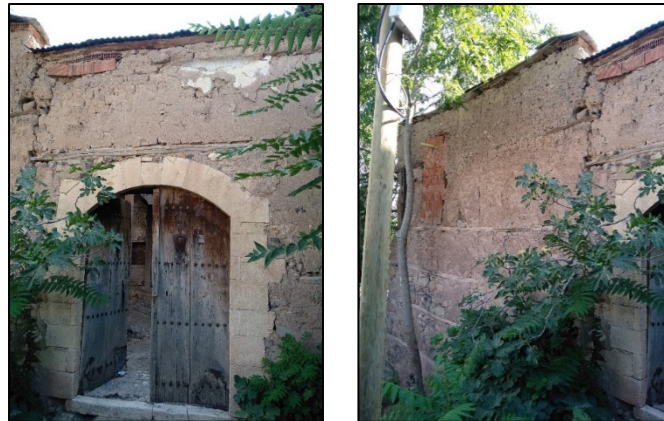
The building is surrounded by a high courtyard wall. Rubble stone, cut stone, adobe and wood materials were used on the walls of the courtyard. The mudbrick walls of the empty and unused building have suffered material losses, axial shifts and weathering damage over time. In the building, the original mudbrick walls were completed with brick materials, with unqualified interventions in the parts destroyed by the users. For this reason, due to unqualified interventions on the adobe walls, the structural integrity has deteriorated, increasing the existing damages. The walls of the courtyard were covered with sheet material and structural problems and damages occurred on the walls due to load irregularities. It has led to an increase in structural and stylistic deterioration in the mudbrick walls and wooden beams, which are vulnerable to external influences. (Figure 7).

Figure 7. Structural damage observed on the courtyard walls of Faik Bey Mansion (2023)

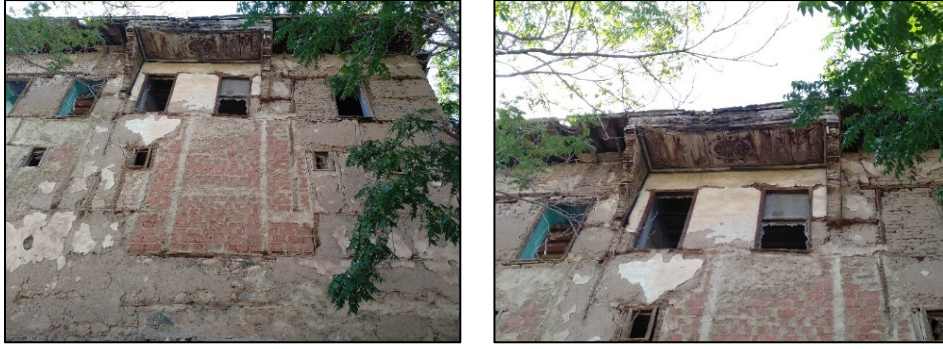
There were losses in the façade walls of the building made of adobe material and unconscious interventions were applied to these parts by the building users. Irregular load distributions occurred on the facade walls, which were completed by using materials and techniques contrary to the original. Due to the discontinuities in the load-bearing facade walls, damage such as axis shifts, cracks and joint discharges have occurred. In the old photographs of the building, it is observed that there is a section called the pavilion room in its original form and designed to protrude. Today, almost all of this section has been destroyed by demolition. Remains of wooden flooring and carrier element belonging only to the protruding part of the mansion room have survived to the present day. Deflection, deformation, decay, color change and material losses have occurred in the wooden elements located here (Figure 8).

Figure 8. Structural damages observed on the southern facade of Faik Bey Mansion and the remains of the Köşk Room (2023)

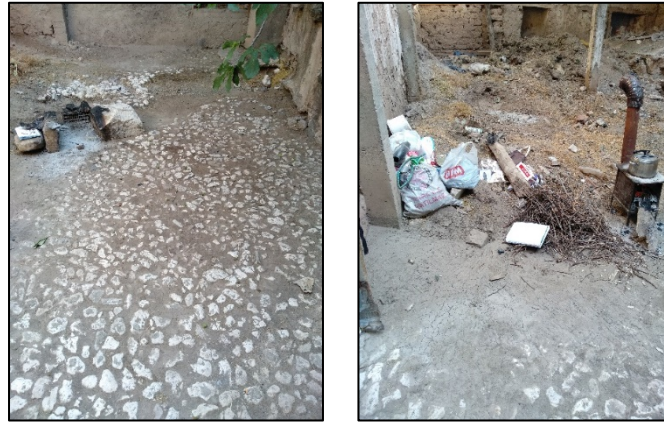
The floor of the courtyard section of the building is covered with stone material (Figure 9). Due to the collapse of the roof of the building and the walls of the courtyard, rubble deposits appeared in the courtyard. The reinforced concrete columns in the courtyard made by the users of the building caused damage to the ground.

Figure 9. Damages observed in Faik Bey Mansion courtyard flooring and stairs (2023)

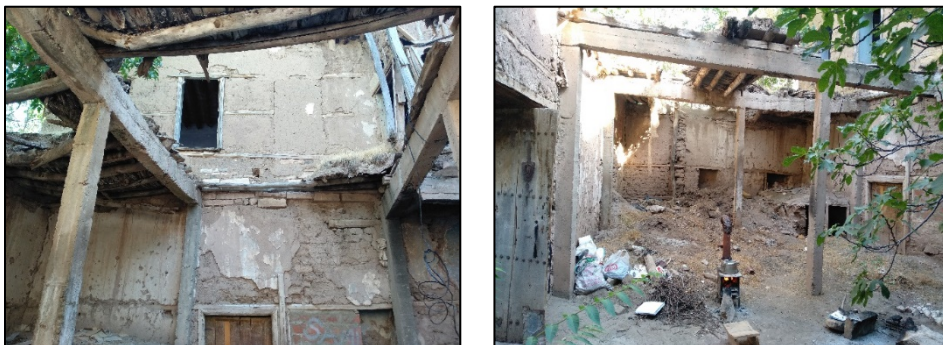
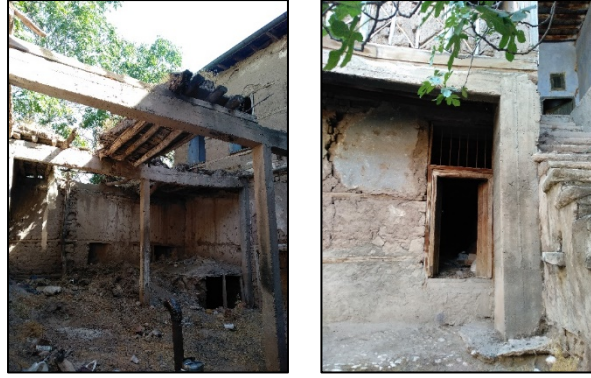
A part of the courtyard of the building was covered and a roof section was formed. The roof section, which is accessible from the first floor, was built using wooden carrier elements. In this section, the damages due to material losses accelerated the collapse of the structure. Due to the unqualified interventions of the users, the construction system was changed with reinforced concrete columns. (Figure 10). Due to improper combinations between reinforced concrete columns and wooden material, collapses in the roof section caused damage to the walls by making reinforced concrete inserts adjacent to the building walls. Material losses and decays in the original wooden elements have caused discontinuities and collapses in the carrier system.

Figure 10. Structural damages and unqualified reinforced concrete annexes observed in the roof section of the Faik Bey Mansion courtyard (2023)

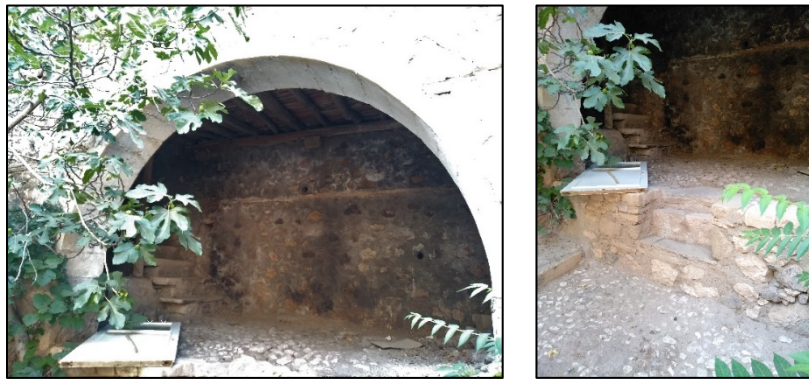
There is an iwan section separated from the building courtyard by a stone arch. The iwan can be reached by climbing the stairs from the courtyard. Weathering and joint losses occurred in the stone arch in the iwan. There are deteriorations due to processing and darkening on the mudbrick walls, which are thought to be due to the interventions of the users. It was also observed that there were material losses in the stone pavements on the courtyard floor (Figure 11).

Figure 11. Structural damage observed in the Eyvan section of Faik Bey Mansion (2023)

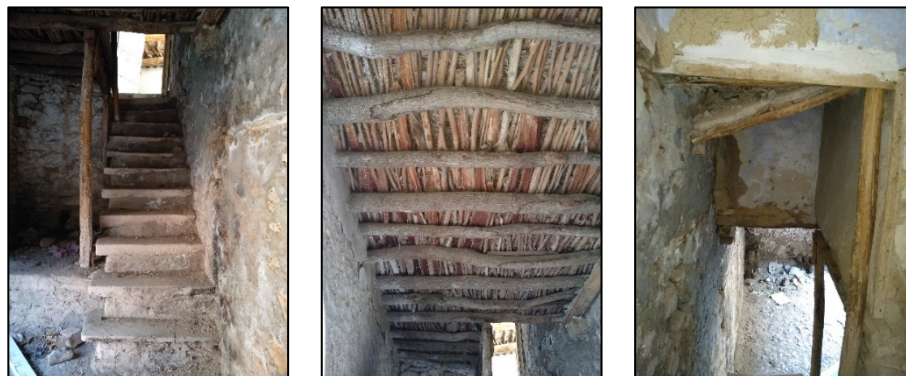
Figure 12. Damages observed on the stairs and ceiling tiles in the iwan section of Faik Bey Mansion (2023)

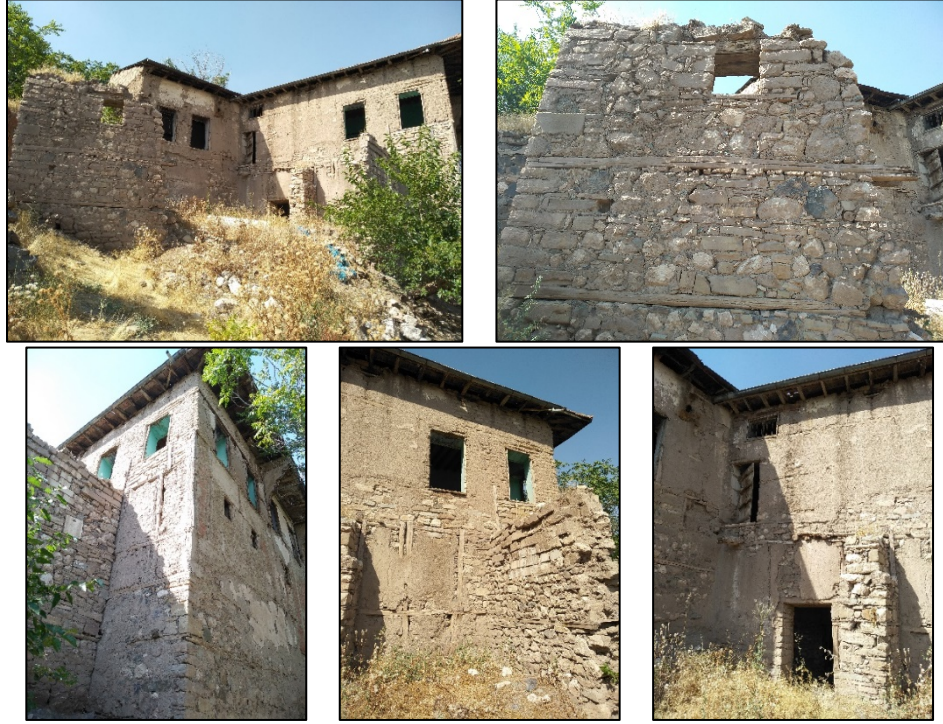
Figure 13. Structural damages observed in the barn and roof section of the southwestern facade of Faik Bey Mansion (2023)

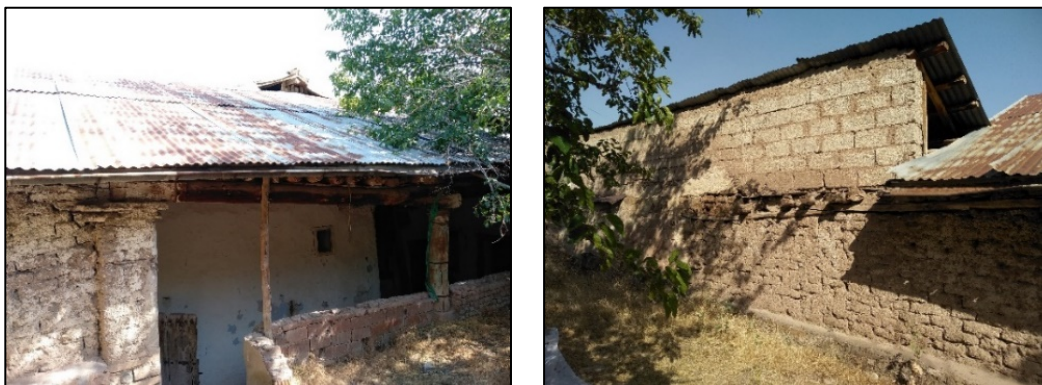
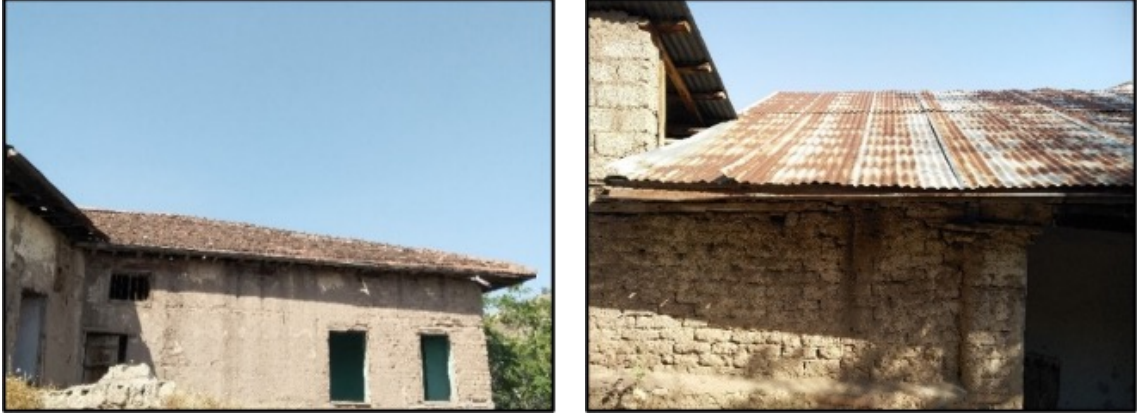
Figure 14. Faik Bey Mansion's non-original roof application and its structural damages (2023)

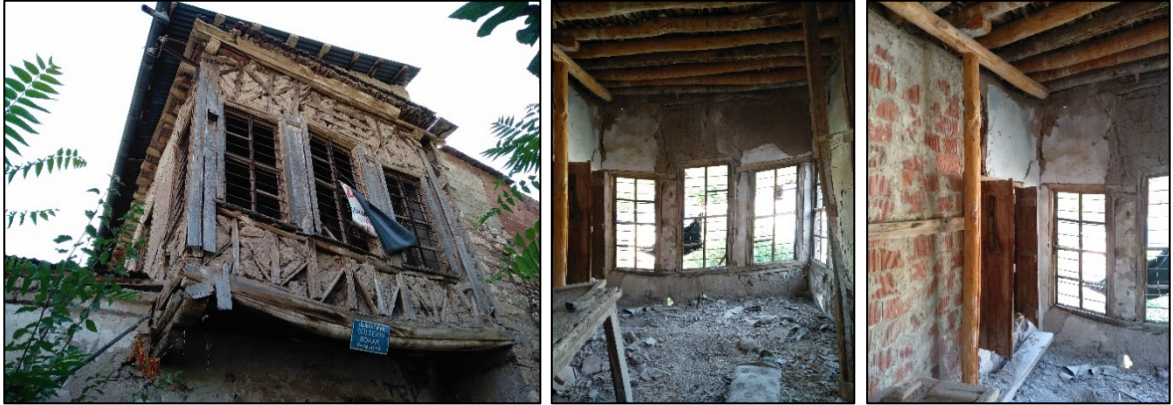
Figure 15. Structural damages observed in the interior and exterior parts of the bay window on the eastern façade of Faik Bey Mansion (2023)

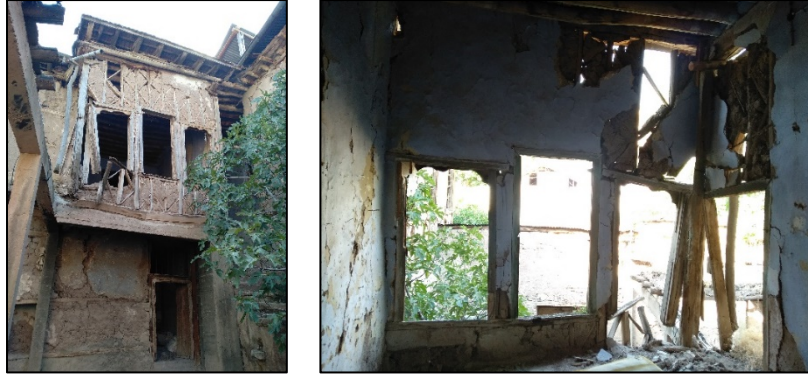
On the first floor of the building, there is a sofa in the form of a Şahnişin(Cumba) (Figure 16). This section is supported externally by reinforced concrete columns and beams made by the users of the building. Serious damage has occurred in this part with unconscious user interventions and some of it has been demolished. Material losses and deformations in the wooden elements of the bagdadi wall are observed in the section of the falcon facing the courtyard. Axle shifts on the walls of the sofa have caused deformities in the window spaces.

Figure 16. Structural damage observed in the bay window of the hall facing the courtyard of Faik Bey Mansion (2023)

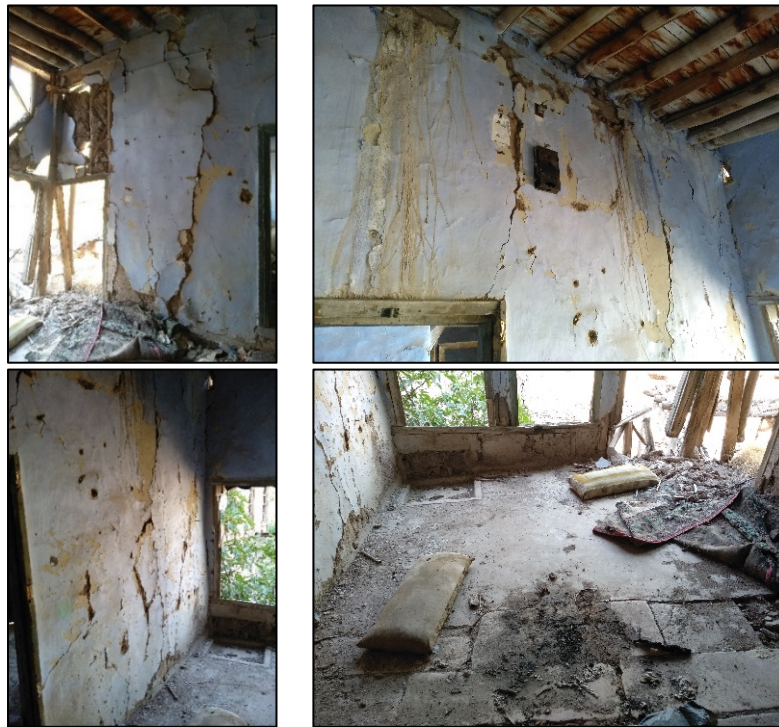
Figure 17. Structural damage observed on the wall and floor of the sofa facing the courtyard of Faik Bey Mansion (2023)

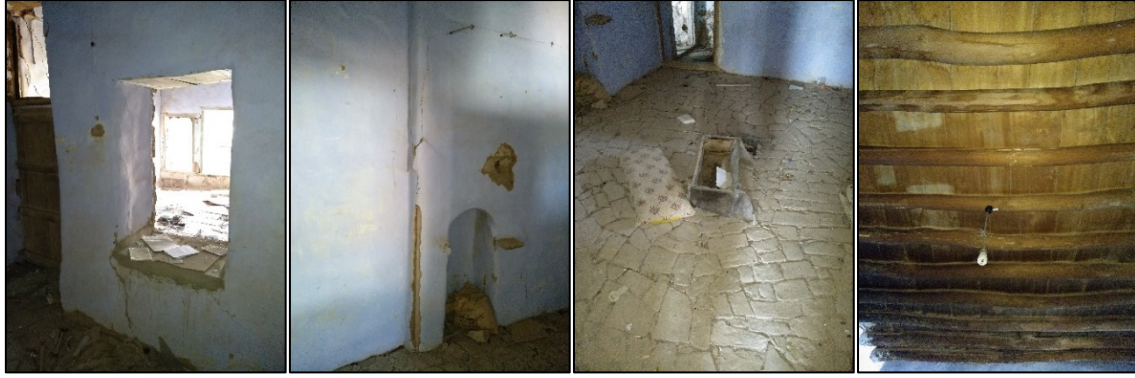
Figure 18. Structural damage observed in the greeting hall of Faik Bey Mansion (2023)

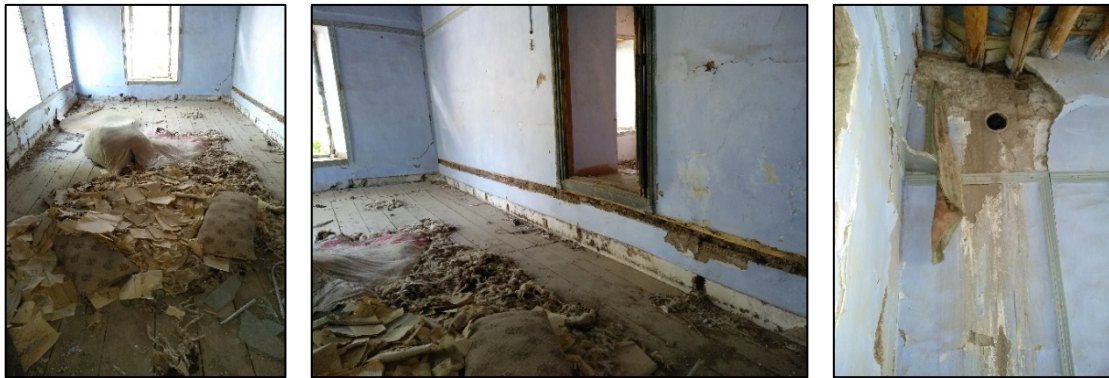
Figure 19. Structural damage observed in the room facing the courtyard in the Selamlık section of Faik Bey Mansion (2023)

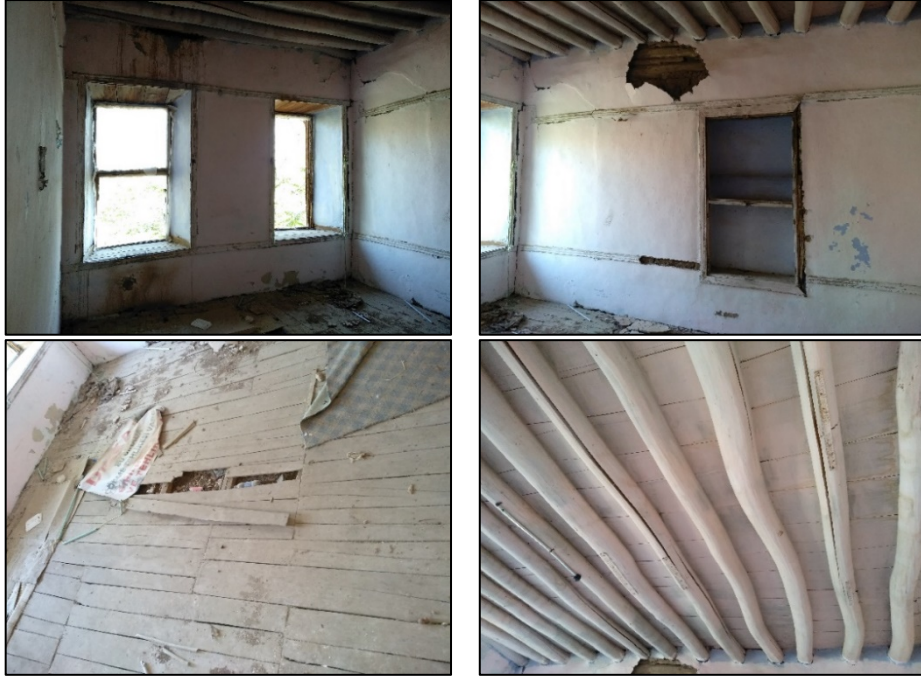
Figure 20. Structural damage observed in the second room in the Selamlık section of Faik Bey Mansion (2023)

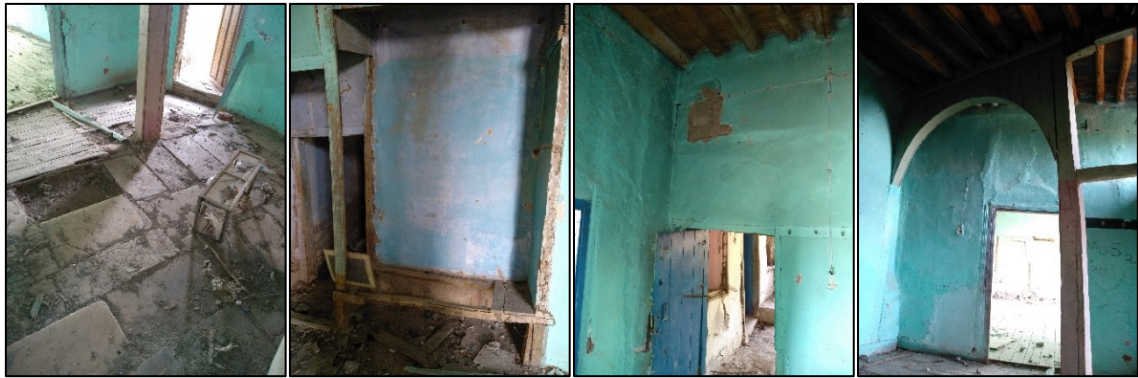
Figure 21. Structural damage observed in the harem hall of Faik Bey Mansion (2023)

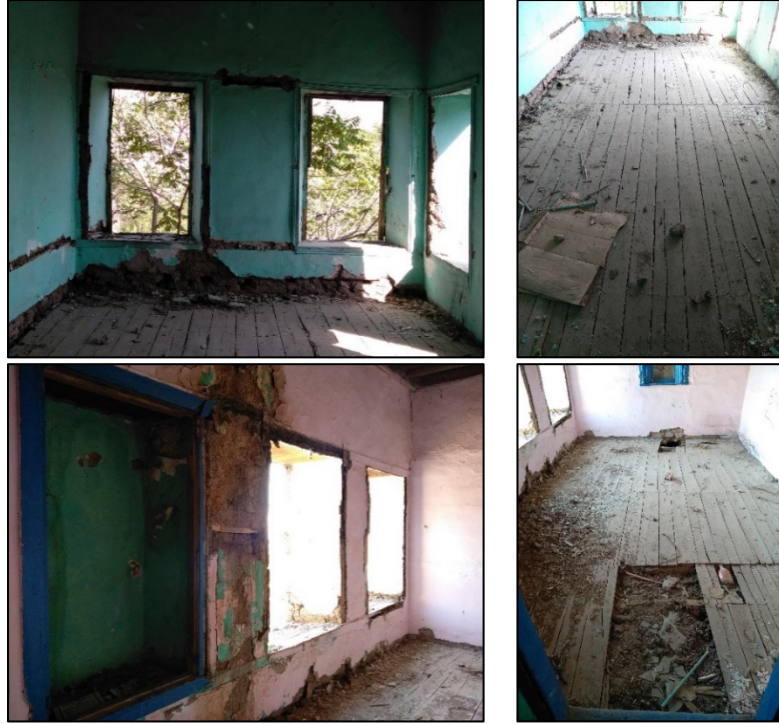
Figure 22. Structural damages observed in the harem rooms of Faik Bey Mansion (2023)

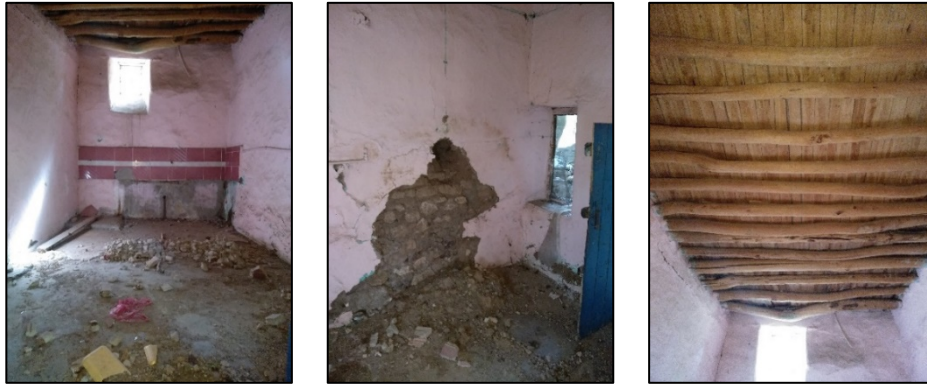
Figure 23. Structural damage observed in the kitchen section of Faik Bey Mansion (2023)

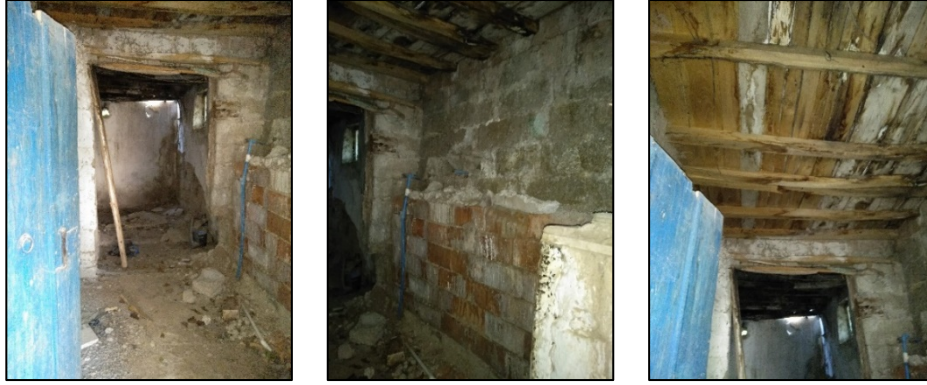
Figure 24. Structural damage observed in the bathroom section of Faik Bey Mansion (2023)

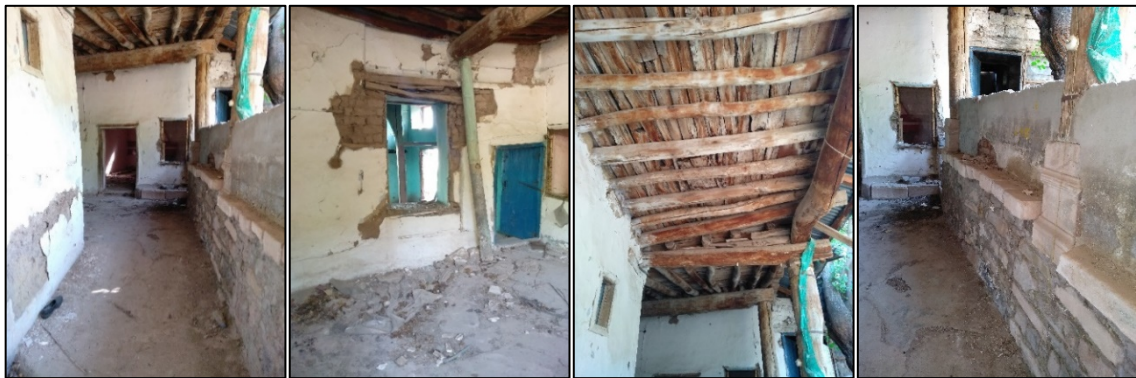
Figure 25. Structural damages observed in the portico section of Faik Bey Mansion (2023)

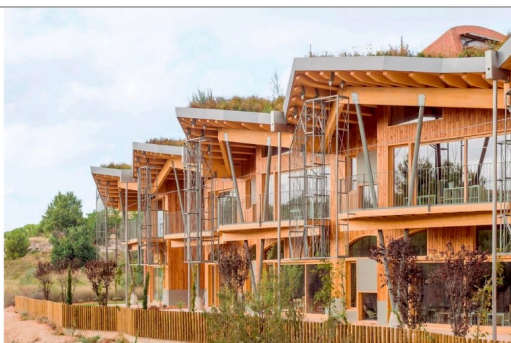
Table 2. Montessori School [Url-2].

TITLE	Montessori School
LOCATION	İSPANYA
YEAR	2019
ARCHITECT	Gradoli & Sanz
AREA	1842 m ²
MATERIAL	Terracotta-based perforated brick and wood

DESIGN: The focal point of the design of the building has been to have flexible spaces that can change and grow according to needs. When desired, there is an environment interaction with the classes that open out. For this, we come across a three-dimension reminiscent of the fan form. Considerable attention has been paid to the heavy use of materials with a smaller ecological footprint: terracotta and wood. Concrete was used only in the foundations, while steel was used in individual columns and balustrades. There is no plaster work, suspended ceiling or suspended floor, paneling. Everything is visible. In this way, it can be understood how the structure works, how the materials are assembled and how it is built. [Url-2]

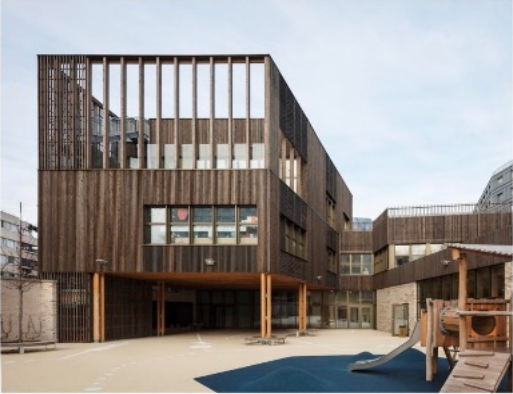
Table 3. Jeanne d'arc Nursery School [Url-3].

TITLE	Jeanne d'arc Nursery School
LOCATION	FRANSA
YEAR	2019
ARCHITECT	Atelier Desmichelle Architecture , La Architectures
AREA	1753 m ²
MATERIAL	Ahşap karkas, volkanik taş ve metal kaplama

DESIGN: The project was designed using a low carbon approach. Therefore, all materials are selected from bio-based and geographically sourced material. As the building is part of the passive design certification, sunlight is optimized, reducing heating needs and using a high-performance cladding and dual-flow ventilation system. [Url-3] Attention is drawn to the use of traditional materials by using wooden walls and terracotta bricks.

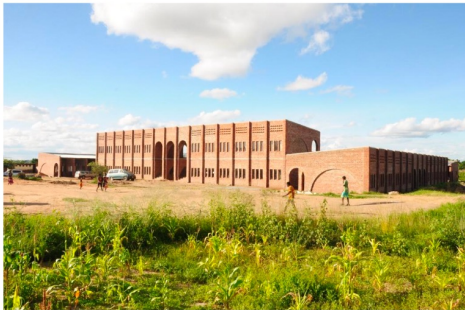
Table 4. Initiative Rising Star School [Url-4].

TITLE	Initiative Rising Star School
LOCATION	ZİMBABVE
YEAR	2023
ARCHITECT	Ingenieure ohne Grenzen
AREA	2552 m ²
MATERIAL	Brick

DESIGN: It's hard to believe that the new school building is completely handmade. About 600,000 bricks were laid by masons, and only a few technical devices assisted the construction. [url-4]

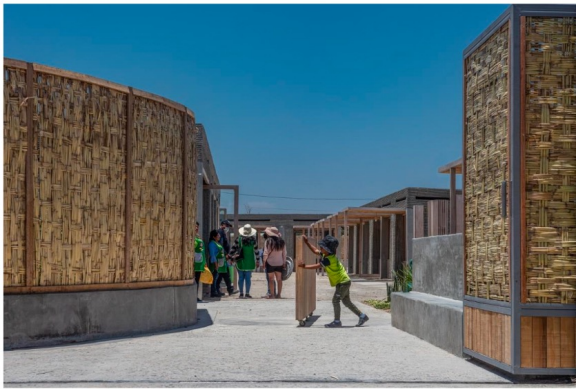
Table 5. Elementary School in Santa Cruz de Villacuri Community [Url-5].

TITLE	Elementary School in Santa Cruz de Villacuri Community
LOCATION	PERU
YEAR	2022
ARCHITECT	Atelier Ander Bados, Betsaida Curto Reyes
AREA	760 m ²
MATERIAL	Brick, wicker, wild cane and wood

DESIGN: The understanding of 'it comes from the community that understands its environment as valuable' has created the design concept. The common point of all constructions is the use of uncoated materials to be economical. The materials are used as they are; exposed brick, exposed concrete, wicker, reed and wood. . The intimacy of the material in its natural state helps the community more identify with the school and feel more respected by the local construction methods. Wild cane and wicker, which are local and traditional materials, are the unifying elements in the project. They are used in the closing, shadow and segmentation functions. [url-5]

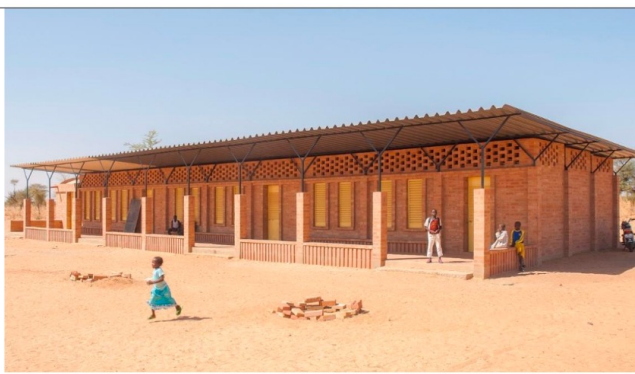
Table 6. Gangouroubouro Primary School [Url-6].

TITLE	Gangouroubouro Primary School
LOCATION	GÜNEY AFRİKA
YEAR	2013
ARCHITECT	LEVS MİMARLIK
AREA	295 m ²
MATERIAL	Hydraulic compacted earth block (HCEB)

DESIGN: The walls are constructed with newly developed and locally produced hydraulic compacted earth blocks (HCEB) in alternating strips. It sets the rhythm of the facades and provides a cool interior climate. The porch with stone rows on both sides forms the wide terrace of the school. The roof is made of overlapping steel sheets, each overhanging 1 meter, creating extra shadow areas. The mass of the roof is transferred to the buttresses by means of thin steel shaft profiles. Poligny beams run throughout the classroom rooms, creating a free floor surface [url-6].

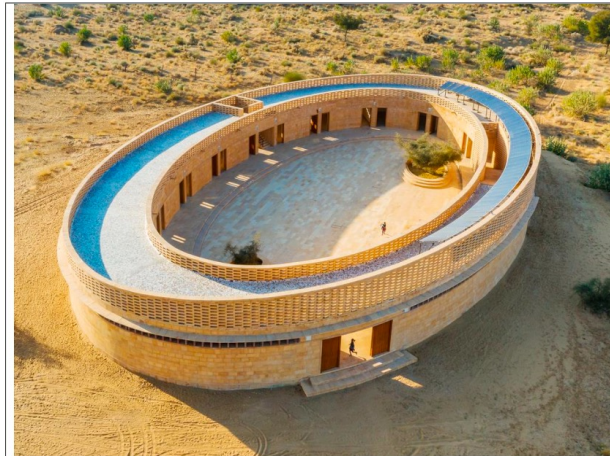
Table 7. The Rajkumari Ratnavati Girl's School [Url-7].

<u>TITLE</u>	The Rajkumari Ratnavati Girl's School
<u>LOCATION</u>	HINDISTAN
<u>YEAR</u>	2021
<u>ARCHITECT</u>	Diana Kellogg Architects
<u>AREA</u>	-
<u>MATERIAL</u>	Sandstone

DESIGN: Rajkumari Ratnavati Girls' School is a school that will serve more than 400 girls from kindergarten to grade 10 living below the poverty line living in the mystical Thar Desert region of Jaisalmer in Rajasthan, India, where female literacy has reached only 32%. Since the GYAAN Center was designed for women by a woman, Kellogg looked at cross-cultural feminine symbols when starting the design process. In particular, a structure consisting of three ovals was designed to represent symbols of power, femininity and the power of eternity. Rajkumari Ratnavati Girls' School is made entirely of local hand-carved Jaisalmer sandstone by local craftsmen. Using local materials has helped reduce carbon emissions. The elliptical shape of the structure also creates a cooling airflow panel, helping to bring out the sustainability aspect. [Url-7]

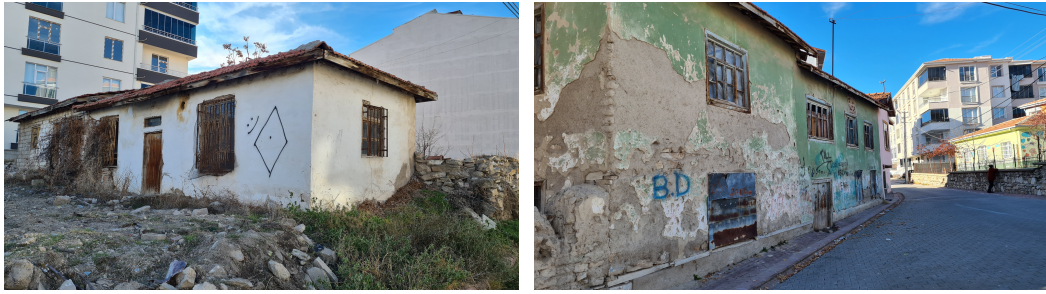
Figure 2. Examples of abandoned houses (Author's Archive)

Among the *socio-economic and socio-cultural challenges*, the abandonment of houses holds particular significance. It is believed that users prefer modern construction systems and materials over adobe houses. Factors such as the perception of contemporary constructions being more durable and capable of providing superior comfort may influence user preferences. Additionally, changes in the traditional neighborhood culture, leading to a weakening of neighborly, kinship, and community relationships, can also contribute to the abandonment of adobe houses. The requirement for annual maintenance and repair, which incurs additional costs, can only be fulfilled based on the economic capabilities of users. Consequently, it is observed that users opt to leave their adobe houses and choose to reside in new dwellings, repurposing their old houses as secondary residences or storage spaces. The complete abandonment or inappropriate utilization of adobe houses impedes the maintenance and repair efforts, hastening the process of deterioration. During the course of this study, it was determined that some abandoned structures had deteriorated into ruins. Moreover, the presence of unused houses within a region can contribute to social decline, leading to areas of social deterioration.

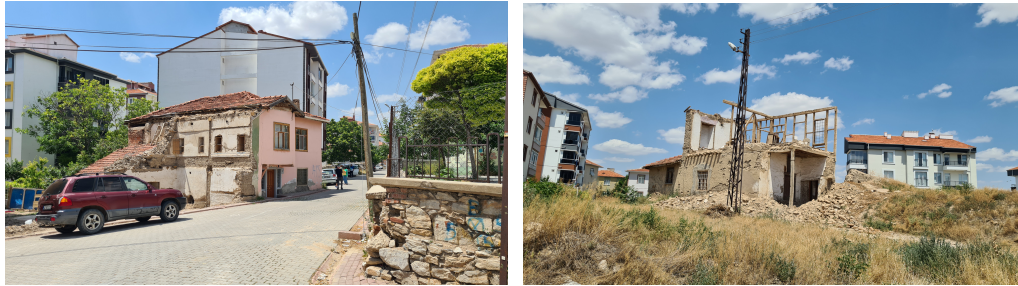
Figure 3. Examples of ruined houses (Author's Archive)

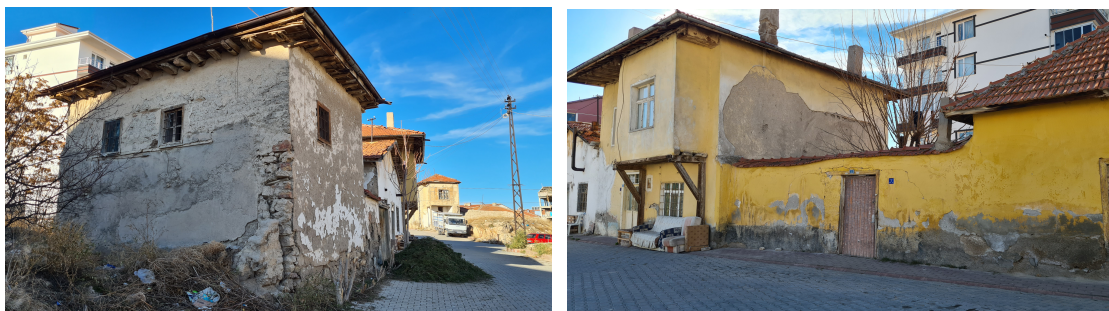
Figure 4. Erosion and plaster repairs on body walls (Author's Archive)

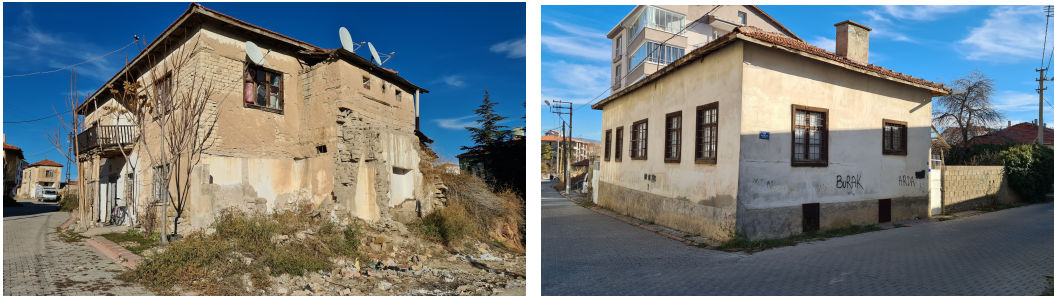
One of the *human-related conservation issues* concerning adobe houses involves proposed solutions to meet additional space requirements, which can be defined as user needs. It can be stated that additional wet areas are identified in the houses in Kayabaşı Neighborhood. These areas are primarily toilets, bathrooms, and kitchens. The incorporation of these areas into the houses to meet comfort conditions may lead to decisions that disrupt the original floor plans of the houses (Figure 5). Moreover, the use of different materials such as bricks, blocks, or cement for these additions creates problems associated with the integration of different materials.

Figure 5. Later added spaces and application of concrete plaster (Author's Archive)

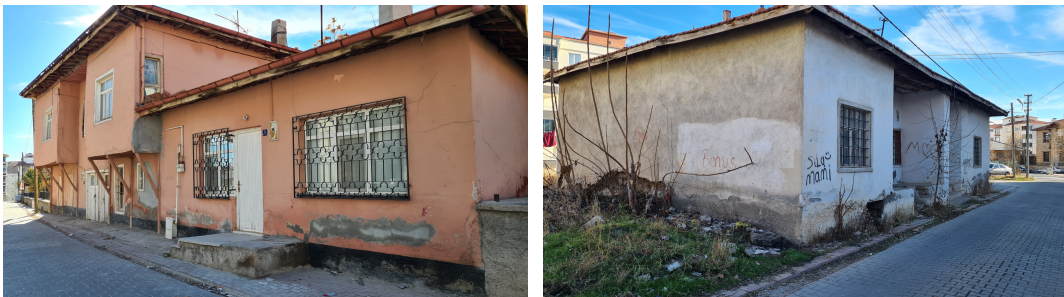
The replacement of window and door frames, which define the original facade character of the houses, with widely used and perceived as more comfortable materials, is a common occurrence in the study area. Furthermore, interventions that alter the balance between solid and void on the facade by closing doors and windows can also have a negative impact on the original facade character (Figure 6).

Figure 6. Change in frame material, damage caused by paint and inscriptions on the facade (Author's Archive)
