PROCEEDINGS

10th International Conference

Kerpik'23

“GAIN INFORMATION FROM THE TRADITIONAL EARTHEN ARCHITECTURE“

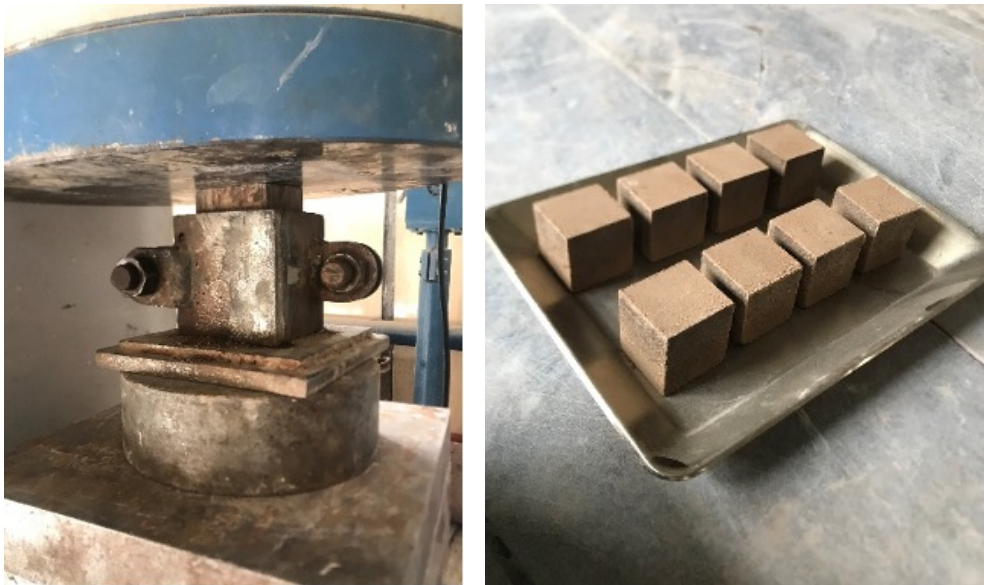
Compressed earth blocks are a contemporary version of molded earthen bricks that are compressed by hand-operated or hydraulic machines. It can be molded into various solid shapes such as bricks, bricks with holes, or interlocking blocks. Compressed Earth Blocks are often made using manual presses that utilize leverage to ensure proper compaction. In order to maintain consistency across all blocks and mixes, this research utilized machine-produced blocks. The hydraulic jack is equipped with a pressure gauge, allowing for precise input pressure for every fabricated block. All of the specimens were produced using hydraulic pressure. Fig1, illustrates the experimental device for manufacturing test specimens including a metal mold and a hydraulic press for soil compaction.

Figure 1. Specimens preparation procedure

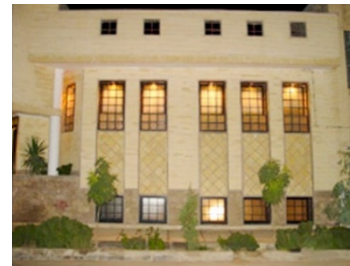
Figure6. Diversity in the materials of the facade facing the street and various movements

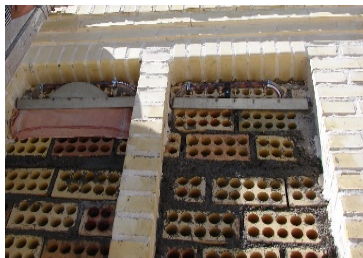
Figure 16. Water spray on porous bricks

With the recent increase in average temperatures, there is a need to improve the performance of Windcatcher. Combining Windcatcher with water spraying results in the air passing through the Windcatcher being cooled by evaporative cooling. After absorbing heat from the air through a phase change, water accompanies the cooled air, resulting in a comfortable environment with balanced temperature and humidity levels. 'Fig. 16'. The designed Windcatcher consists of porous bricks at its head, sprayed with water in a controlled manner by adjustable valves 'Figs. 17 and 18'. To conserve water, gutters have been designed around the head of the Windcatcher so that used water can be collected and returned to the source by a pump for reuse 'Figs. 19 and 20'. Given the water scarcity problem in Yazd City, the Windcatcher can still function even when the pool in the Hozkhaneh is empty. The Windcatcher begins to function when the windows of the living room are closed, and the air inside the Hozkhaneh begins to heat up due to the wide glass surface, causing it to rise upward 'Figs. 21-23'. The suction of warm air by the Windcatcher leads to fresh air entering from the other side, resulting in the cooling of indoor spaces such as the living room and the master bedroom 'Fig. 24'. During winter, the Windcatcher channel is closed from the inside by a metal gate, and the warm air from the Hozkhaneh is directed inside by opening the living room window 'Figs. 25 and 26'.

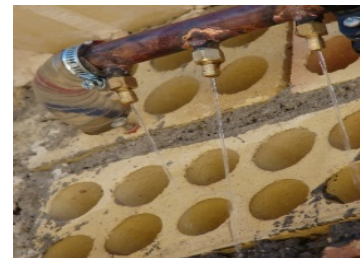
Figure 18. Water spraying pipes

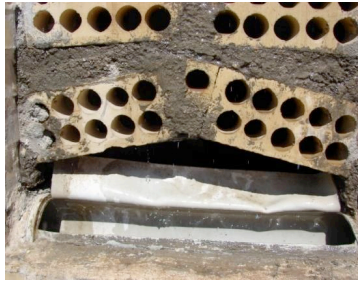
Figure 19. The gutter beneath the porous clay bricks facilitates the return of water to its source.

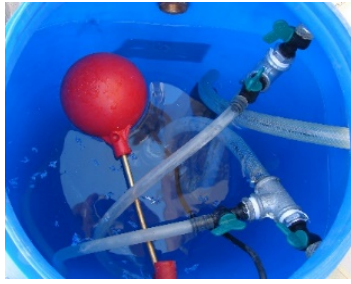
Figure 20. Water pump components

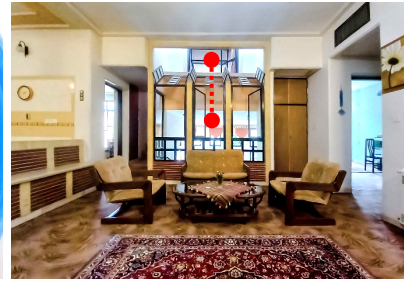
Figure 21. The interaction between living room, Hozkhaneh, and Windcatcher

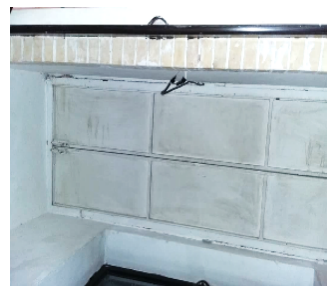
Figure 26. Windcatcher metal gate

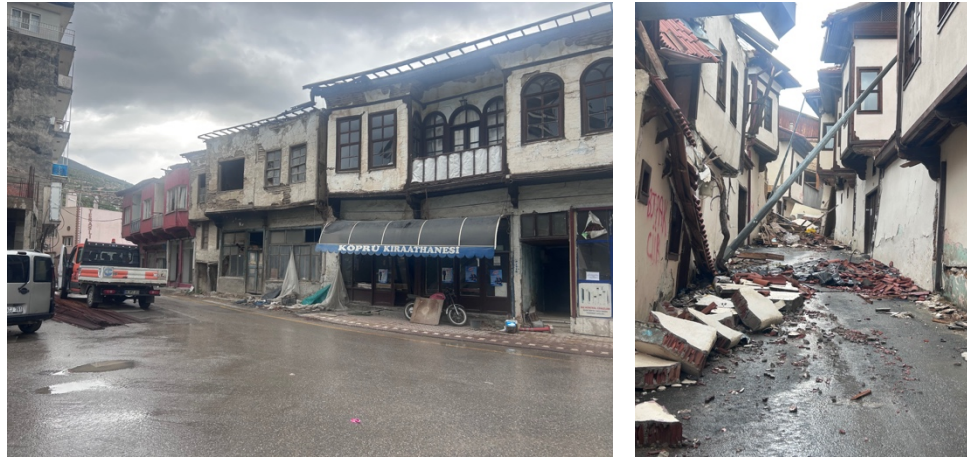
Most of the buildings in the study area are proprietary buildings. The buildings are traditional Malatya houses of the Turkish house type, built with adobe. The building stock in the study case defines a house typology and forms a morphological region. All buildings were destroyed or severely damaged by the February 6 Kahramanmaraş and February 27 Malatya earthquakes. After the earthquakes, the condition and inventory of the houses were observed, photographed and archived during a technical site visit on May 15 (Figure 2).

Figure 2. Gündüzbey after the earthquake [11]

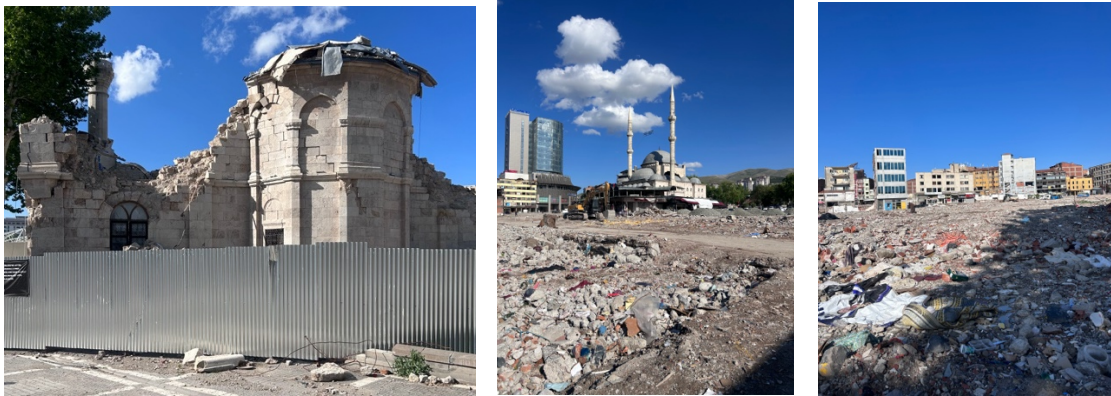
Figure 5. Urban texture of Malatya after the earthquake [11]

The urban texture of Malatya was severely damaged by the earthquakes (Figure 5). The Malatya Governor's Office stated that 3,899 buildings were destroyed and 23,968 buildings were severely damaged after the earthquake [17]. After the devastation of the city, the traditional building fabric was examined and the destruction in the region was observed. The causes of damage to adobe houses were evaluated based on the information found in the literature [18] [6]. In accordance with the information obtained, the damages present in the field study were listed.

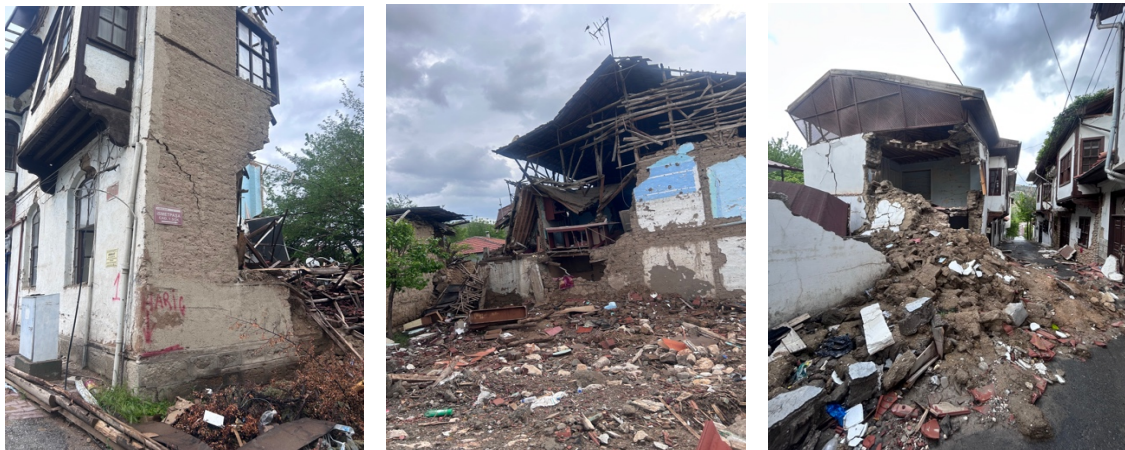
Figure 6. Examples of fracture at joints [11]

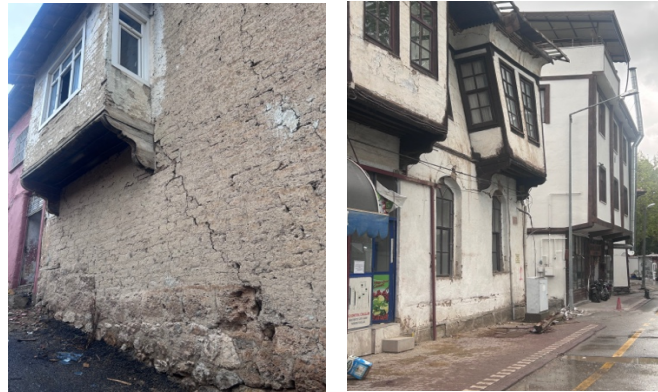
Damage caused by the detachment of the annex from the main building as a result of earthquake loading (Figure 7).

Figure 7. Examples of separation of the annex [11]

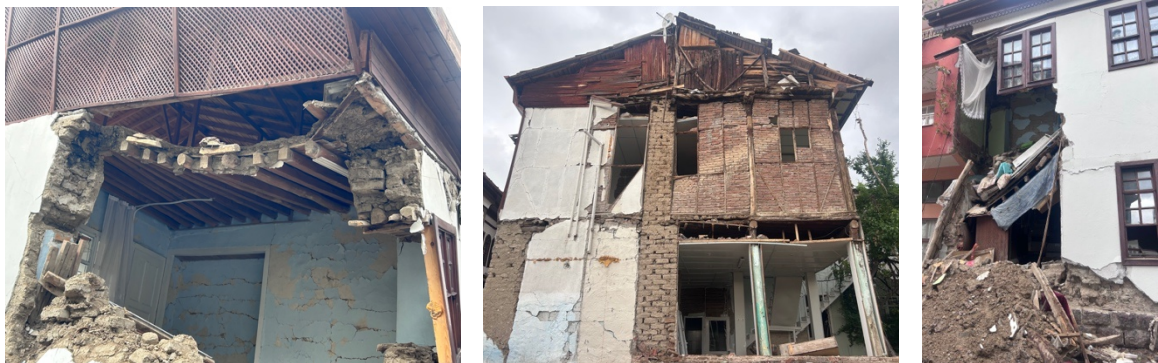
Figure 8. Examples of collapse due to ceiling load [11]

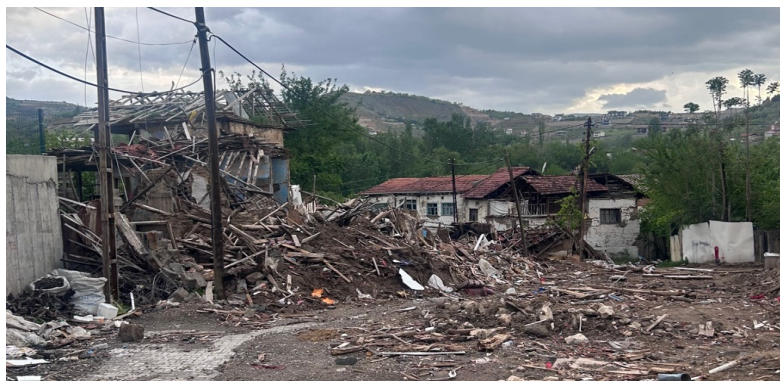
In masonry structures, the walls also have load-bearing properties. If the walls are severely damaged under the earthquake load, the structure will collapse completely (Figure 9).

Figure 9. Examples of complete collapse [11]

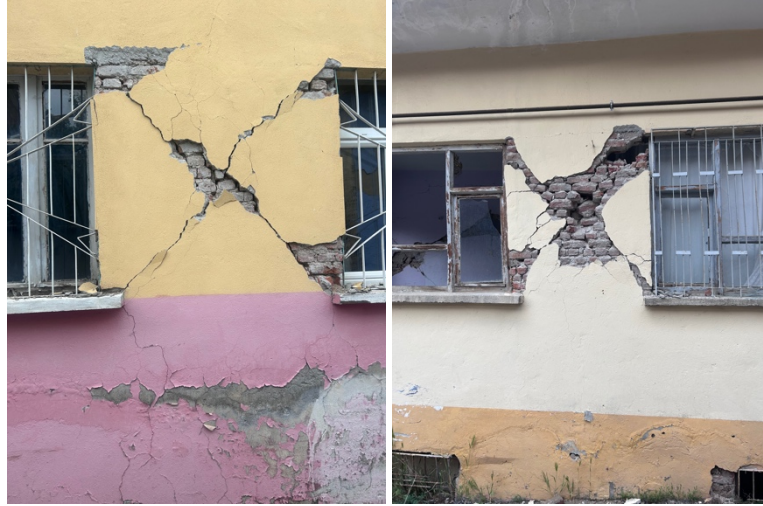
Figure 11. Examples of structural cracks [11]

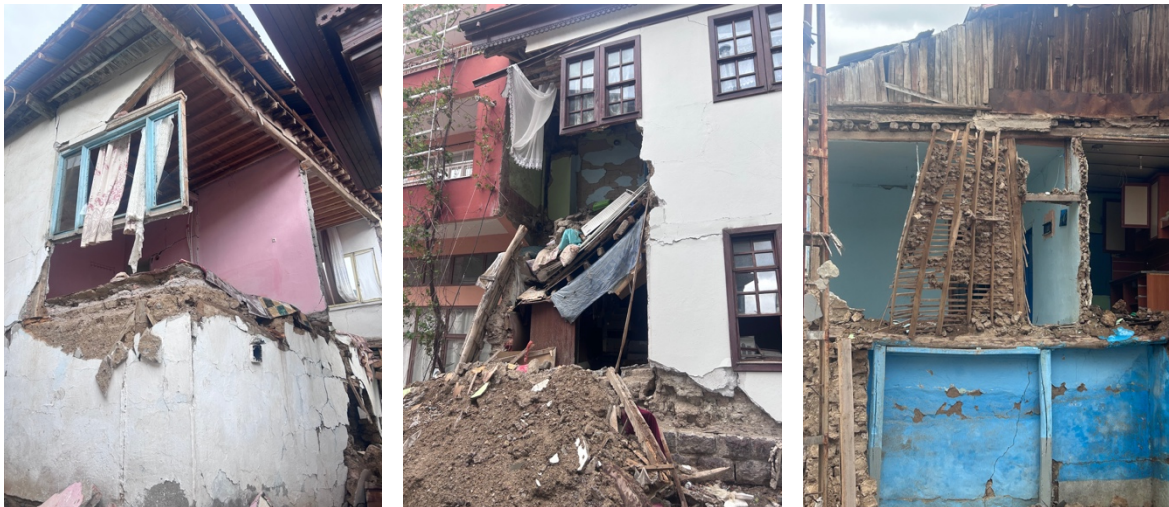
Figure 12. Examples of formation of void circles [11]

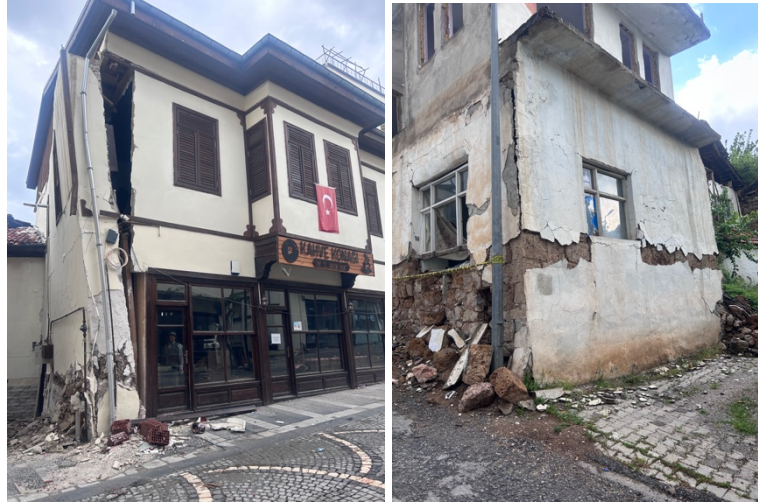
Figure 13. Examples of damage to the corner [11]

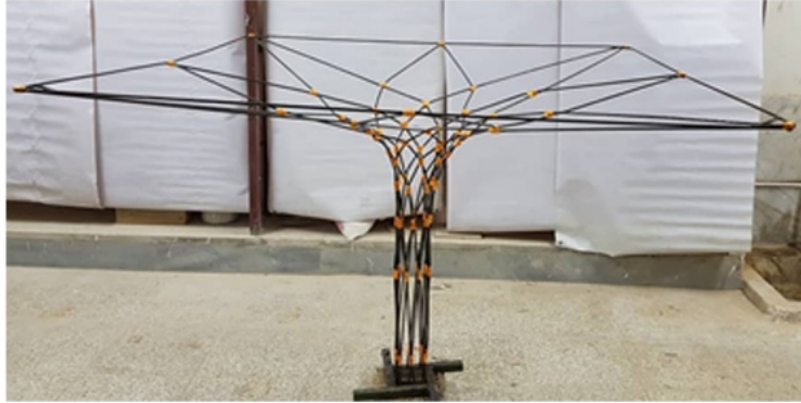
Kerpik 2022 paper was a report of the design and construction process of a lightweight roof structure over the remains of a historical building called the "Naji House" in the Historical City of Yazd (Photo 1). The construction of a structure to preserve the valuable historical building of the Shirazi courtyard on the site of the Art and Architecture faculty of Yazd University was considered as the final project of the technical design of buildings course for B.Arch students. During this project, students became familiar with this valuable house and collected information, took

Figure 1. Constructed structure 2020, kerpik2022

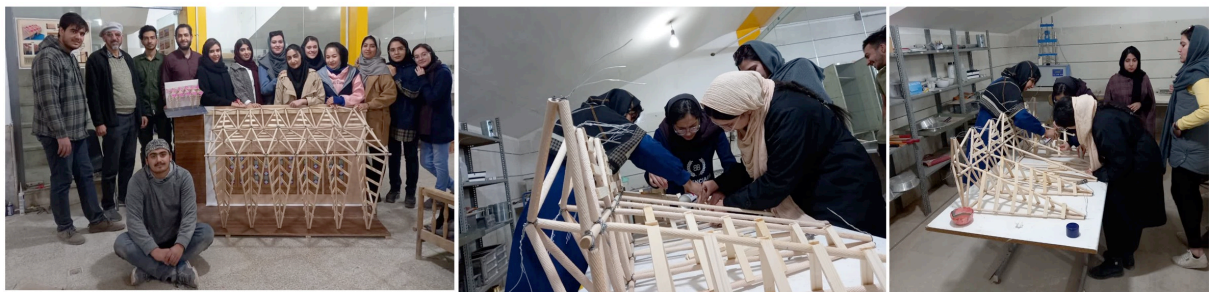
The selected design was a latticework structure with tensile and compression elements in a truss shape. the initial structure was a tensegrity but in the developing process, it became a truss structure that satisfied the design criteria including the lightness and efficiency of the structure, the small number of foundations and the minimum intervention in the historical site, the applicability of the structure without damaging the historical building.

Figure 7. Construction process of the selected structure, in the workshop of Rasoolian's house (art & architecture faculty of Yazd).

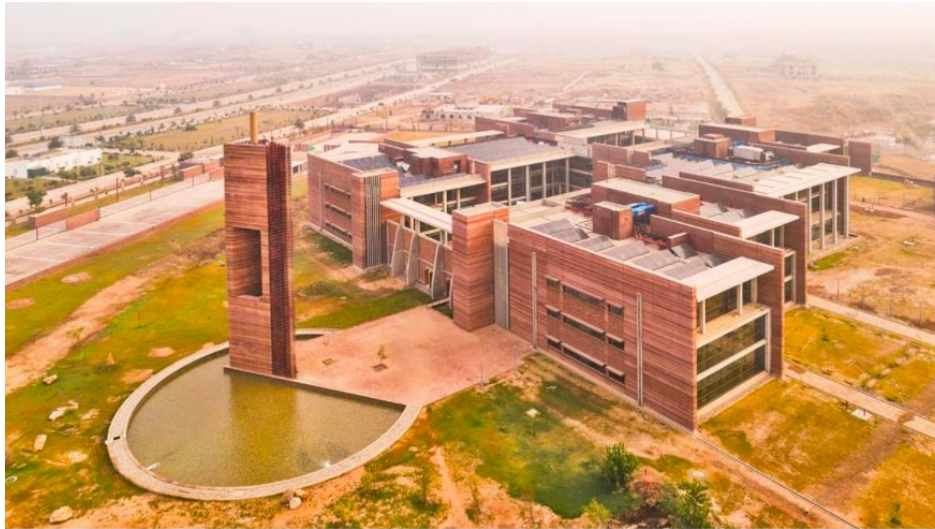
In order for a soil structure to be considered modern, it should not only rely on past teachings in its construction techniques but also benefit from innovations brought by contemporary technology. Adobe, a natural and sustainable soil building material, possesses thermal and sound insulation properties. However, it has disadvantages such as low compressive strength and vulnerability to water, which hinder its widespread use. In many parts of the world, these limitations have been addressed by improving the weak aspects of adobe through modern construction techniques. Examples of soil construction techniques that have been used since ancient times and have been modernized to meet the needs of today include "rammed earth technique, compressed earth block technique, on-site cast earth technique, lightweight soil technique, stabilized earth technique, and PISE technique."

Figure 1. The Telenor Office Building in Islamabad, Pakistan (URL 1).

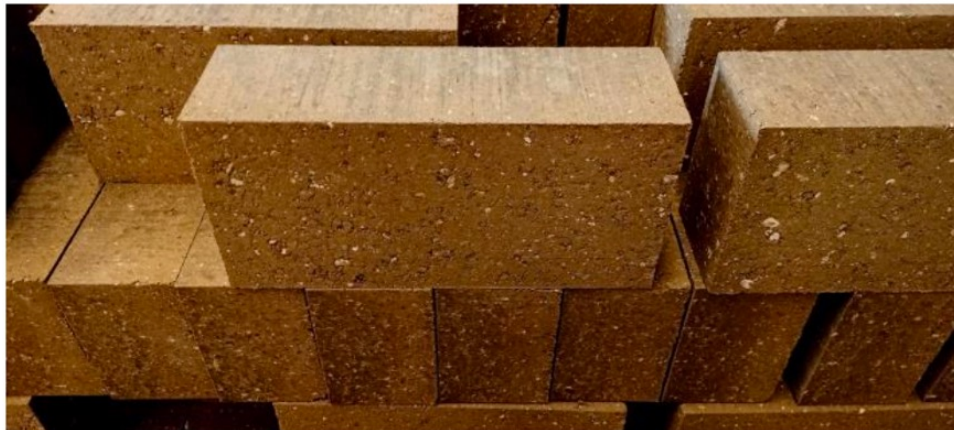
Promoting the sustainable use of soil materials and construction techniques related to soil is of paramount importance for the future of the world. It is crucial to examine the methods used, especially in their application to meet modern needs. As part of this paper's focus on modern soil constructions, examples of sustainable use of soil materials will be explored. The acquisition of materials is also a component of ecological design, which is part of the Building Life Concept. Due to the increasing pressures of urbanization worldwide, it is recommended to source soil for new housing developments from excavated soil that is lost and can be recycled for suitable purposes. Excavated soil can be reintegrated into the construction cycle by being used in the building's structure. Such applications can be particularly preferred in industrial areas where soil is the primary raw material. The practice known as "urban mining" has become increasingly prevalent, especially in European cities in recent years (Figure 5). Benefits:

Figure 5. Compressed Earth Blocks made of excavated earth (Resource: URL 6)

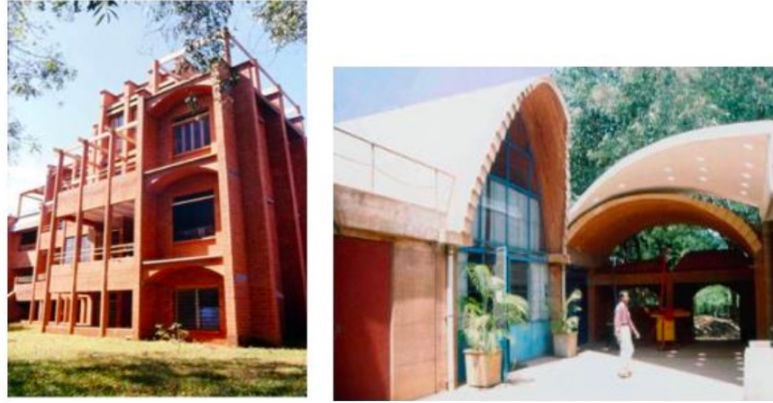
For example, in France, the research group CRAterre focuses on the development of earth construction techniques, with a specific focus on the use of excavated soil in modernizing local systems [9]. Satprem Maini, who works on the reuse of excavated soil by benefiting from CRAterre's courses, established the Auroville Earth Institute (AVEI) in India. The institute has constructed a type of compressed earth block using a mechanized block press. They have also developed techniques based on the use of stabilized soil for vaults and domes [10] (Figure 6).

Figure 6. The example of integrated quarries by AVEI and the Auroville Earth Institute on the left was built entirely with stabilized soil (URL 9)

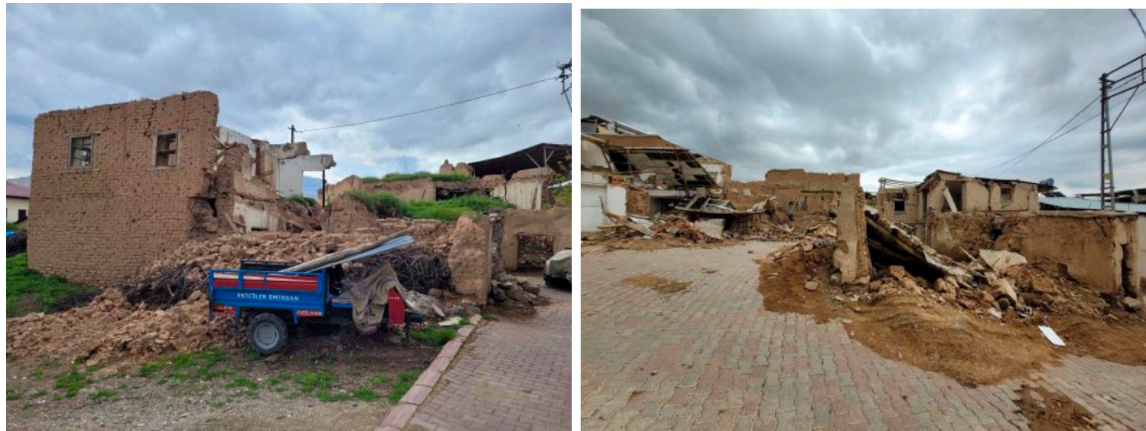
Recent earthquakes in our country have shown that, although soil material may be seen as an outdated and easily destructible material with maintenance challenges, it is once again being considered due to its advantages such as rapid production, lightweight nature, and its potential for eco-design by improving climatic conditions. For example, in the earthquakes that occurred in cities like Malatya and Elazığ, many traditional houses built with adobe techniques in rural areas were destroyed (Figure 8). Considering the characteristics of these regions, the possibility of using the excavated soil generated after the destruction in the field could be explored for temporary or long-term housing solutions after earthquakes.

Figure 8. The situation of Malatya Balaban Village after the earthquake (29.04.2023, Ulubay Archive)

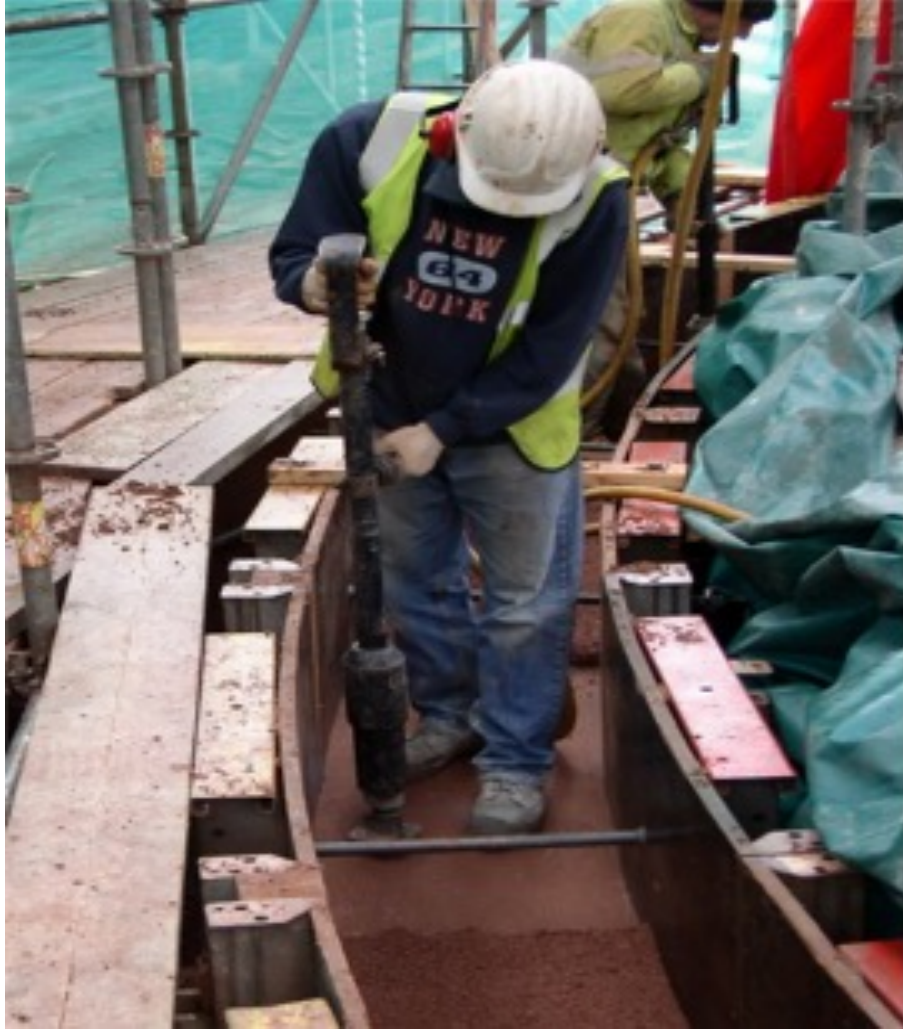
It was decided to produce a temporary housing structure as an alternative to the container structure. In this study, ALKER (Gypsum Adobe) building material, which is an improved adobe material that is also used in other productions and greatly reduces the disadvantages of traditional adobe building material, was produced using compression technique [Figure 2].

Figure 2: Compression technique

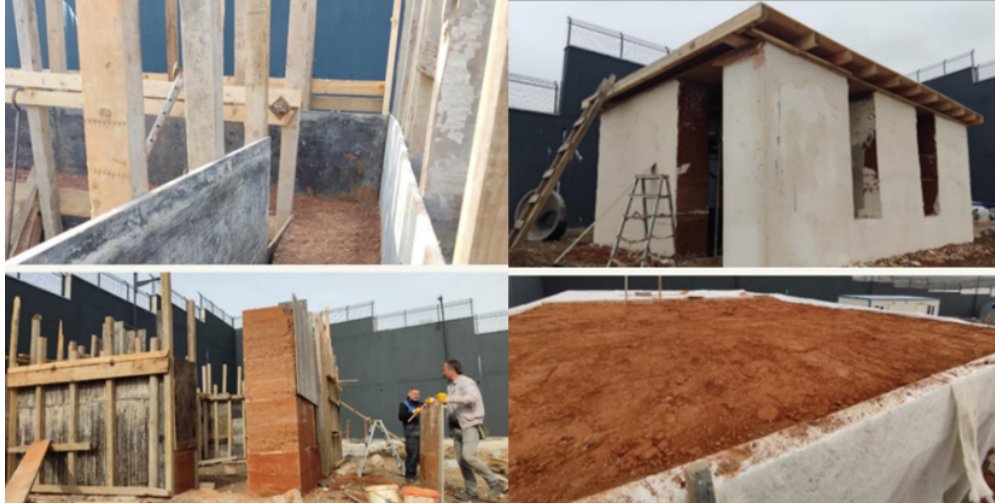
After the application manual was published, the first prototype study, which will be applied in Tuzla, Istanbul, was started [Figure 4].

Figure 4: Temporary shelter plan and 4-module system produced from earth

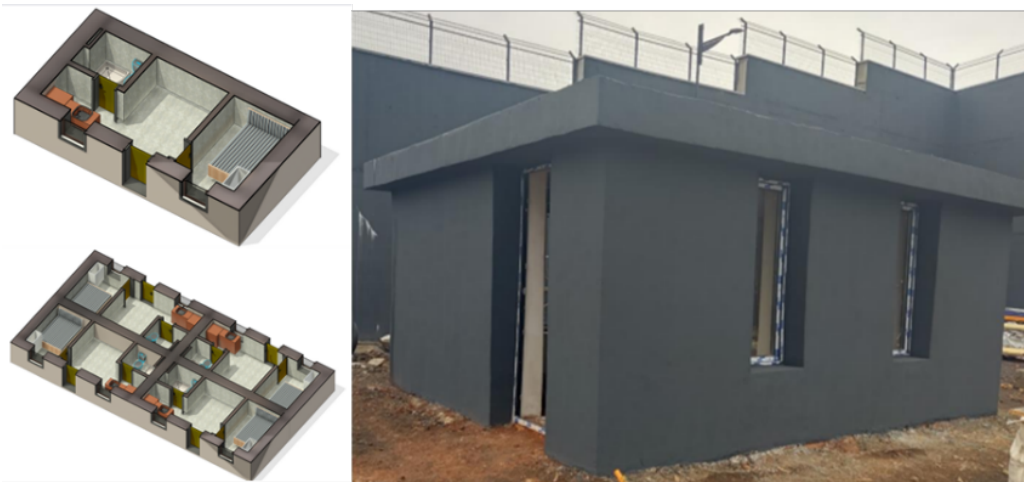
Due to cost reduction and a number of social and physical needs, 4 pieces module system has been developed for different user groups [Figure 5].

Figure 5: Temporary shelter plan produced from earth, 4-module system and the final version of the temporary shelter

In the preliminary study, it was determined that the total construction cost of a unit is almost half of the container construction cost. In addition, it has been seen that labor and equipment costs can be reduced with some interventions.

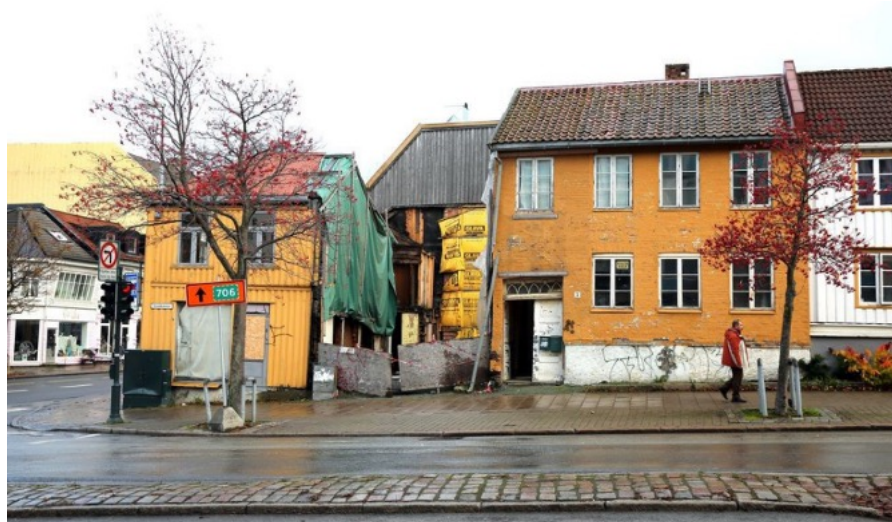
Figure 1. The façade of Smedbakken 5 in Trondheim built in 1846: approx. 40-year-old paint that acts as a vapour barrier and visible damage to the building physics caused by disturbed micro-meteorology: frost wedging, cracks and flaking of the paint (source: Adresseavisen)

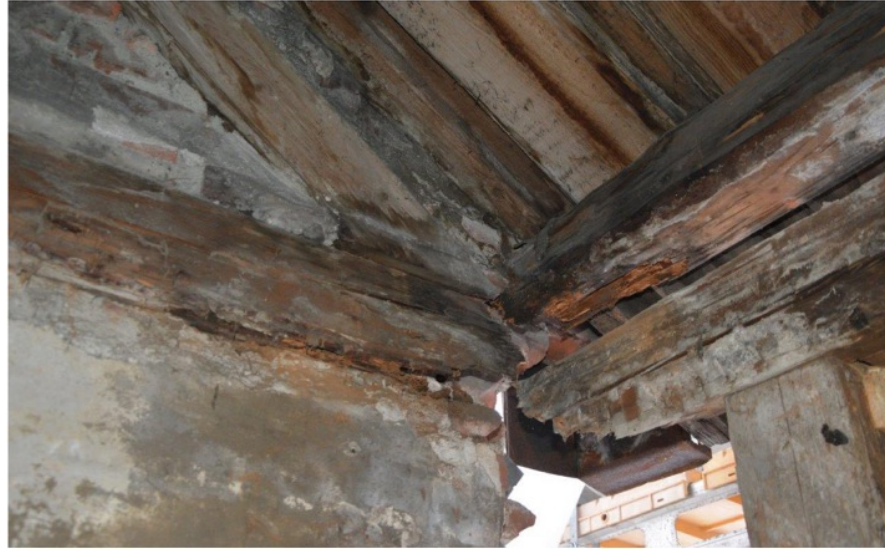
Figure 2. All of the geometric envelopes of the 175-year-old residential house are affected due to the micro-meteorological reversal of the vapour permeability and the following change of the dew point. (Source: Author)

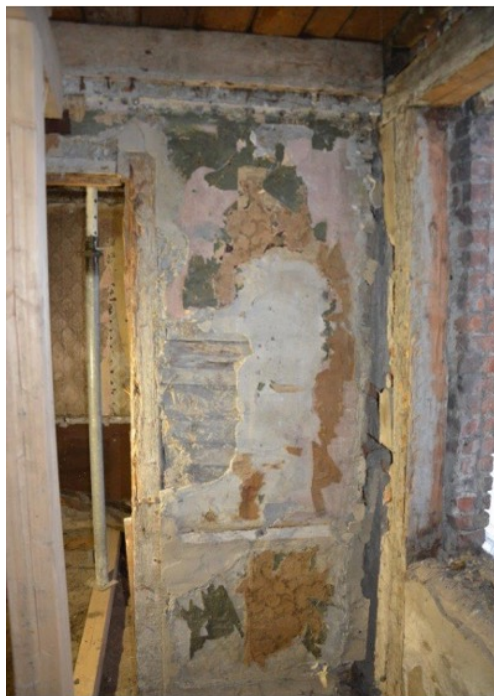
Figure 3. Traditional type of vernacular Nordic timber and earthen construction (earth mortar layer between squared timber in wood framing) with “rapping” (a type of Norwegian clay plaster on wooden surfaces), in the house Smedbakken 5 from 1845/46 in Trondheim, Norway (source: author)

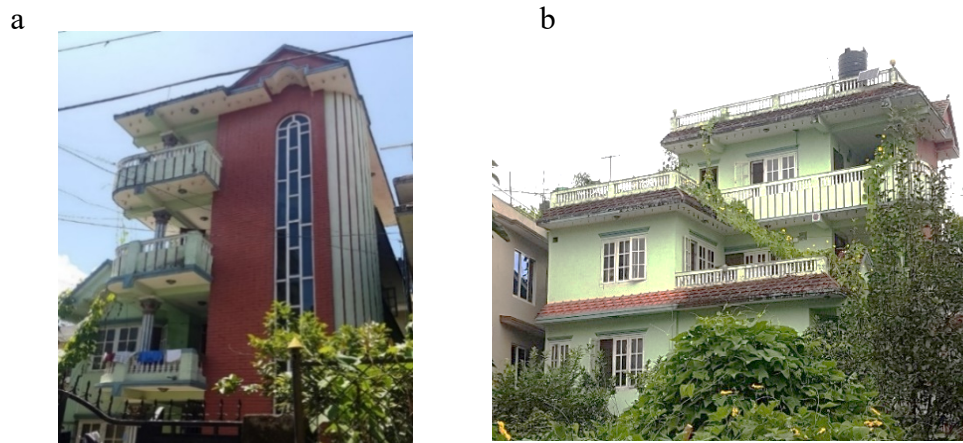
The existing reinforced concrete residential building selected for study is shown in Fig. 2. Data on building materials, architectural features, structural conditions, thermal comfort, energy consumption and inhabitant's interest for upgradation of the building, were recorded along with the building drawing and measurement which are required for simulations. The building informations are tabulated in [Table 1, Table 2].

Figure 2: Picture of East elevation (a) and South elevation (b) of an existing residential reinforced concrete building, Tokha, Nepal.
